AIRCRAFT ACCIDENT REPORT AND EXECUTIVE SUMMARY

Ref No.	CA18/2/3/8327	
Aircraft Registration	ZS-RHI	Date of Accident	10 July 2007		Time of Accident	1000Z
Type of Aircraft	ROBINSON R22	Type of Operation		Private		
Pilot-in-command Licence Type	Private (Helicopter)	Age	40	Licence Valid	Yes	
Pilot-in-command Flying Experience	Total Flying Hours	1 046.5		Hours on Type	784.7	
Last point of departure	Bergtop farm, Waterpoort, Limpopo					
Next point of intended landing	Hoedspruit Aerodrome (FAHS), Limpopo					
Location of the accident site with reference to easily defined geographical points (GPS readings if possible)						
20 nm east of Louis Trichardt in the Soutpansberg gorge (GPS co-ordinates: S22°'59.31 E029° 38.32)						
Meteorological Information	Surface wind at 070° at 3 kts, temperature, 17°C, CAVOK					
Number of people on board	1 + 1	No. of people injured	0 + 1	No. of people killed	0	
Synopsis	<p>The pilot was accompanied by a passenger on a private flight from the Bergtop farm in the Waterpoort area to Hoedspruit. According to the pilot, he departed with full tanks. He planned to drop the passenger (his 16-year-old nephew) at Klaserie Game Reserve en route to Hoedspruit. As t

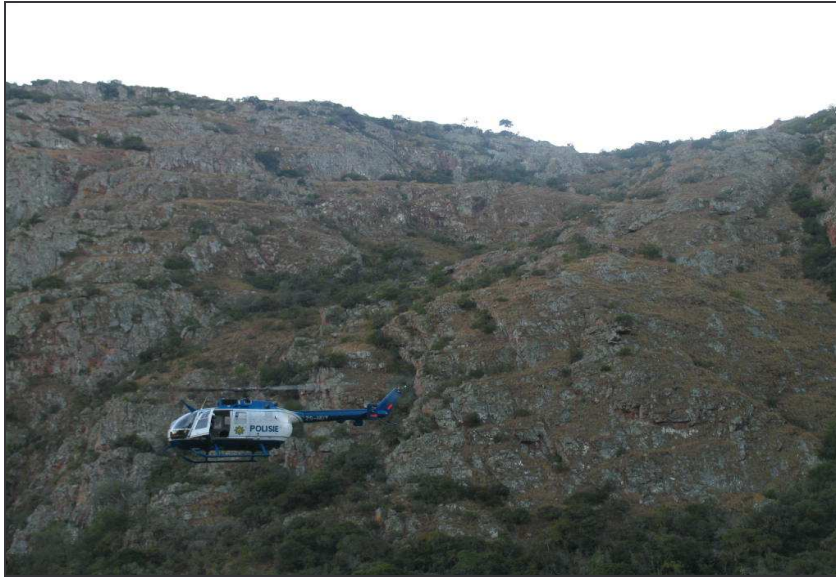
Figure 1: The police helicopter flying over steep and rocky terrain near the site

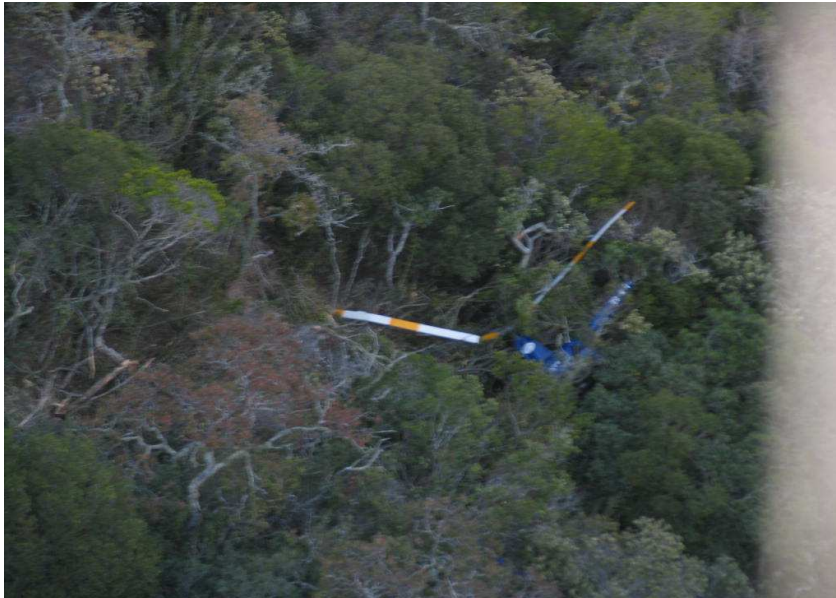
Figure 2: Aerial view of the helicopter wreckage in trees

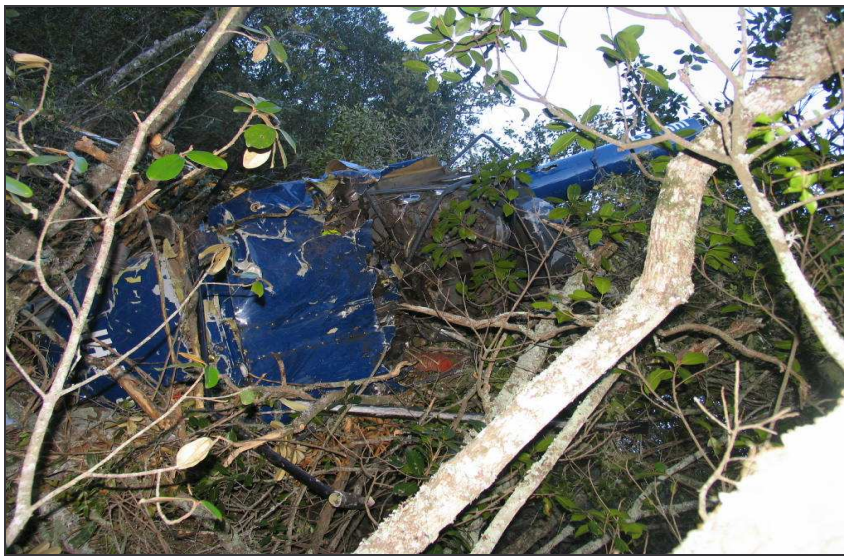
Figure 3: The helicopter mashed into trees

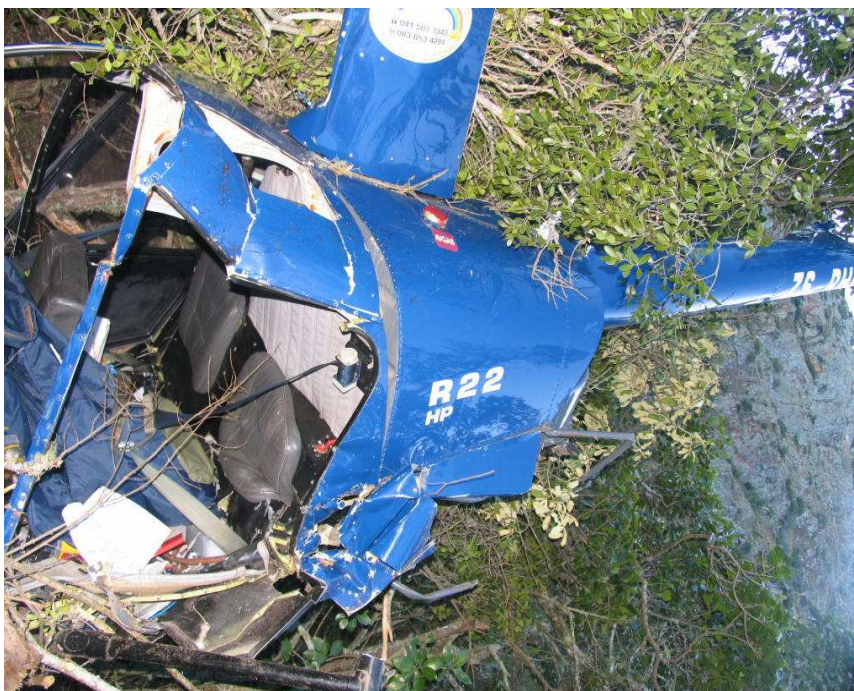
Figure 4: The helicopter wreckage, extensively damaged on impact with trees

1.3.1 The helicopter fuselage, main rotor blades, tail rotor blades, landing skids and airframe were extensively damaged during the impact sequence.

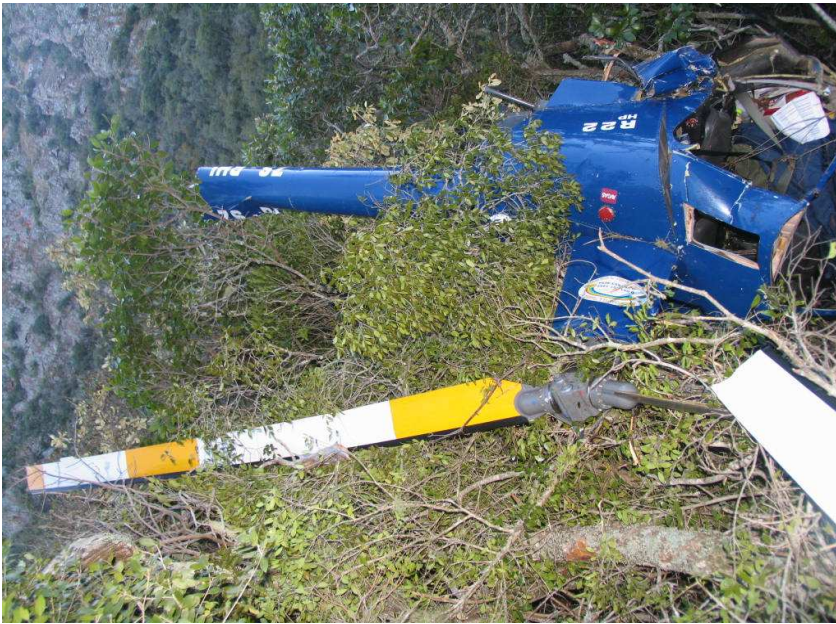
1.12.1 The pilot was flying in an easterly direction when he executed an auto-rotational landing in a valley/gorge in the Makhado mountains near Louis Trichardt in the Limpopo district. The helicopter mashed into some trees. The rear section of the tail boom broke off during the impact sequence. The tail rotor separated from the tail boom and could not be located at the accident site.

Figure 5: The helicopter in the trees in the valley

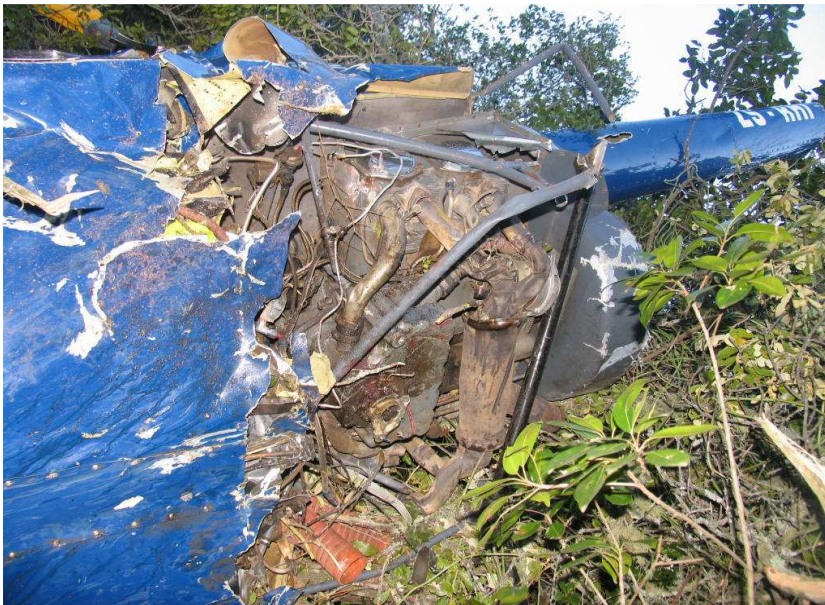
Figure 6: The main wreckage and damage sustained
