AIRCRAFT ACCIDENT REPORT AND EXECUTIVE SUMMARY

Name of Owner/Operator : Lezmin CC
Manufacturer : Cessna
Model : 177A
Nationality : South Africa
Registration Marks : ZS-FJY
Place : Bethlehem Aerodrome
Date : 26 July 2007
Time : 0830Z

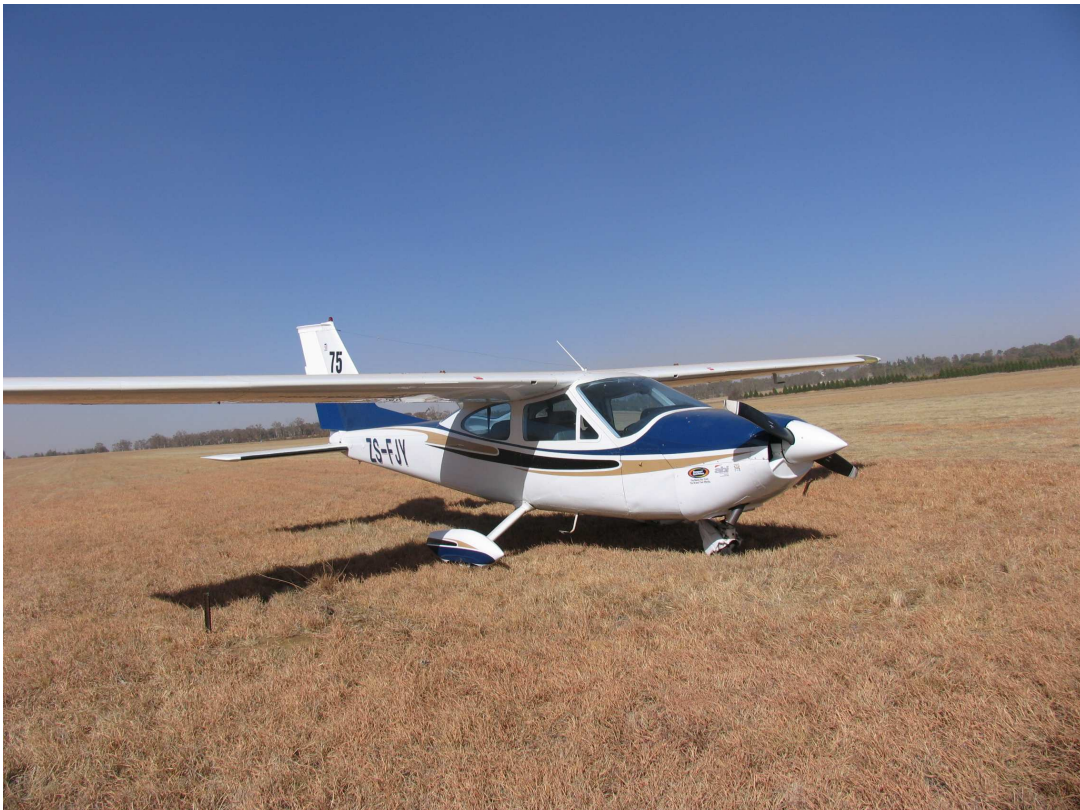
1.3.1 The aircraft sustained damage to the propeller, nose gear and main landing gear.

Figure 1: The aircraft after landing

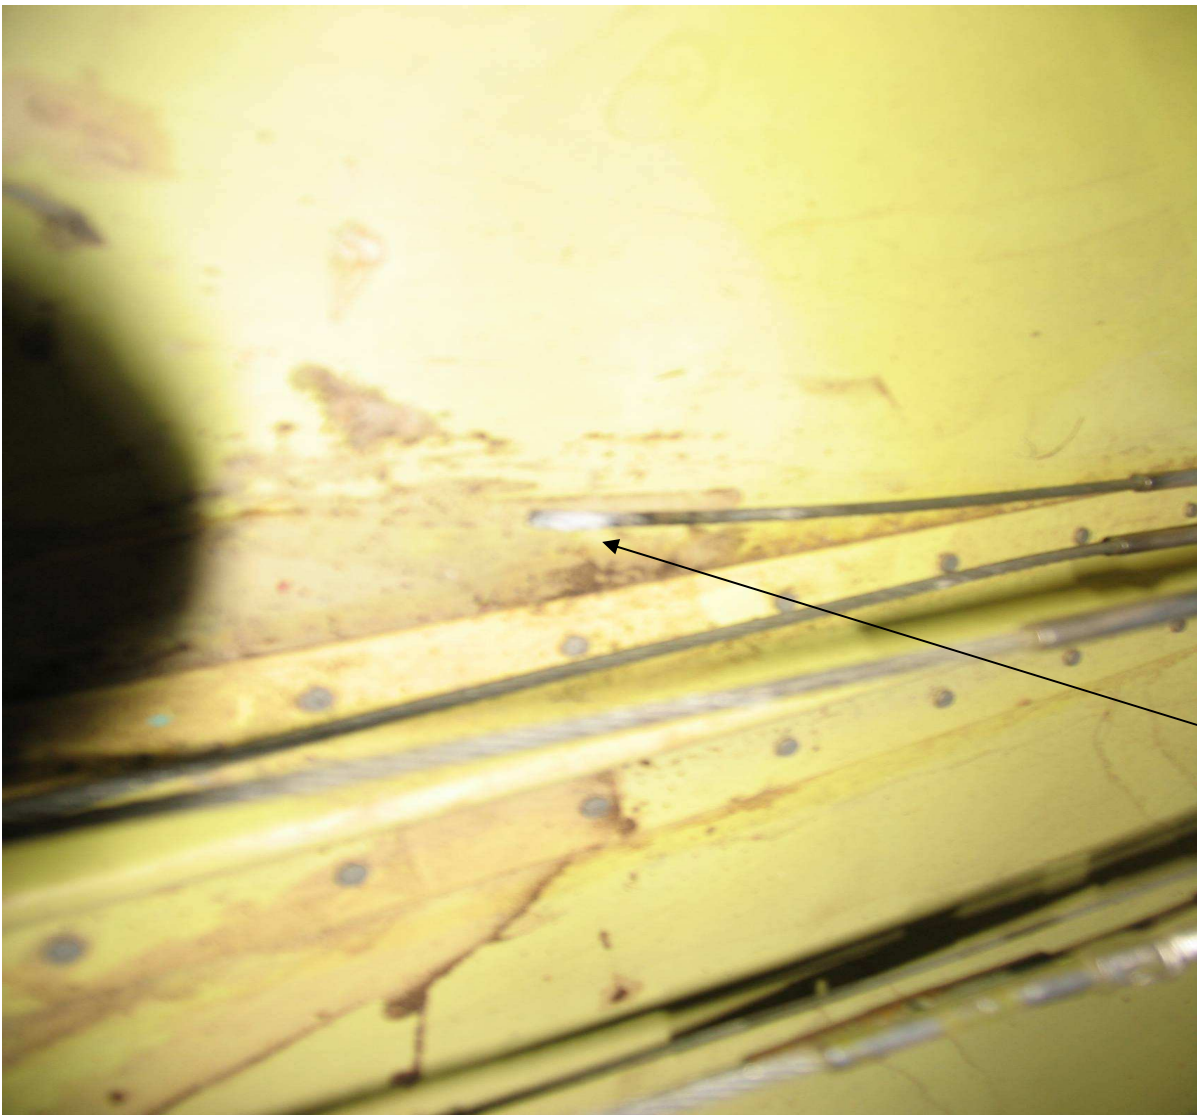
1.16.1 On-site investigations revealed that the right-hand elevator control cable had failed due to corrosion caused by the leakage of battery acid. The battery is situated above the cables in the aft fuselage section. The battery overboard vent-pipe was found to be venting into the fuselage instead of overboard.

Figure 2: The elevator control cable which broke off.

- 2.1 The pilot departed from Bethlehem Aerodrome uneventfully but on final approach for landing he noticed that the elevator control was inoperative. The elevator control cable had fractured and failed due to corrosion where the control cable is routed through the fairlead in the aft baggage compartment as a result of battery acid spillage.

- 3.2.1 The elevator control cable failed due to corrosion where the control cable is routed through the fairlead in the aft section of the fuselage as a result of battery acid spillage.

- 4.1 In the interest of aviation safety, it is recommended that the AMO should be audited regarding maintenance practice in terms of scope of work and approval certificate. The AMO had inspected the control cables but had not noticed the corrosion.

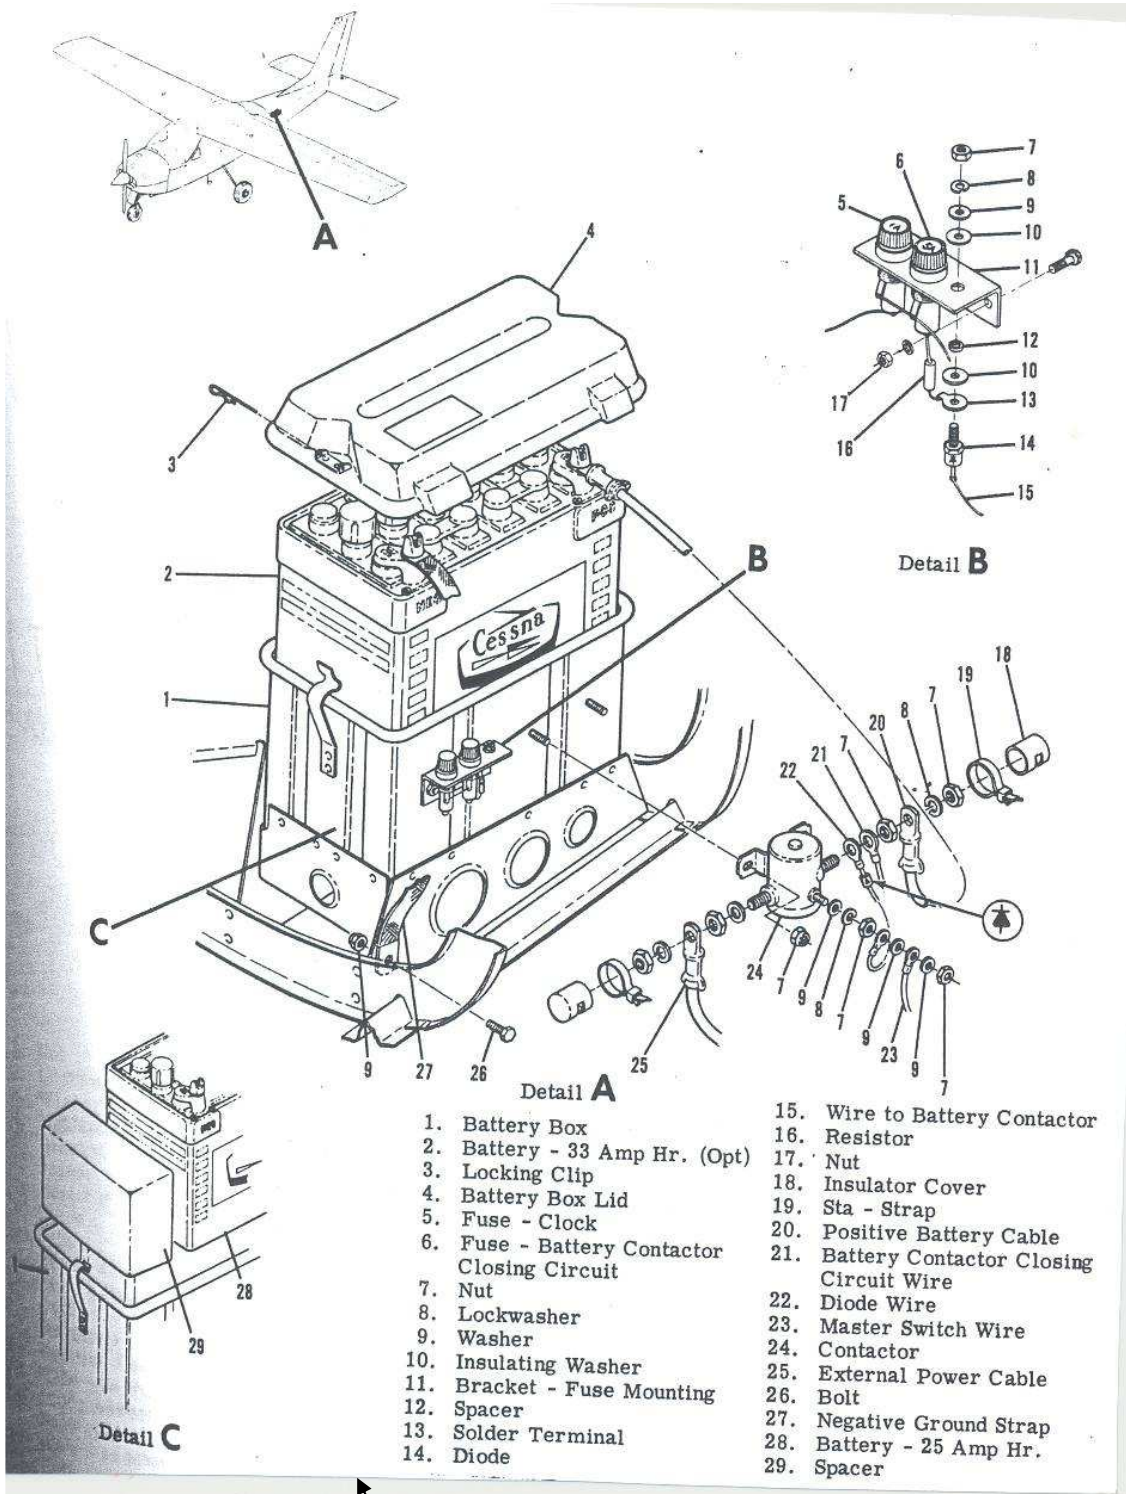
Figure 3: The schematic diagram of the battery.
