AIRCRAFT ACCIDENT REPORT AND EXECUTIVE SUMMARY

Reference:	CA18/2/3/8338	
Aircraft Registration	ZS-RRF	Date of Accident	28 July 2007	Time of Accident	1445Z	
Type of Aircraft	Robinson R22		Type of Operation	Training		
Pilot-in-command Licence Type		Student	Age	37	Licence Valid	Yes
Pilot-in-command Flying Experience		Total Flying Hours	73.0	Hours on Type	38.7	
Last point of departure		Kimberley Aerodrome (FAKM) – Northern Cape				
Next point of intended landing		Kimberley Aerodrome (FAKM)– Northern Cape				
Location of the accident site with reference to easily defined geographical points (GPS readings if possible)						
In the Vaal River at the General Flying Area (GFA) approximately 40 km North of Kimberley Aerodrome. GPS points: S28°30.761' E024°40.962' and elevation of 3332 feet.						
Meteorological Information		Clouds: Nil, Visibility: 10km, Wind: 300 ⁰ /05kts, Temperature: 11°C, Freezing level: 6000ft AMSL.				
Number of people on board	1 + 0	No. of people injured	0	No. of people killed	1

Name of Owner/Operator : Westline Aviation
Manufacturer : Robinson
Model : R22
Nationality : South African
Registration Marks : ZS-RRF
Place : Riverton
Date : 28 July 2007
Time : 1445Z

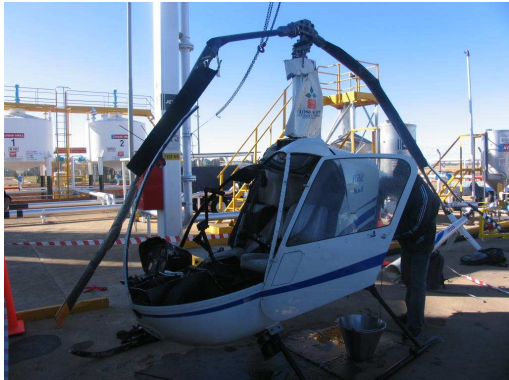
1.3.1 The aircraft was destroyed during the impact sequence with high tension electrical wires and water. See photo 1 and 2.

Photo 1 showing damage to the helicopter.

1.12.1 The helicopter impacted with electrical wires, which were approximately 10-12 metres high in a straight and level attitude with its main rotor mast before it was flipped over the wires, and in the process the main rotors severed the tail boom.

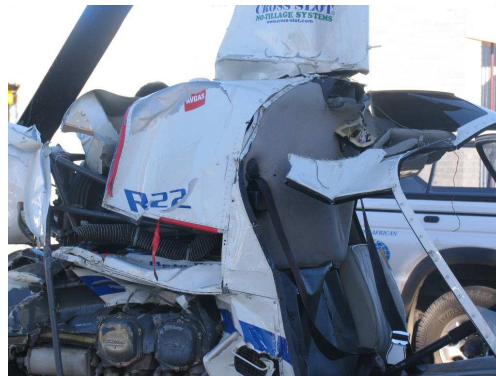
Photo 2 damage to the starboard side of the helicopter.

1.12.2 The helicopter subsequently impacted with the surface of the water on its starboard side before it submerged.

1.12.4 The helicopter came to rest on its starboard side at the bottom of the river, which was approximately 04 metres deep.

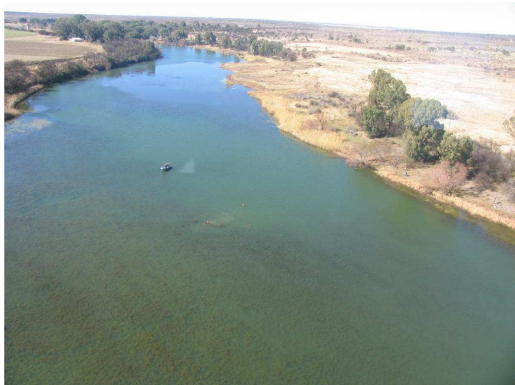
1.4.1 The only other damage was to the electrical cables which failed and had to be replaced. The river was contaminated by fuel when the right-hand fuel tank ruptured during the impact sequence. See photo 3 and 4.

Photo 3 showing the accident site.

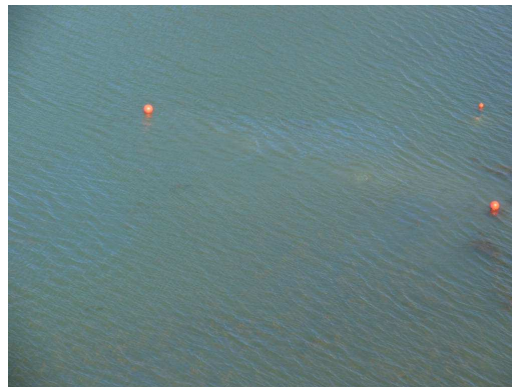
Photo 4 showing the submerged helicopter and contamination to the river.

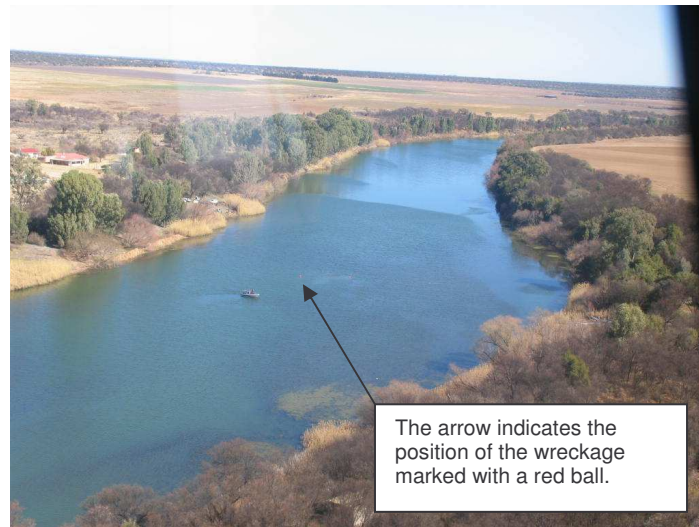
1.10.1 The accident occurred in the Vaal River at KGFA in Riverton 16 kilometres north of Kimberley Town at the following coordinates: S28°30.761' E024°40.962' at an elevation of 3332 feet. See photo 4.

Photo above indicates the accident site (Photo 4).
