EXECUTIVE SUMMARY - AIRCRAFT ACCIDENT REPORT

Reference:	CA18/2/3/8344	
Aircraft Registration	ZU-TWH	Date of Accident	6 August 2007		Time of Accident	1400Z
Type of Aircraft	Samba UFM-10		Type of Operation	Private		
Pilot-in-command Licence Type		Microlight (SA Validation)	Age	54	Licence Valid	Yes
Pilot-in-command Flying Experience		Total Flying Hours	1 060,0		Hours on Type	Unknown
Last point of departure		Pemba Aerodrome, Mozambique (FQPB)				
Next point of intended landing		Ibo Island Aerodrome, Mozambique				
Location of the accident site with reference to easily defined geographical points (GPS readings if possible)						
Ibo Island Aerodrome, Mozambique						
Meteorological Information		Surface wind: 185°/15kt; Temperature: 25°C; Visibility: CAVOK				
Number of people on board	1 + 1	No. of people injured	0	No. of people killed	0	
Synopsis						
<p>The pilot, who was a German citizen, obtained a South African Validation and was a member of a group of five aircraft flying together on a holiday excursion. After they cleared customs at Kruger Mpumalanga International Aerodrome in South Africa, they flew to Maputo International Aerodrome as port of entry into Mozambique. Fuel was up

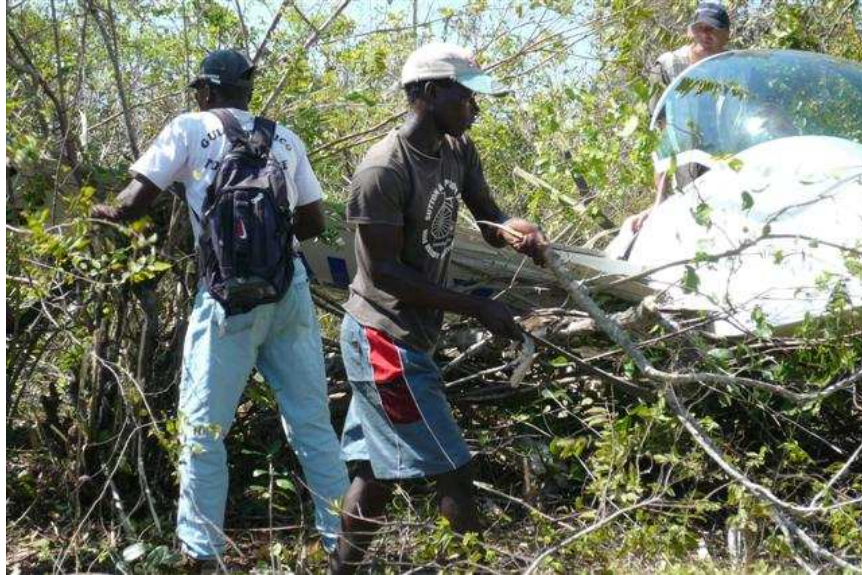
Figure 1. The wreckage being recovered from dense vegetation next to the runway.

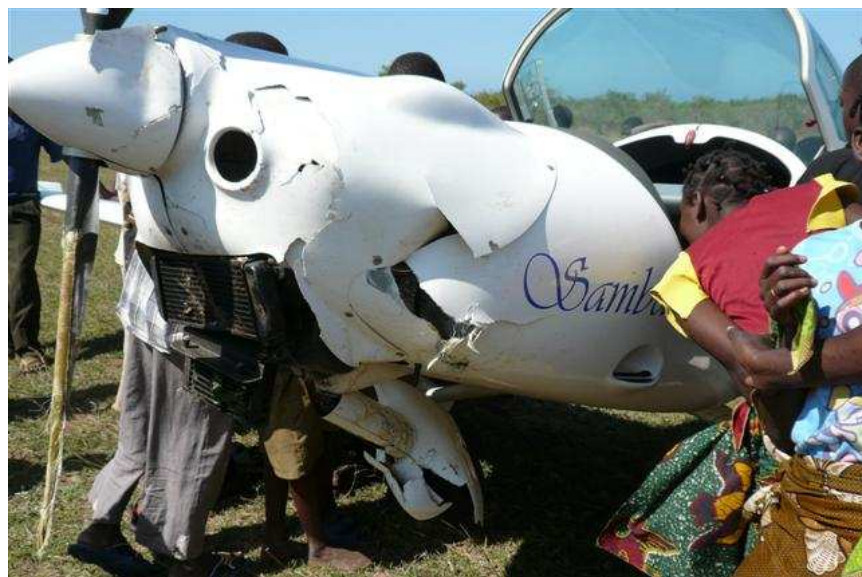
Figure 2. The aircraft was substantially damaged during the accident sequence.
