## AIRCRAFT ACCIDENT REPORT AND EXECUTIVE SUMMARY

Reference:	CA18/2/3/8346	
<b>Aircraft Registration</b>	<b>ZS-MNJ</b>	<b>Date of Accident</b>	8 August 2007	<b>Time of Accident</b>	1550Z	
<b>Type of Aircraft</b>	Piper PA-34-220T (Aeroplane)		<b>Type of Operation</b>	Private		
<b>Pilot-in-command Licence Type</b>		Private	<b>Age</b>	47	<b>Licence Valid</b>	No
<b>Pilot-in-command Flying Experience</b>		Total Flying Hours	453,3		Hours on Type	Unknown
<b>Last point of departure</b>		Lanseria Aerodrome (FALA), (Gauteng Province)				
<b>Next point of intended landing</b>		Rand Aerodrome (FAGM), (Gauteng Province)				
<b>Location of the accident site with reference to easily defined geographical points (GPS readings if possible)</b>						
25 Wingfield Avenue, Birdhaven, Johannesburg. GPS co-ordinates: S26°08.422' E028°03.209'						
<b>Meteorological Information</b>		Surface wind: 020°/3 kt; Temperature: 12°C; Dewpoint: 1°C; Visibility: > 10 km				
<b>Number of people on board</b>	1 + 1	<b>No. of people injured</b>	1 + 1	<b>No. of people killed</b>	0

<b>Probable Cause</b>						
<p>Unsuccessful forced landing after the aircraft was unable to sustain height due to an engine failure in flig

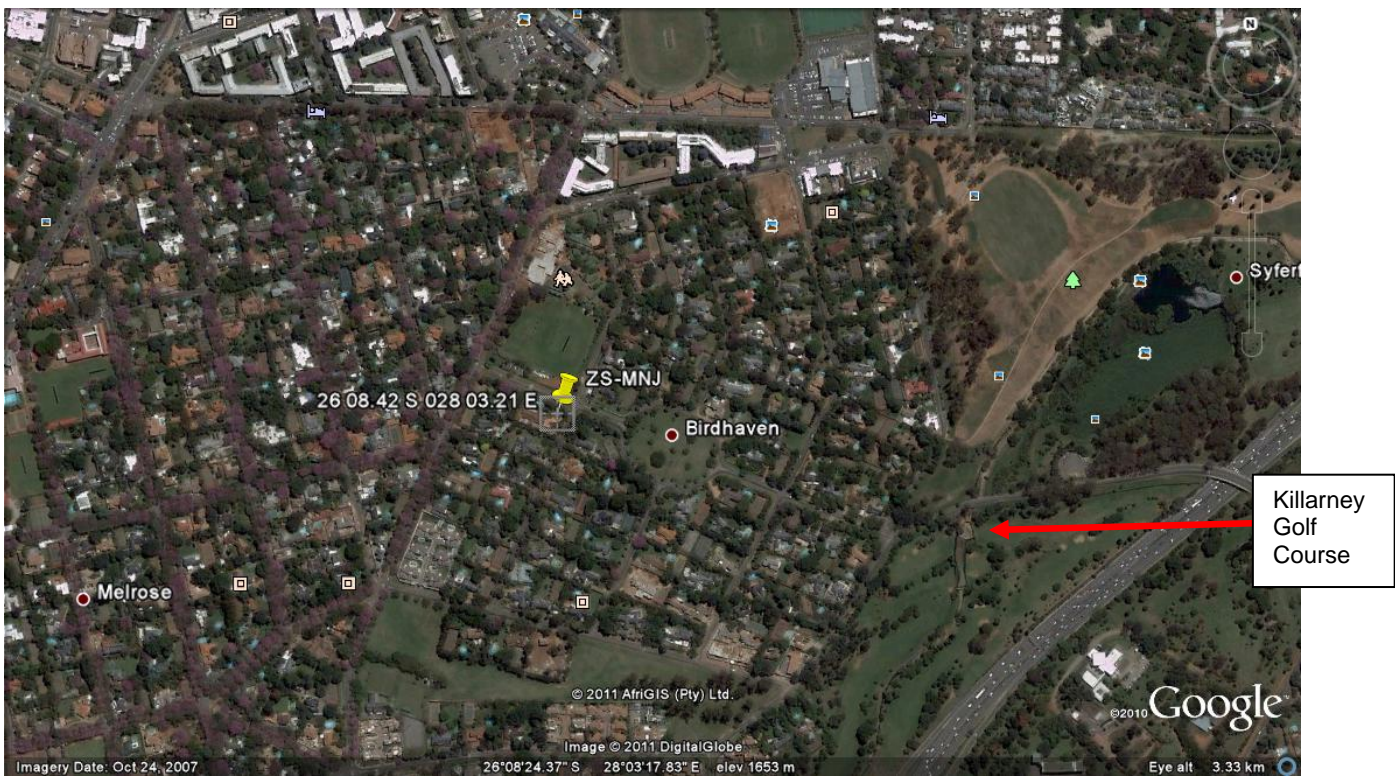
**Figure 1.** The location of the accident site relative to the golf course, the intended point of landing.

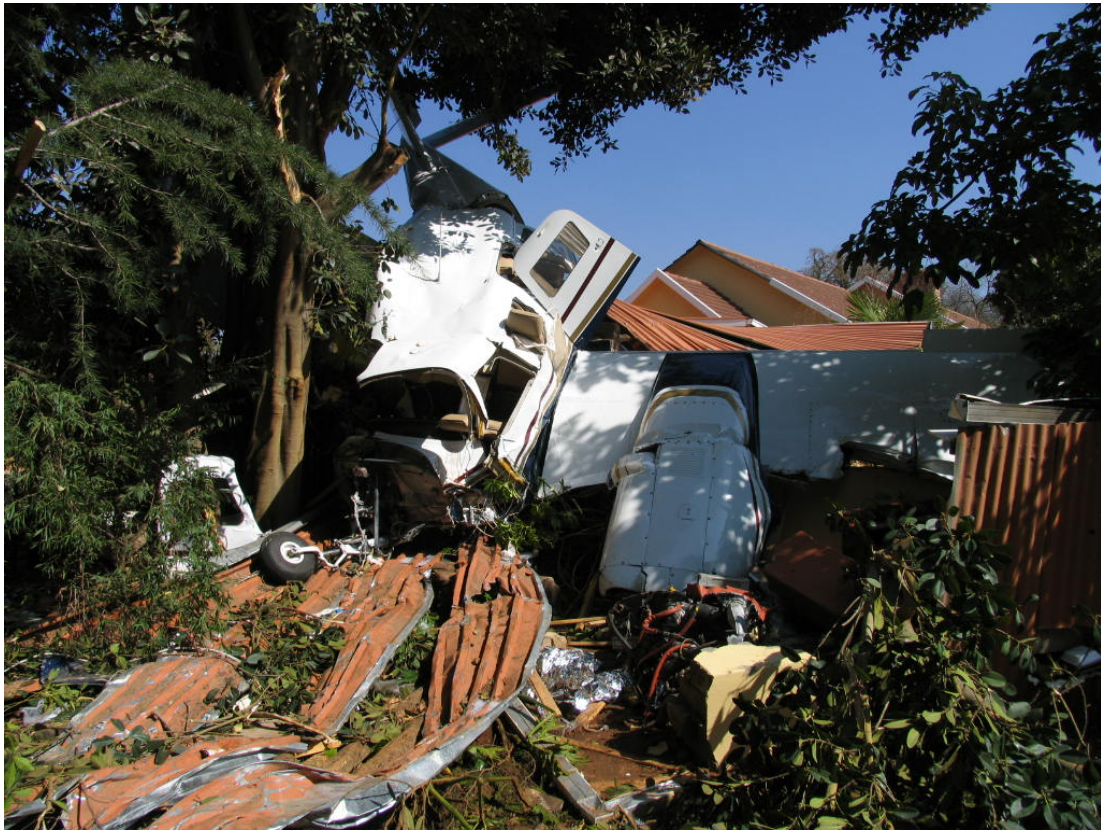
- 1.3.1 The aircraft was destroyed following impact with a large tree and an entertainment area on a residential property.

**Figure 2.** The wreckage of ZS-MNJ.

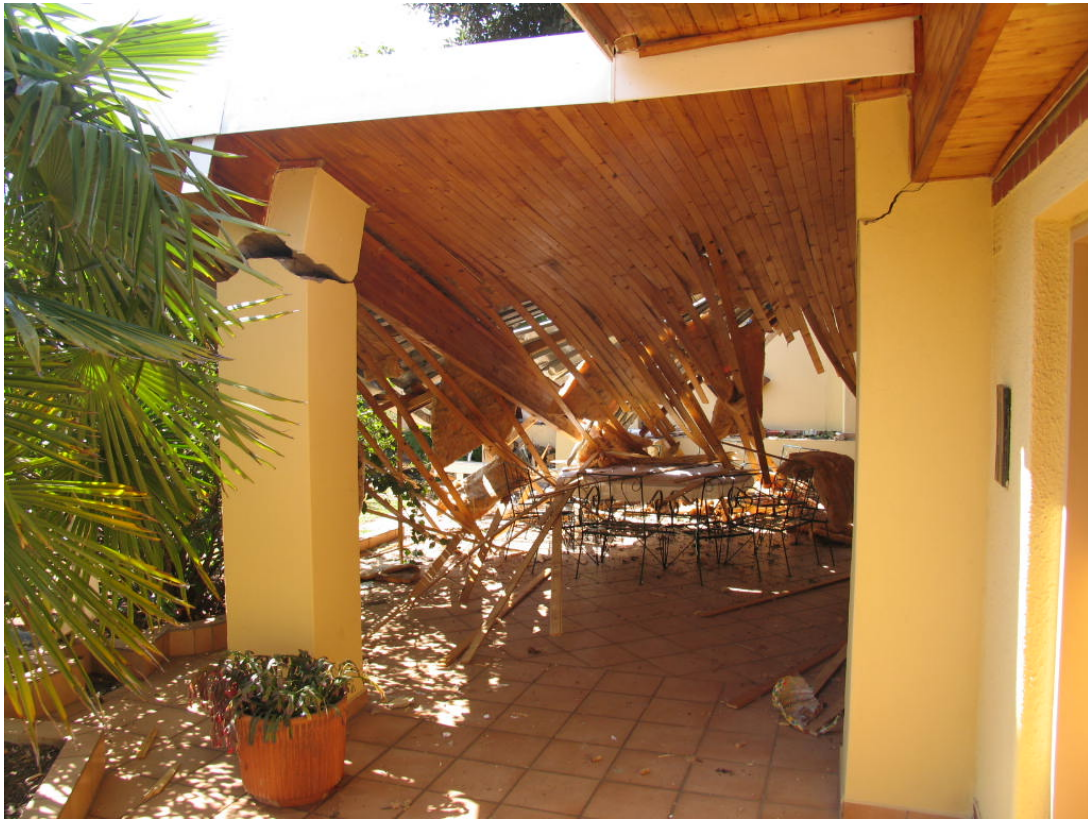
- 1.4.1 The aircraft crashed into an entertainment area of a residential house in Wingfield Avenue, Birdhaven, Johannesburg. The entertainment area and a section of the perimeter wall were destroyed during the impact sequence.
- 1.4.2 An additional section of the perimeter wall was knocked down by rescue and fire-fighting personnel to gain access to the injured occupants as the property was completely walled in and the only vehicular gate was locked at the time of the accident.

**Figure 3.** Structural damage to the entertainment area.

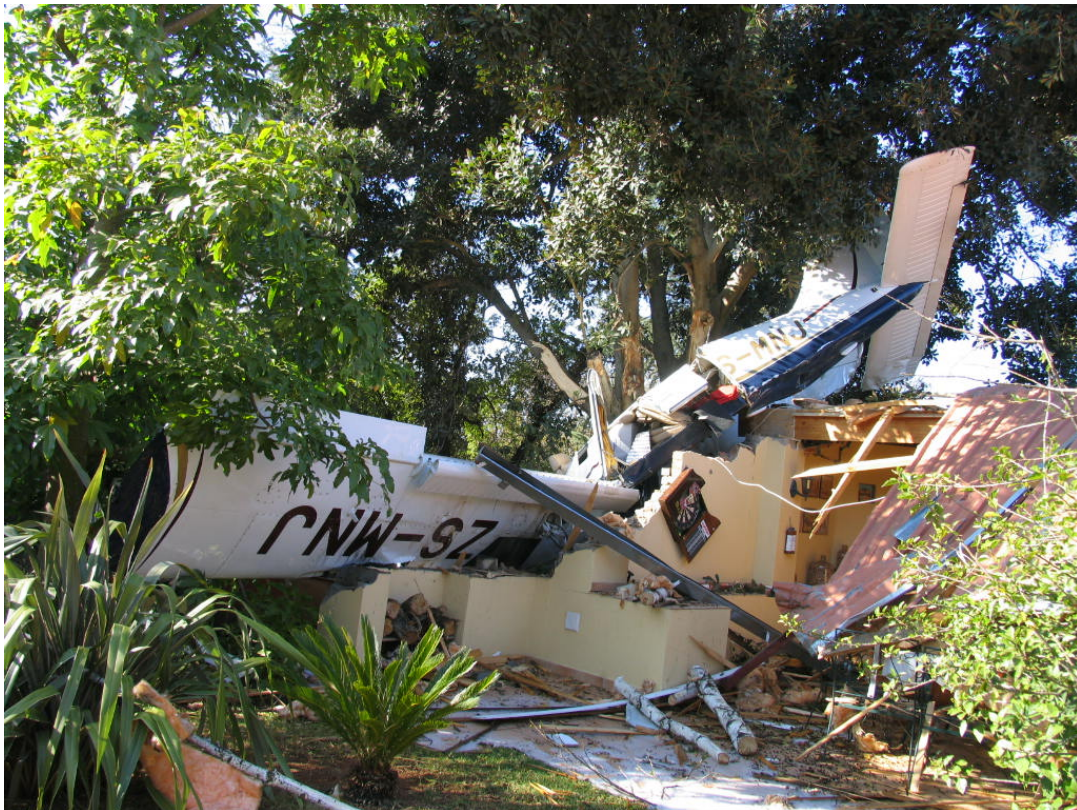
**Figure 4.** Another view of the damage to the entertainment area and the aircraft.

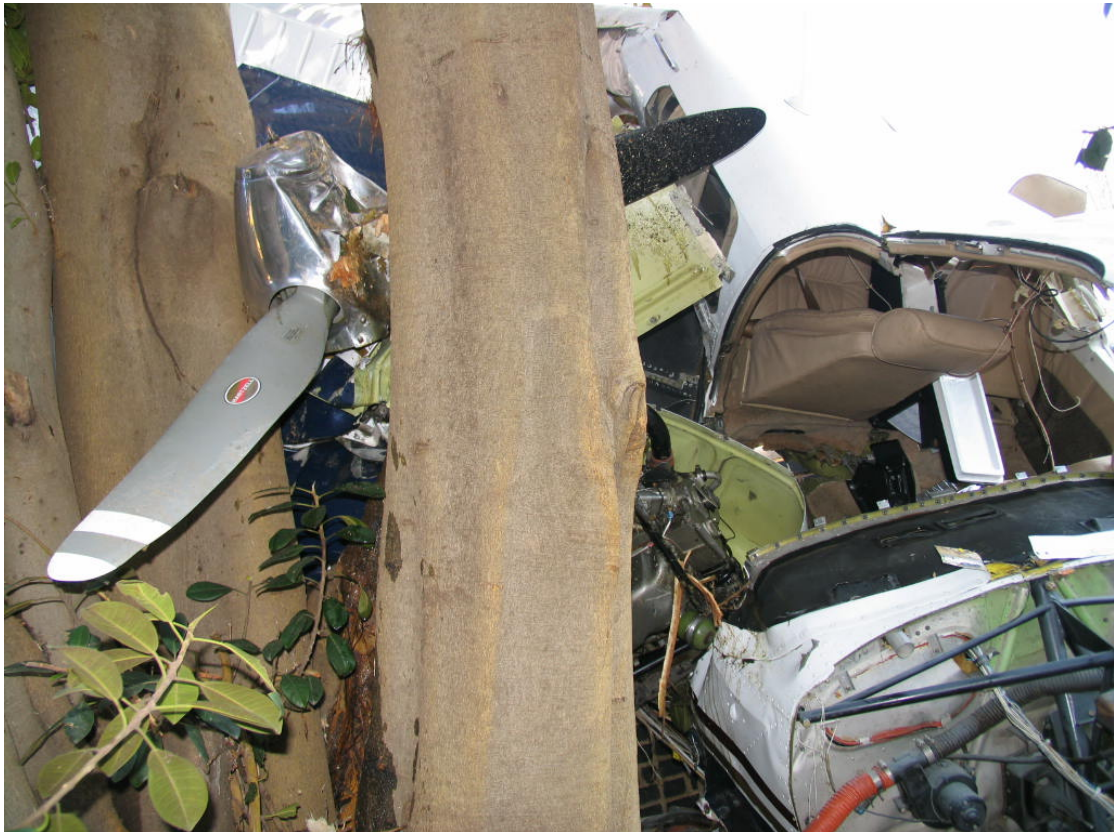
The right engine was founded wedged in a large tree. The propeller had fractured at the crankshaft attachment to the engine and was wedged in front of the engine in the tree. The propeller blades did not display any deformation or rotational signatures.

**Figure 5.** The right-hand propeller entangled in a tree.

The right propeller, which was found lodged in a tree after it had severed at the crankshaft flange, did not display any evidence of rotation, with only minor bending, attributed to impact, noted on the blades. The left propeller, which had also failed at the crankshaft flange in overload mode, showed evidence of damage following impact with the brick wall of the entertainment area: the blades were bent backwards along their tip area, with two of them displaying substantially more bending than the third. Both engines were subjected to a detailed engine teardown procedure and all relevant components that were still intact were bench-tested. No mechanical evidence was found that could have contributed to, or caused, the in-flight stoppage.

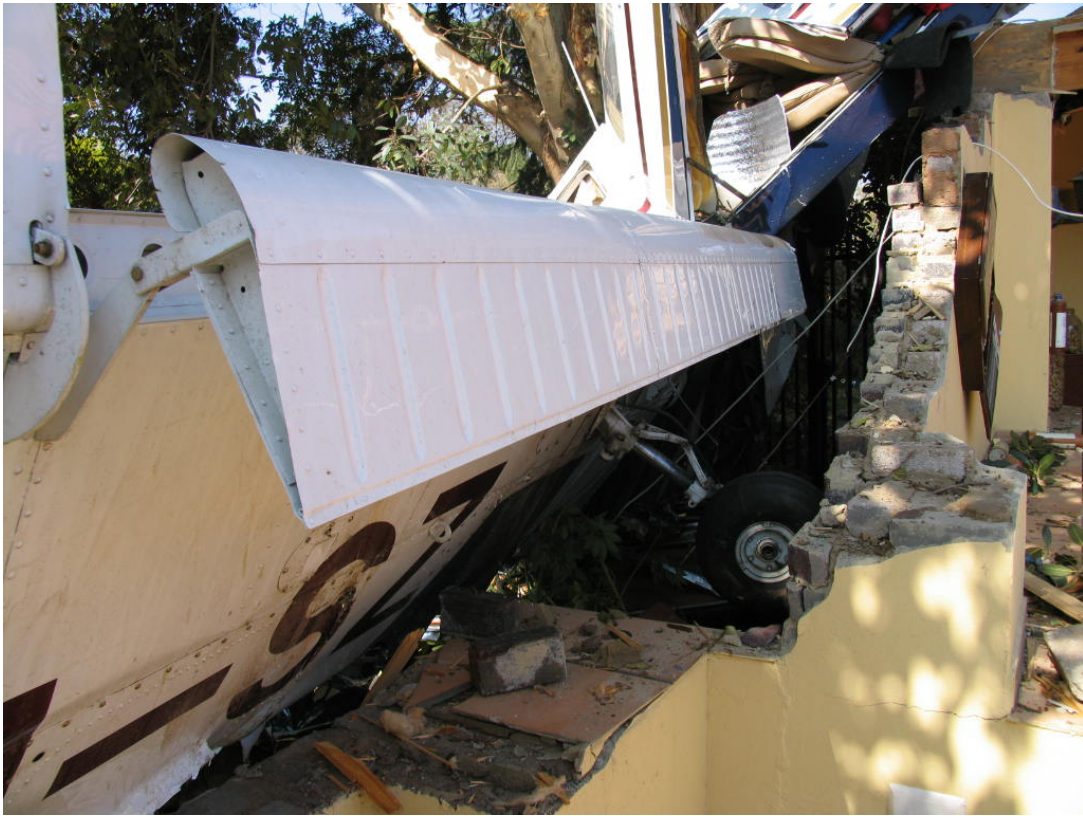
1.12.3 The nose-gear assembly collapsed during impact but remained attached to the fuselage. The two main undercarriage assemblies also remained secured to the wing. The left gear strut was found in the fully extended position, indicating that the gear had been selected down prior to impact. The right gear torque tube had failed during the impact sequence but was still attached to the wing.

**Figure 6.** The left wing with the main gear in the extended position.

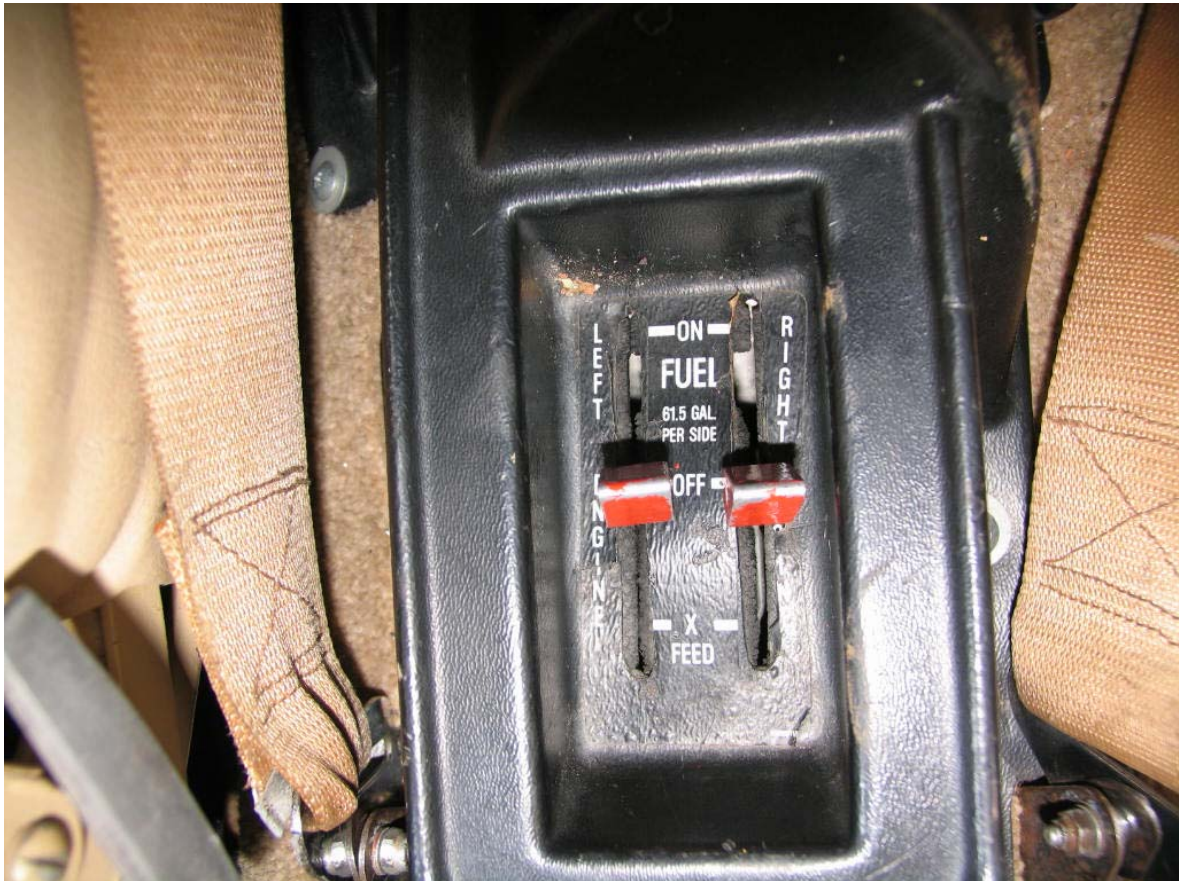
During examination of the wreckage, both fuel tank selector levers (ie, for the left and right engines) were found in the OFF position. Interviewed after their discharge from hospital, neither occupant could recall having made this selection. Emergency response personnel also confirmed that they had not tampered with the wreckage in any way, apart from cutting open the roof to free the trapped passenger.

**Figure 7.** The fuel tank selector levers as found on site.

A second question that could not be answered was why the two fuel selector levers were found in the OFF position. Neither of the occupants nor any member of the rescue personnel could recall making this selection. However, it cannot be ruled out that one of the occupants made this selection as a safety measure shortly before impact. With the fuel selector levers located on the floor pedestal between the two seats, it is highly unlikely that the selection could have been performed inadvertently.
