AIRCRAFT ACCIDENT REPORT AND EXECUTIVE SUMMARY

Reference:	CA18/2/3/8313	
Aircraft Registration	ZS-EUF	Date of Accident	21 Aug. 2007	Time of Accident	1540Z	
Type of Aircraft	Mooney M20F		Type of Operation	Private		
Pilot-in-command Licence Type		Private Pilot	Age	55	Licence Valid	Yes
Pilot-in-command Flying Experience		Total Flying Hours	2315,2		Hours on Type	203,0
Last point of departure		Kimberley Aerodrome, Northern Cape				
Next point of intended landing		Kimberley Aerodrome, Northern Cape				
Location of the accident site with reference to easily defined geographical points (GPS readings if possible)						
On farm, approximately 5 km north west from Kimberley.						
Meteorological Information		Wind direction 020°/5kt; Temperature 20 °C; Visibility >10km; CAVOK				
Number of people on board	1 + 0	No. of people injured	0	No. of people killed	0	
Synopsis						
<p>On 21 August 2007, at approximately 1540Z, the pilot who was the sole occupant onboard the aircraft, departed from Kimberley Aerodrome on a private flight in order to conduct some test circuits at the aerodrome.</p> <p>The pilot stated that after takeoff, the aircraft climbed to approximately 800 ft AGL when the engine s

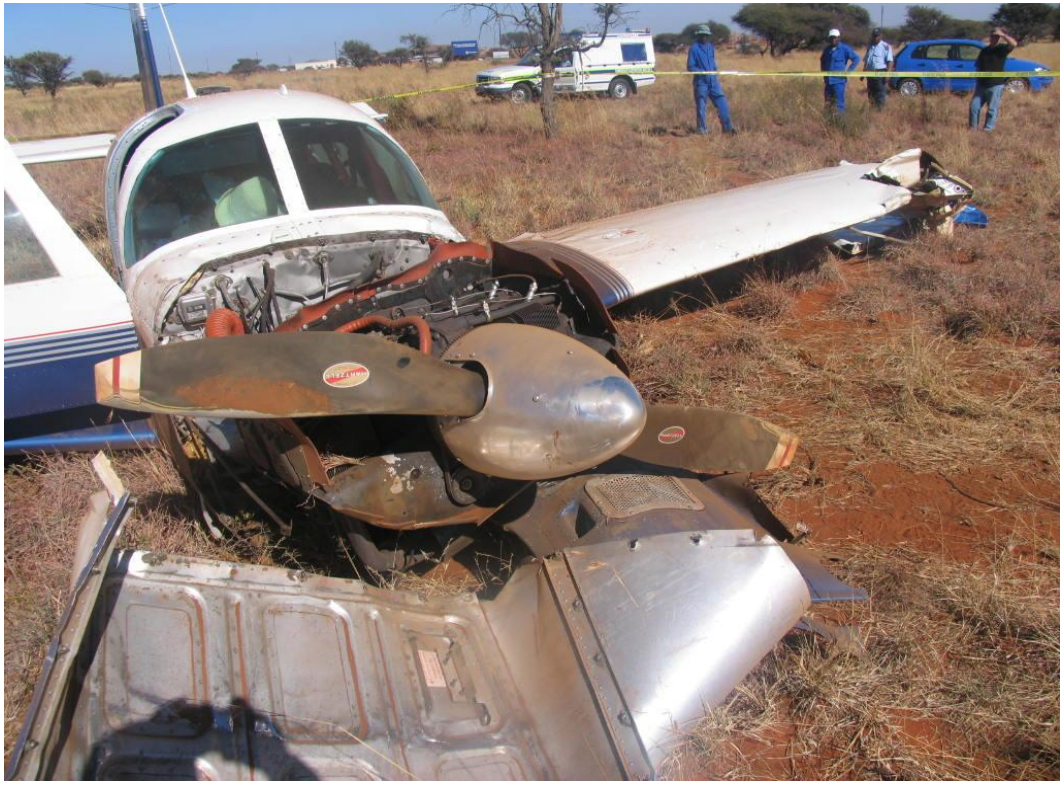
- 1.3.1 The aircraft sustained extensive damage to the fuselage structure, the propeller and engine, and the left wing.

PHOTO 1: VIEW OF DAMAGE TO UNDERCARRIAGE, ENGINE AND LEFT WING

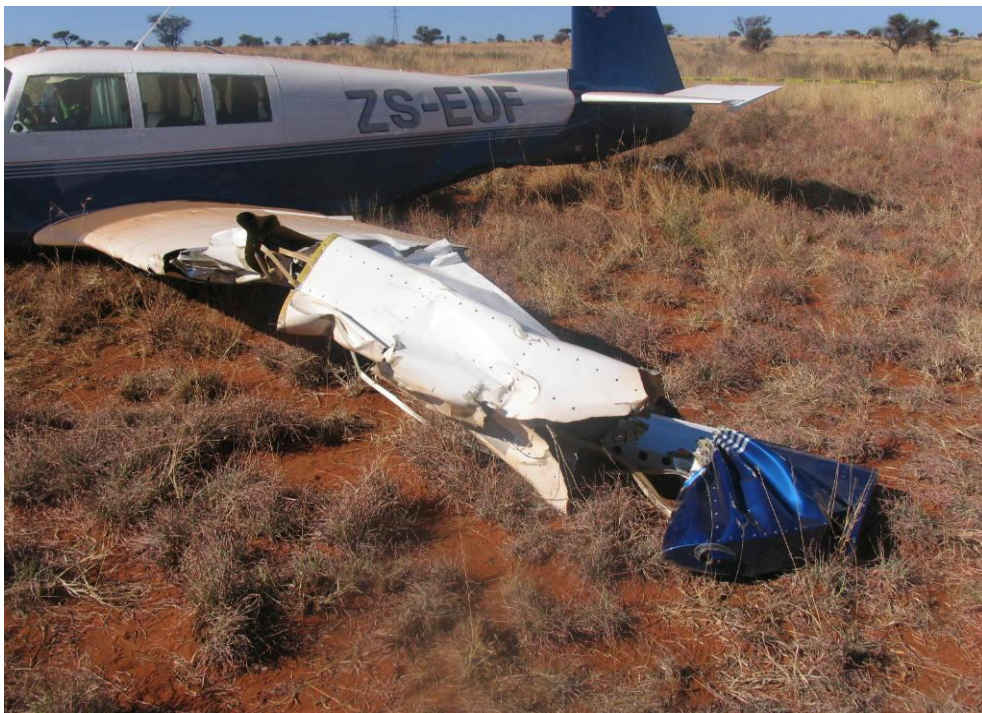
1.12.1 The pilot was committed to executing a forced landing on an open field after takeoff. The aircraft subsequently landed on its belly with the undercarriage retracted. The aircraft sustained extensive damage to the fuselage, left wing, engine and propeller.

PHOTO 2: VIEW OF AIRCRAFT LEFT WING, EXTENSIVELY DAMAGED

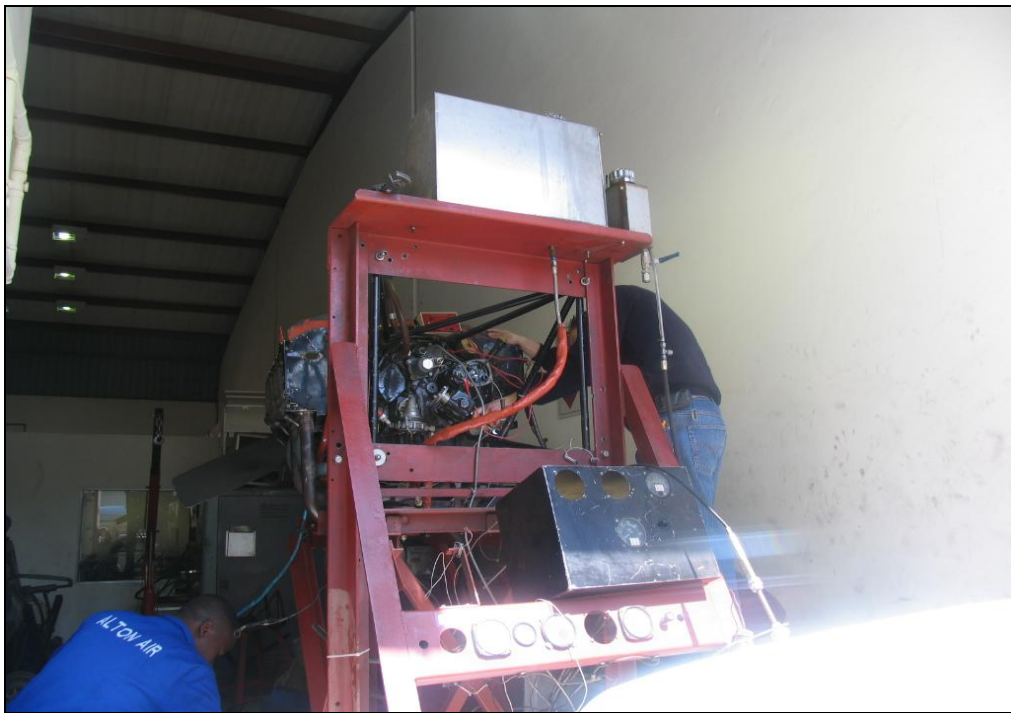
1.16.5 The engine was recovered to an approved engine overhaul facility and ground tested on a test bench and found to be operating satisfactorily in all respects.

PHOTO 3: VIEW OF ENGINE TEST IN TEST STAND AT APPROVED ENGINEOVERHAUL FACILITY
