## AIRCRAFT ACCIDENT REPORT AND EXECUTIVE SUMMARY

Reference:	CA18/2/3/8356	
<b>Aircraft Registration</b>	<b>ZU-DMT</b>	<b>Date of Accident</b>	29 August 2007	<b>Time of Accident</b>	1210Z	
<b>Type of Aircraft</b>	Tecnam P92-S ECHO		<b>Type of Operation</b>	Training		
<b>Pilot-in-command Licence Type</b>		Student	<b>Age</b>	41	<b>Licence Valid</b>	Yes
<b>Pilot-in-command Flying Experience</b>		Total Flying Hours	36.9		Hours on Type	6.3
<b>Last point of departure</b>		Rand Aerodrome (FAGM)				
<b>Next point of intended landing</b>		Rand Aerodrome (FAGM)				
<b>Location of the accident site with reference to easily defined geographical points (GPS readings if possible)</b>						
Open field in Lambton (Germiston), GPS co-ordinates: S26° 15' 13.30" E028° 09' 51.4"						
<b>Meteorological Information</b>		<b>Temperature:</b> 22°C; <b>Wind:</b> 340°/12 kts; <b>Visibility:</b> +10 km				
<b>Number of people on board</b>	1 + 0	<b>No. of people injured</b>	0	<b>No. of people killed</b>	0

**Name of Owner/Operator** : Aircraft Fractional Ownership Services (PTY) Ltd  
**Manufacturer** : Tecnam  
**Model** : P92-S Echo  
**Nationality** : South African  
**Registration Marks** : ZU-DMT  
**Pl

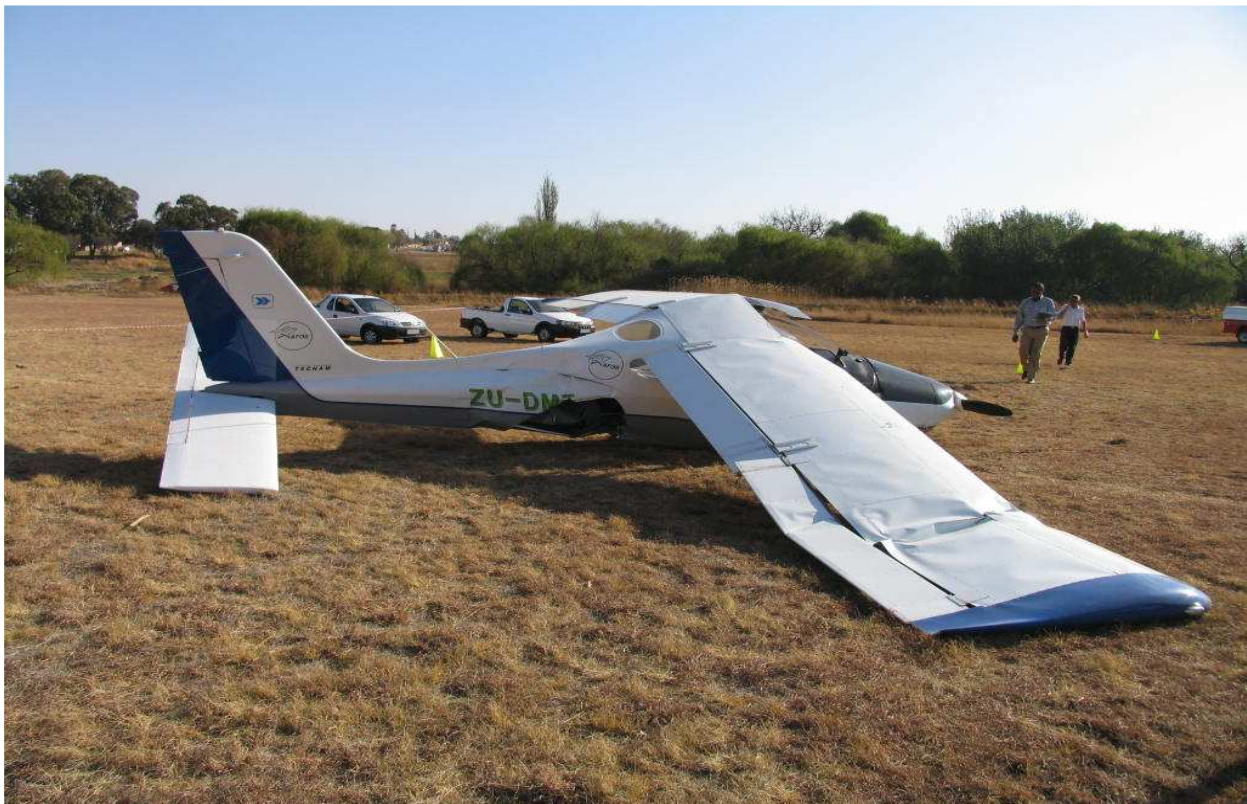
1.12.1 During a forced landing in an open field due to engine stoppage, the aircraft collided with a rock and sustained damage to the fuselage and wings.

**Figure 2.** Side view of the damaged aircraft after the forced landing.

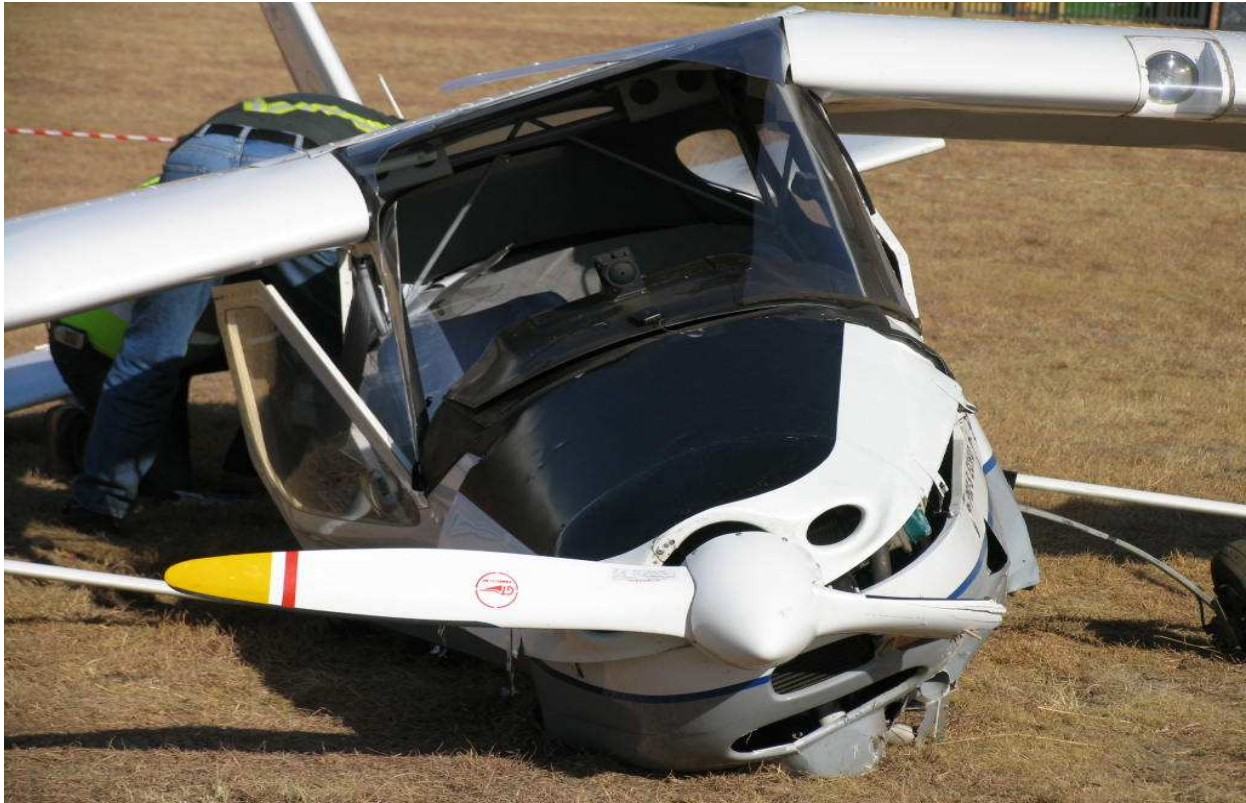
**Figure 3.** Front view of the aircraft at the accident site.

1.15.1 The impact forces associated with the accident were relatively low. Although the windscreen broke, the cabin remained fairly intact and the pilot was shielded. The use of the safety harness also assisted in preventing injury. The accident was considered survivable.

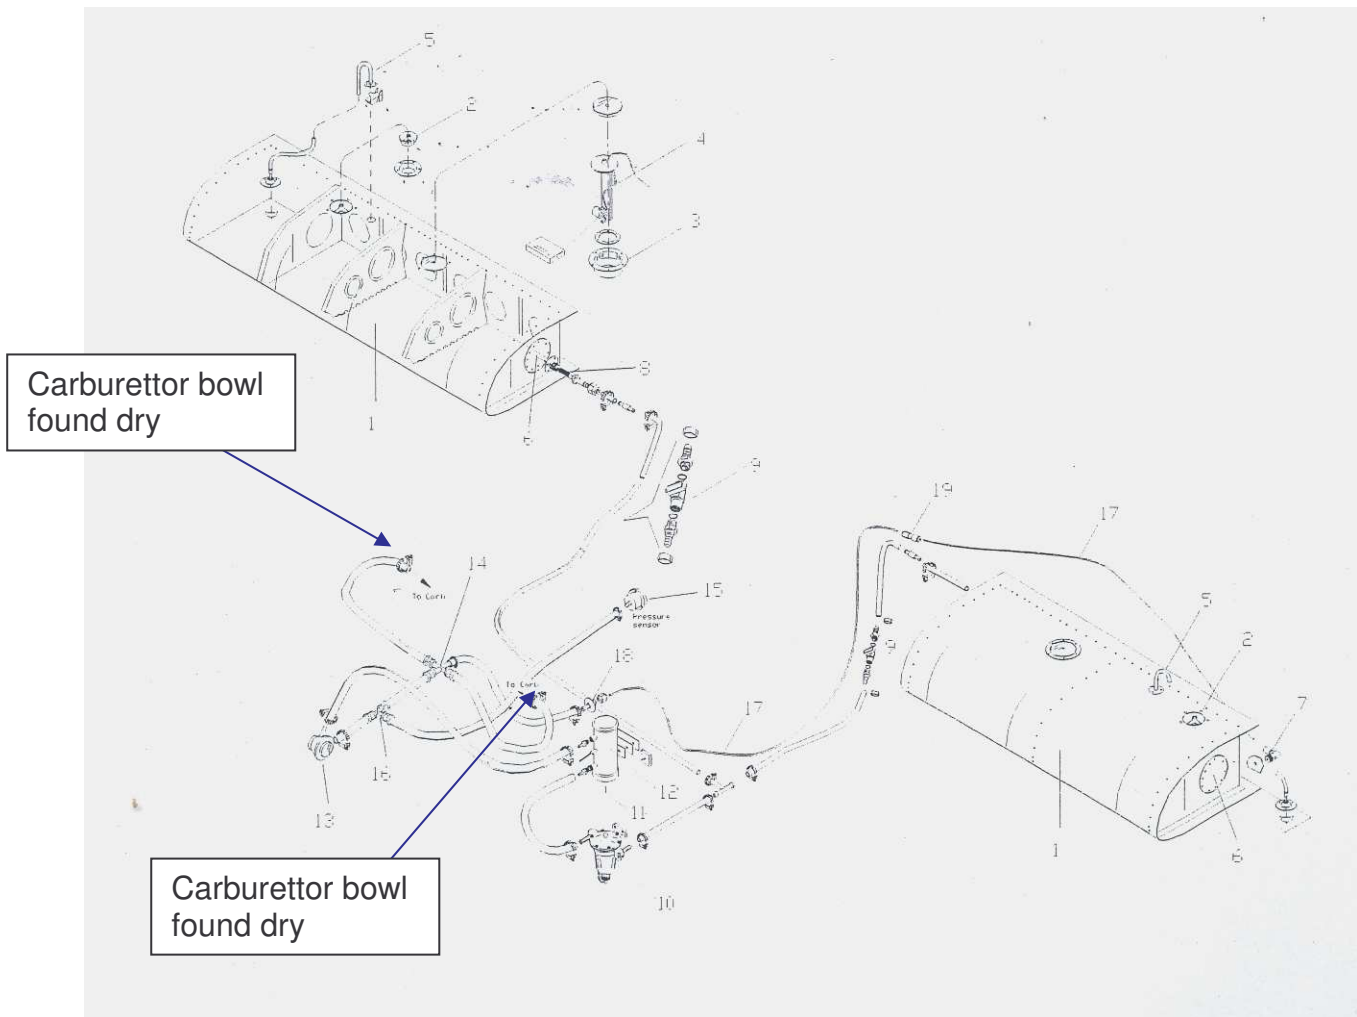
Figure 4. Tecnam P92-S Echo Fuel system

- 2.4 During the investigation, the engine was bench-tested and performed satisfactorily, thus removing the possibility of a mechanical engine failure. Fuel contamination and fuel-line blockage were also eliminated during the on-site investigation, and it was found that there was adequate fuel in the tanks. Nonetheless, it was discovered that the engine had stopped due to fuel starvation.

- 2.5 From the fuel system diagram in Figure 4, it can be seen that the only factor that would prevent the fuel reaching the engine would be the closure of the circuit on/off valve (OFF position selected). The circuit on/off valve is easily accessible to the pilot in the cabin.
