AIRCRAFT ACCIDENT REPORT AND EXECUTIVE SUMMARY

Reference:	CA18/2/3/8382	
Aircraft Registration	ZS-RPY	Date of Accident	2 November 2007		Time of Accident	0830Z
Type of Aircraft	Robinson R22 Beta II		Type of Operation	Private		
Pilot-in-command Licence Type		Private	Age	31	Licence Valid	Yes
Pilot-in-command Flying Experience		Total Flying Hours	803.2		Hours on Type	803.2
Last point of departure		Hunter's Moon (private farm) near Colesberg				
Next point of intended landing		Hunter's Moon (private farm) near Colesberg				
Location of the accident site with reference to easily defined geographical points (GPS readings if possible)						
Hunter's Moon (private farm) at GPS coordinates S30° 25".4' E024° 55".6'						
Meteorological Information		The weather was fine. Surface wind: 5 kts. Temperature: 20°C.				
Number of people on board	1 + 1	No. of people injured	1	No. of people killed	1	
Synopsis						
<p>The pilot, accompanied by a passenger, took off from Hunter's Moon farm near Colesberg on an animal-darting flight. He was familiar with the area. He lifted off approximately 100 m from electrical wires and about 400 m from telephone wires. The distance between these two sets of wires w

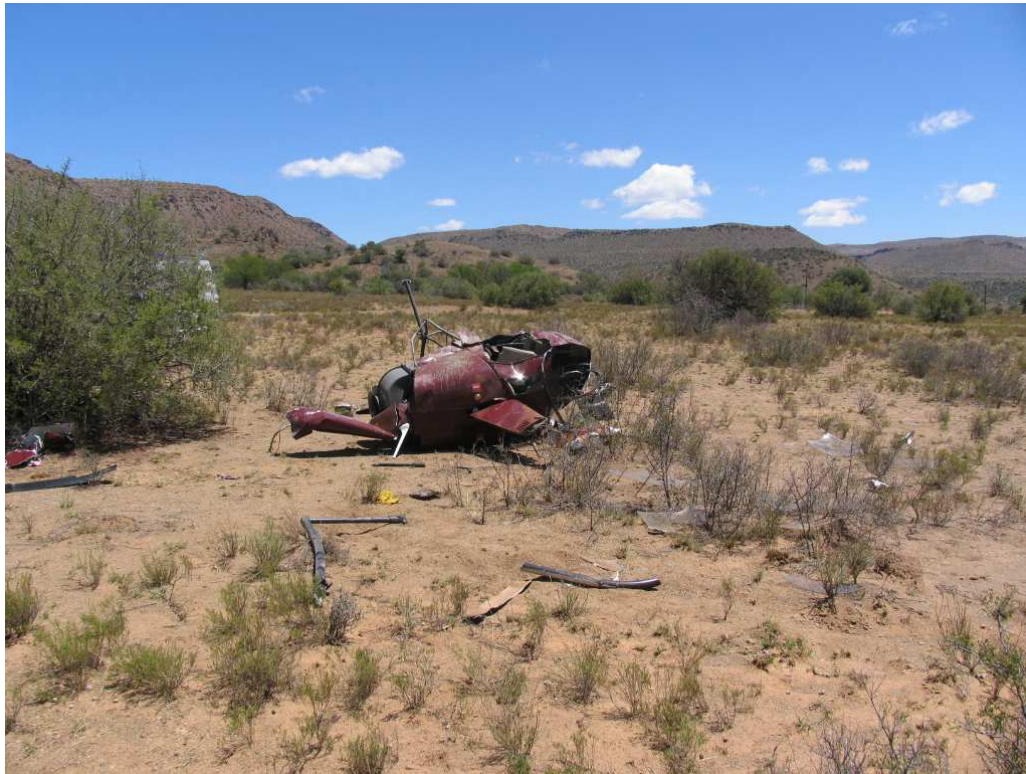
1.3.1 The helicopter was destroyed.

Figure 1. The wreckage of the helicopter.

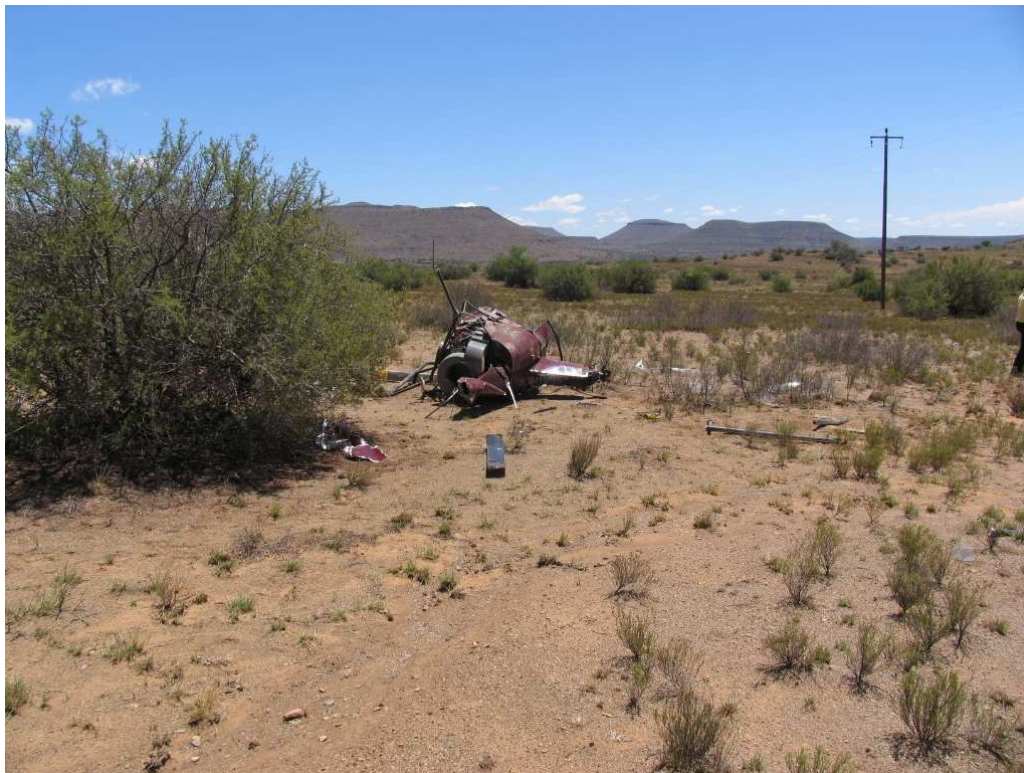
1.12.2 The helicopter's skids made contact with the electrical wires, which caused the aircraft to nose over and strike the ground on its fuselage. On impact with the ground, the main rotor and tail boom separated from the wreckage. The distance from the main wreckage to the high-tension cables was approximately 63 m. These cables were about 5M above ground level. The cables did not break but the wrap lock tie was torn open. See the photograph below.

Photo 2: The wreckage of the helicopter near the high-tension cables.

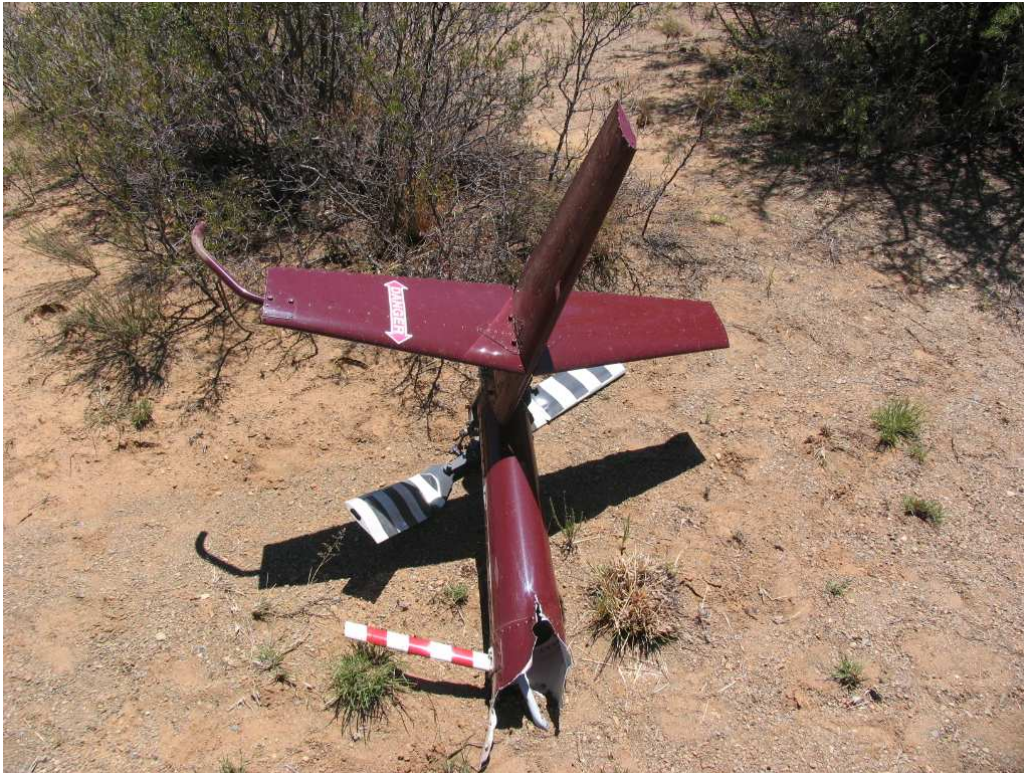
1.12.4 The tail boom was severed by the main rotor during the impact.

Figure 3. The severed tail boom.
