AIRCRAFT ACCIDENT REPORT AND EXECUTIVE SUMMARY

Reference:	CA18/2/3/8417	
Aircraft Registration	ZS-PTB	Date of Accident	5 January 2008		Time of Accident	1215Z
Type of Aircraft	Beech E55		Type of Operation	Private		
Pilot-in-command Licence Type	Private		Age	56	Licence Valid	Yes
Pilot-in-command Flying Experience	Total Flying Hours	1 475.0		Hours on Type	190.2	
Last point of departure	Kitty Hawk Aerodrome (FAKT)					
Next point of intended landing	Ubundu Game Lodge					
Location of the accident site with reference to easily defined geographical points (GPS readings if possible)						
5m to the right of Runway 35, Ubundu Game Lodge (GPS position: South 24°55.593' East 027°55.693')						
Meteorological Information	Wind reported to be from the west / gusting, Temperature; Hot, Visibility; Good					
Number of people on board	1 + 1	No. of people injured	0	No. of people killed	0	
Synopsis	<p>The pilot, accompanied by a passenger, departed from Kitty Hawk Aerodrome (located to the east of Pretoria) on a private flight to Ubundu Game Lodge, a private game lodge, located near the town of Bela-Bela, about one hour's flight from Kitty Hawk. This was the pilot's first flight to Ubundu Lodge. Th

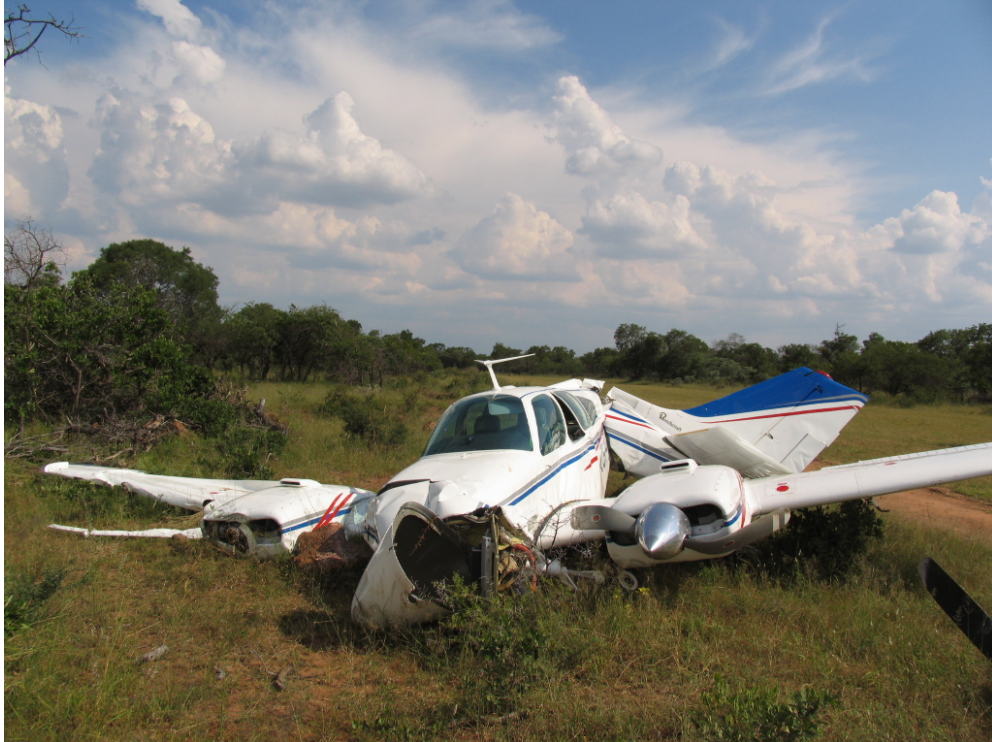
1.3.1 The aircraft sustained extensive damage when it collided with a power line consisting of three conductors and thereafter it impacted with several trees on the right-hand side of Runway 35.

Figure 1. A view of the wreckage lying on the right-hand side of Runway 35.

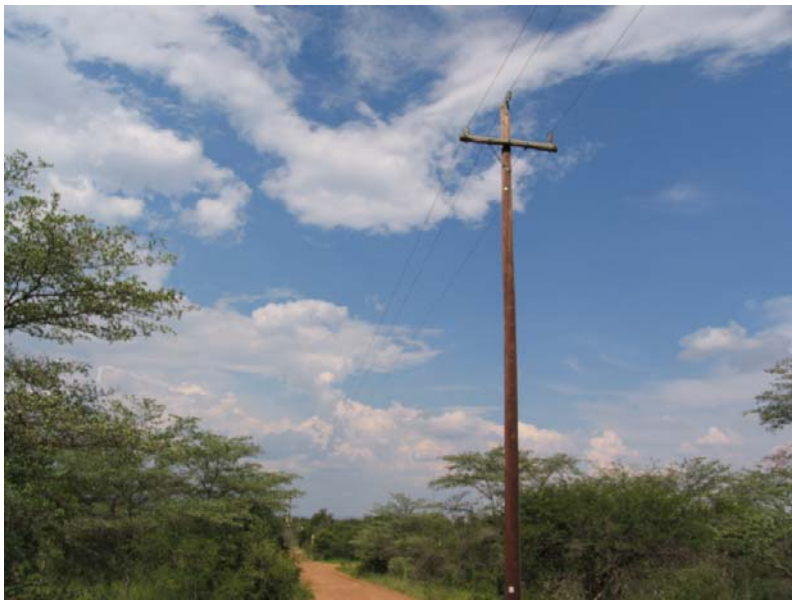
1.4.1 The aircraft collided with a 10-kilo volt Eskom power line on final approach for landing Runway 35. Following the impact, all three conductors on the line were severed, resulting in a power failure in the area. Eskom maintenance personnel repaired the power line several hours after the accident.

Figure 2. A view of the power lines in question, which were 10m (33 feet) in height.

- (vii) The power line in question was spanned diagonally across the approach path of Runway 35 and was approximately 60m from the runway threshold.

- (viii) No hazard identification markers were installed on the power line.
- (ix) The right-hand propeller impacted and severed the power line with clear indentation markings visible on the spinner and blades.
- (x) The aircraft impacted terrain on the right side of Runway 35 and collided with several small trees and shrubs.
- (xi) A substantial amount of electrical wire was found entangled around the crankshaft flange of the No. 2 engine (right hand).
- (xii) Nobody was injured in the accident.

- (i) Installing clearly visible hazard identification markers to properly mark the electrical conductors on the approach path;
 - (ii) or, alternatively ensure that the power line section in question (entire width of the approach path) be installed underground.

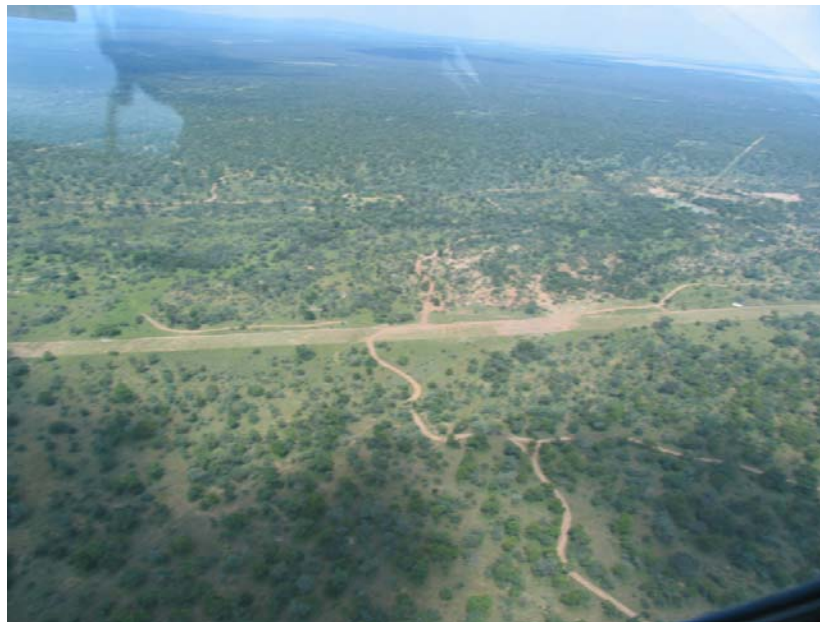
Figure 3. A view of the runway taken during the runway inspection on 7 January 2008.

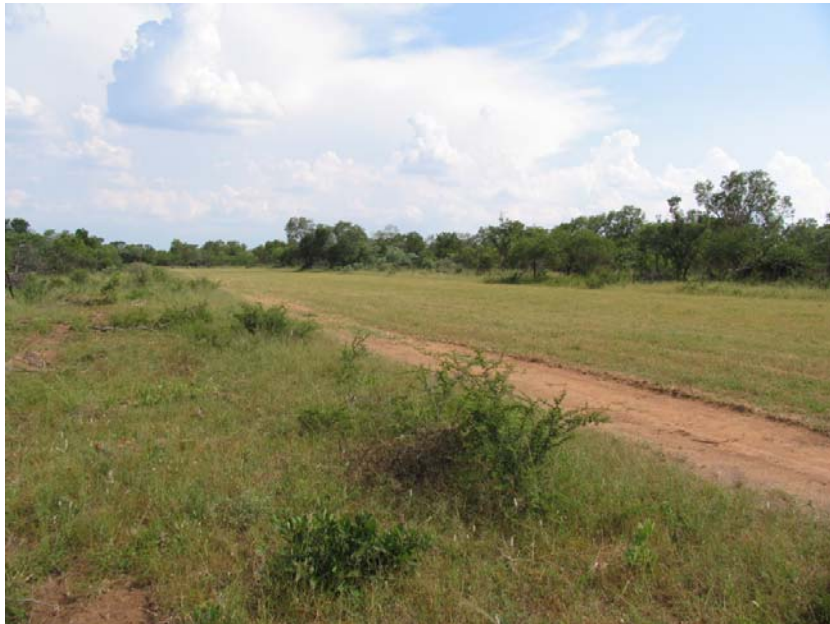
Figure 4. A view of the runway taken in the direction of the threshold of Runway 35.

Following a ground inspection of the facility, it was noted that the approach for Runway 35 had some trees ($\pm 10\text{m}$ or 33 feet in height) at approximately the same height as the Eskom power line into which the aircraft had collided. The power line was located approximately 60m from the edge of the threshold (clearway).

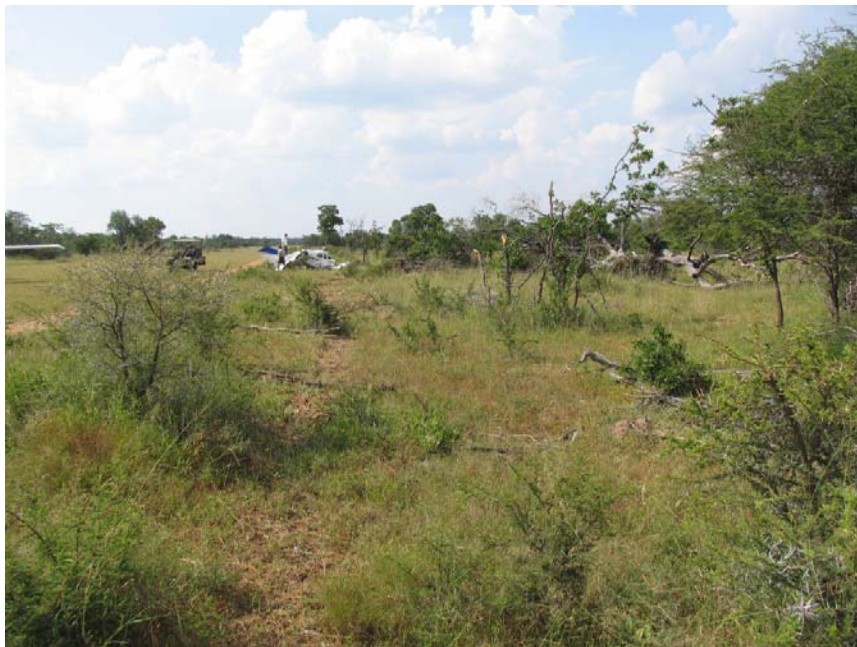
Figure 5. A view of the impact trajectory of the aircraft on the right-hand side of the runway.

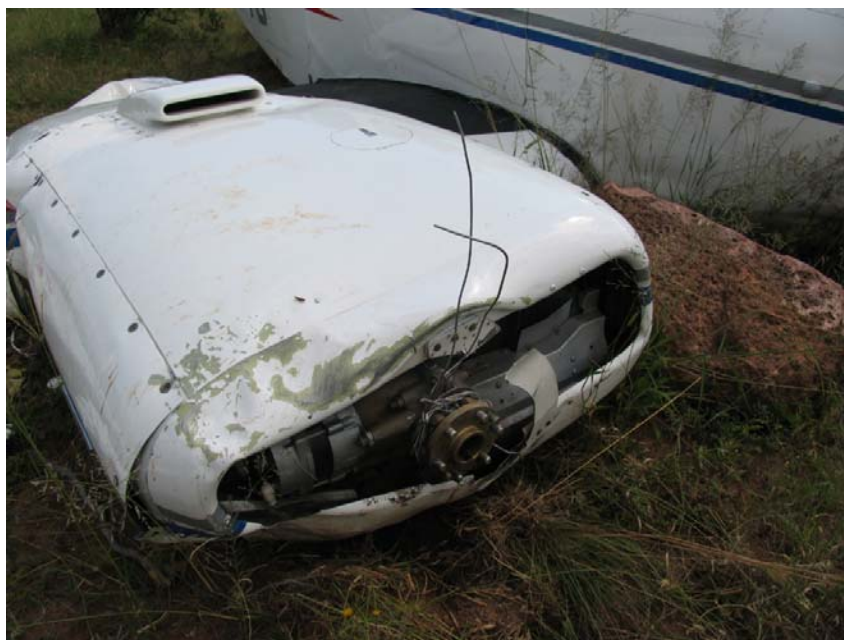
1.12.1 The right-hand propeller of the aircraft impacted with three electrical conductors, which were at a height of about 10m or 33 feet AGL (above ground level) and positioned approximately 60m from the threshold of Runway 35. The electrical conductors were approximately at the same height as the surrounding trees on final approach for Runway 35. All three conductors were severed when the aircraft collided with the wires, rendering it basically uncontrollable and as a result the aircraft veered to the right. The aircraft impacted with several small trees and shrubs on the right-hand side of the runway and came to a halt approximately 5m to the right of the runway's edge and approximately 500m past the first point of impact with the electrical conductors. Several metres of the electrical conductor were found entangled around the crankshaft flange on the No. 2 engine. Wire strike markings were clearly visible on the right-hand spinner and the propeller blades.

Figure 6. A view of the crankshaft flange with some electrical wire entangled around it.
