AIRCRAFT ACCIDENT REPORT AND EXECUTIVE SUMMARY

Reference:	CA/18/2/3/8426	
Aircraft Registration	ZU-ETF	Date of Accident	26 January 2008		Time of Accident	0939Z
Type of Aircraft	IKARUS-C42		Type of Operation	Aerial Survey		
Pilot-in-command Licence Type		Commercial	Age	25	Licence Valid	Yes
Pilot-in-command Flying Experience		Total Flying Hours	229.2		Hours on Type	10.0
Last point of departure		Howick Aerodrome (FAHC)				
Next point of intended landing		Howick Aerodrome (FAHC)				
Location of the accident site with reference to easily defined geographical points (GPS readings if possible)						
Between Howick and Underberg on a farm into the valleys of the hills: GPS position: S2935, 883 E03007, 835						
Meteorological Information		According to the SA Weather Service, the temperature was 26°C with visibility of 10 km or better and the surface wind was 120° True North @ 05 knots.				
Number of people on board	1 + 1	No. of people injured	0	No. of people killed	2

Name of Owner/Operator : Spatial Intelligence (Pty) Ltd.
Manufacturer : COMCO IKARUS GMBH
Model : IKARUS C42B
Nationality : South Africa
Registration Marks : ZU-ETF
Place : Into the valley on a farm between Howick and Underb

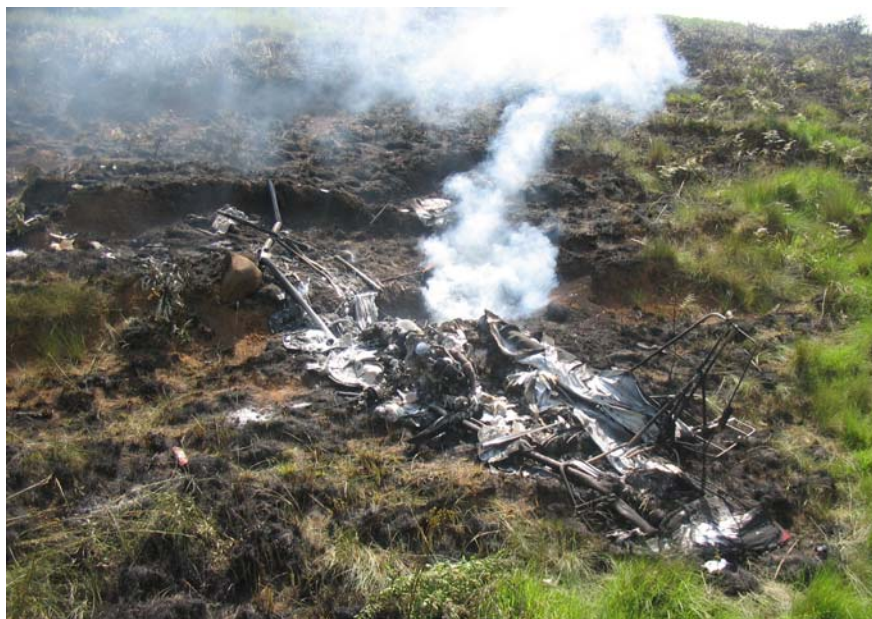
1.3.1 The aircraft was destroyed by the impact and the post-impact fire.

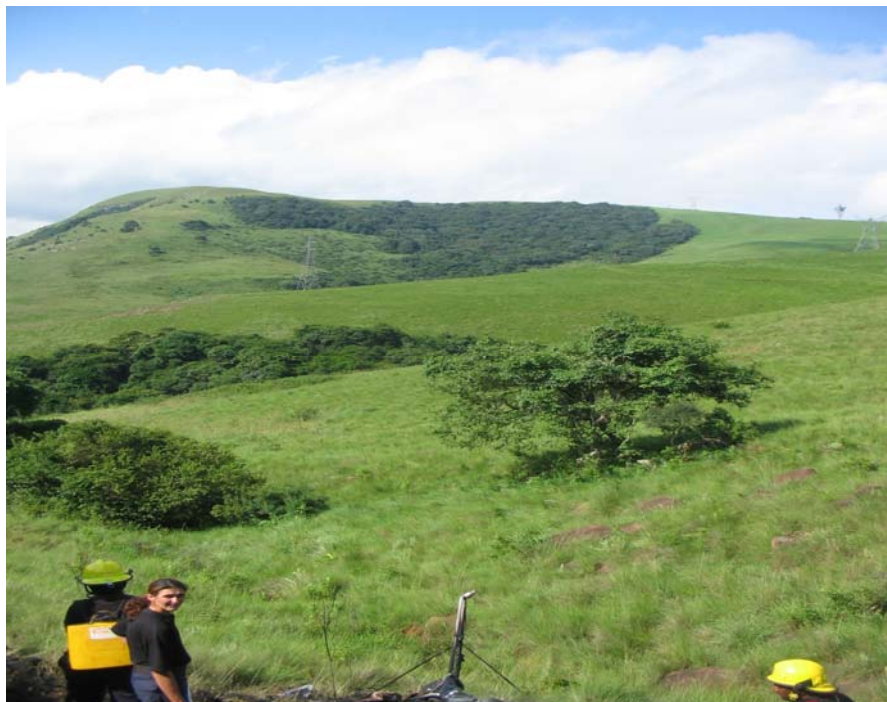
- 1.12.1 When the aircraft impacted with the ground, a post-impact fire erupted and this destroyed the aircraft. Both occupants were fatally injured. Only a small section of the aircraft's tail section did not burn. The ground scars indicated that the aircraft's right-hand wing stalled first before the crash.

Photo 1 shows the valley where the accident happened.

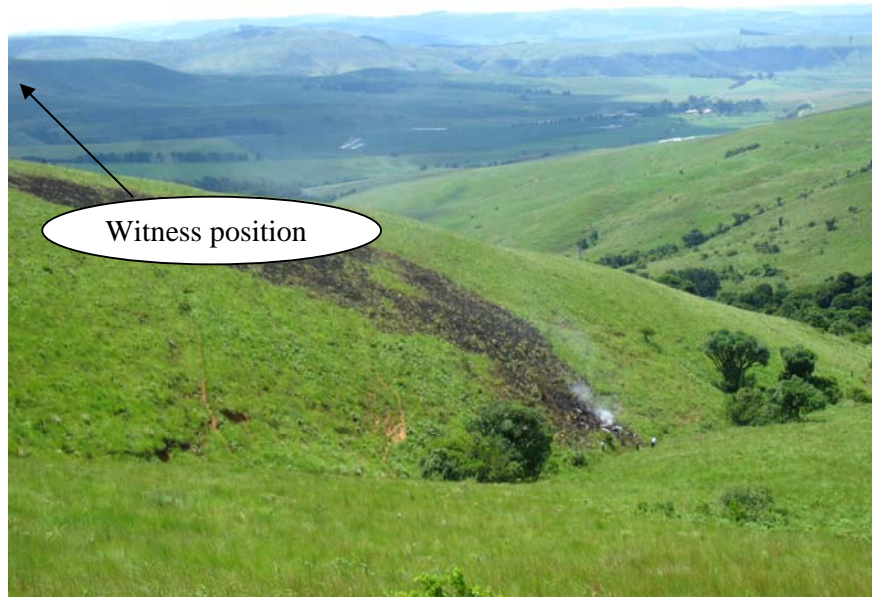
Figure 2 shows the valley which the pilot was using as a guide (from the picture it shows that the pilot was following the contour of the earth up the mountain).

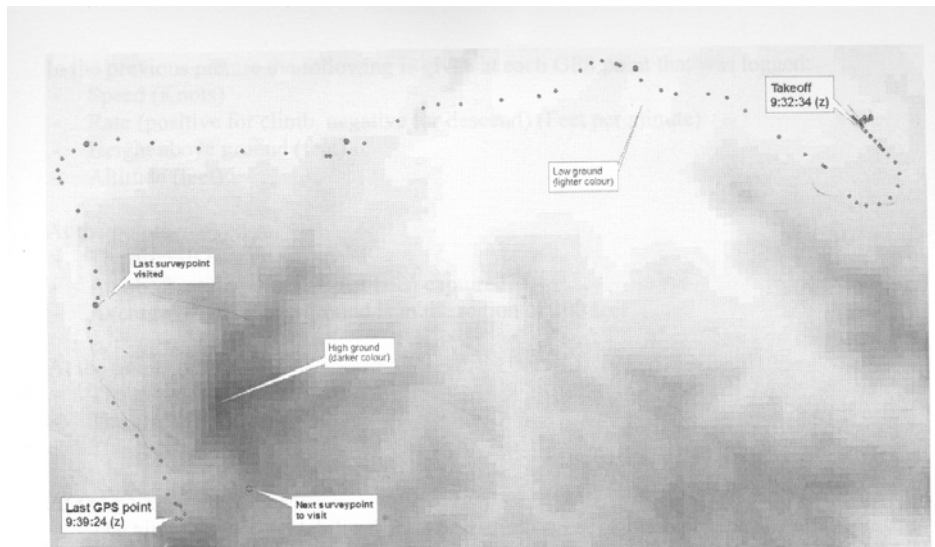
Figure 1: Overview of flight

This was the second flight of the particular aircraft and crew for the day. The flight commenced at Howick airfield at 09:32 after a refuelling stop. From the picture it can be seen that the flight only lasted approximately 6 minutes and 50 seconds. The grey background is obtained from the Digital Elevation Model (DEM). Lighter colours indicate lower areas and darker colours indicate higher areas.

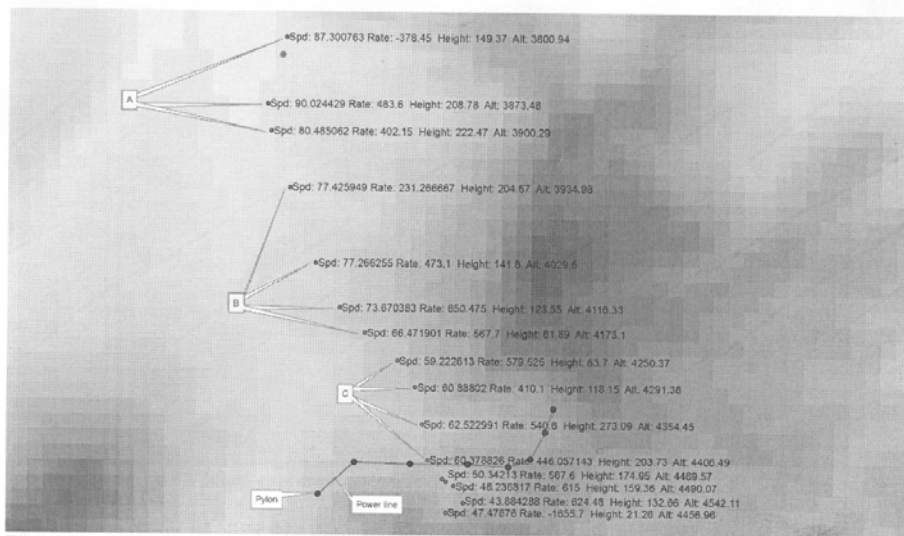
Figure 2: Last point surveyed to next point to be surveyed

In the previous picture (Figure 2) the following is given at each GPS point that was logged:

At the points marked A- The aircraft is at cruise speed
-An observation point has just been captured
-Average height above ground is in the region of 200 feet

At points marked B- The ground is rising
-The aircraft is also ascending
- The speed is decreasing

At points marked C- The aircraft's speed is stabilised at its best climb speed (60 knots)
-The climb rate is approximately 500 feet per minute (which is normal under the conditions). From the picture it shows that the pilot was following the contour of the earth up the mountain.
