AIRCRAFT ACCIDENT REPORT AND EXECUTIVE SUMMARY

Reference:	CA18/2/3/8427	
Aircraft Registration	ZS-NWO	Date of Accident	30 January 2008		Time of Accident	0945Z
Type of Aircraft	Piper PA23-250		Type of Operation	Training		
Pilot-in-command Licence Type		Commercial	Age	33	Licence Valid	Yes
Pilot-in-command Flying Experience		Total Flying Hours	1 313.4		Hours on Type	67.0
Last point of departure		Benoni/Brakpan Aerodrome (FABB)				
Next point of intended landing		Benoni/Brakpan Aerodrome (FABB)				
Location of the accident site with reference to easily defined geographical points (GPS readings if possible)						
On the apron at Benoni/Brakpan Aerodrome (FABB)						
Meteorological Information		Wind 090° at 5 kts, temperature 24°C, visibility CAVOK				
Number of people on board	1 + 1	No. of people injured	0	No. of people killed	0	
Synopsis						
<p>The flight instructor and a pilot under training returned from the East Rand general flying area where they were conducting conversion training for the pilot onto the Piper PA23-250 aircraft type.</p> <p>After landing on runway 18, they turned off the runway onto the taxiway at the end of the runway. The flight instructor stated that they pro

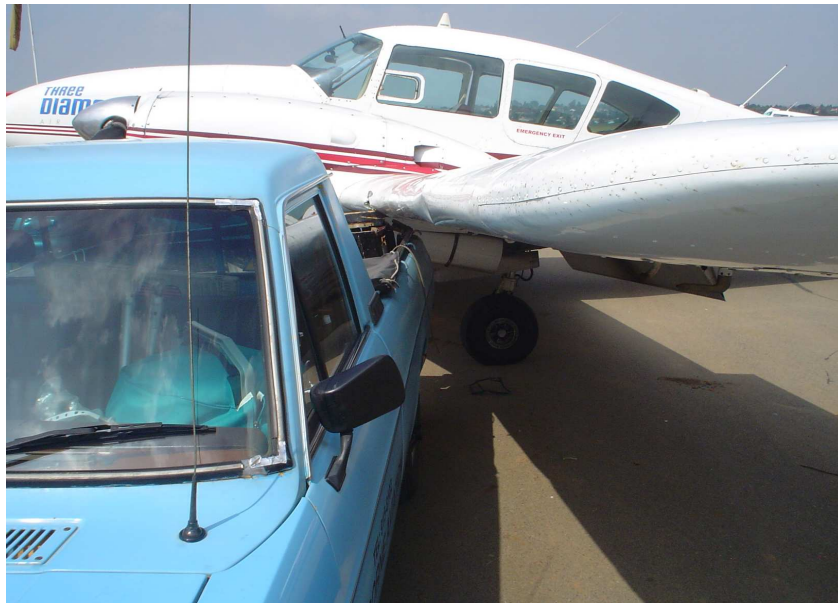
1.3.1 The aircraft sustained damages to the left-hand wing, both propellers and both the engines.

Figure 1: Damage to the left-hand wing leading edge

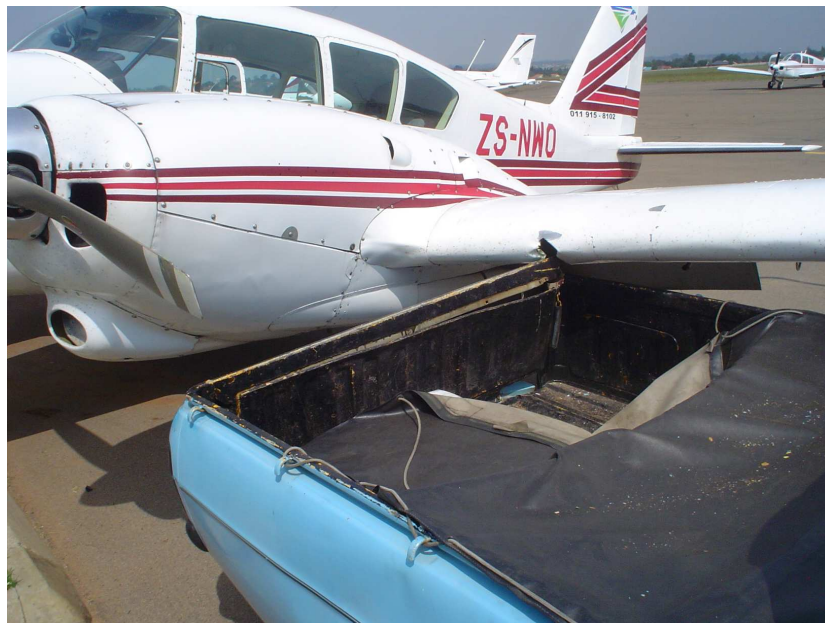
Figure 2: Damage to the left-hand wing's skin

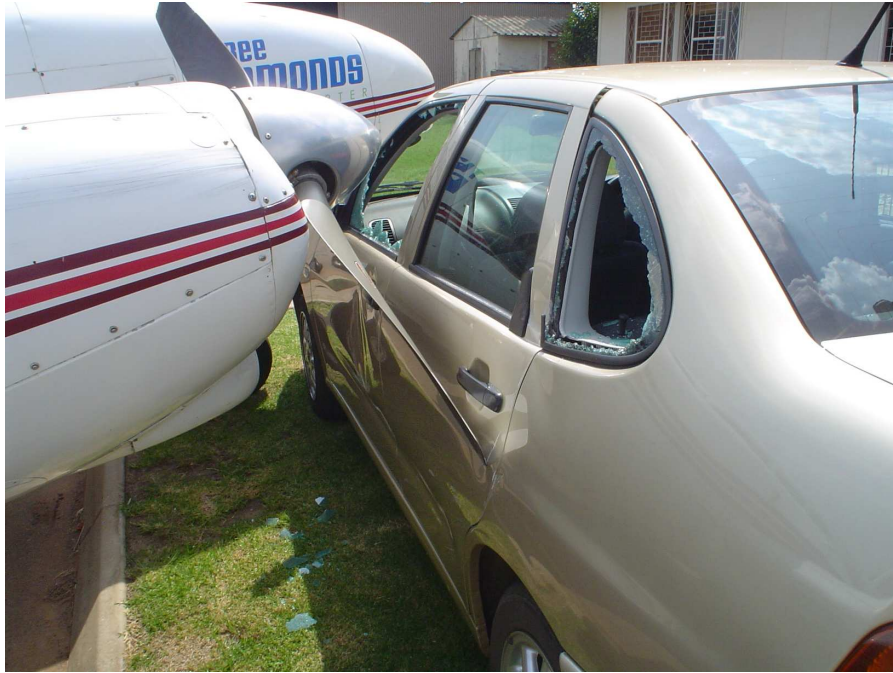
Figure 3: Damage to the right-hand propeller

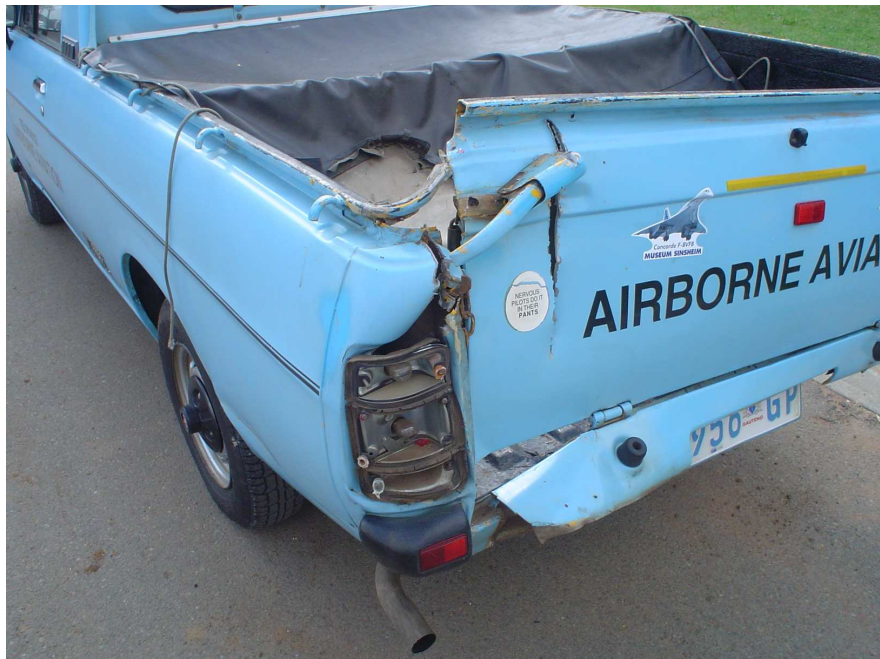
- 1.4.1 Damage was caused to a vehicle that was parked on the apron area and to another vehicle that was parked on grass next to the apron.

Figure 4: Damages to the vehicle parked on the apron

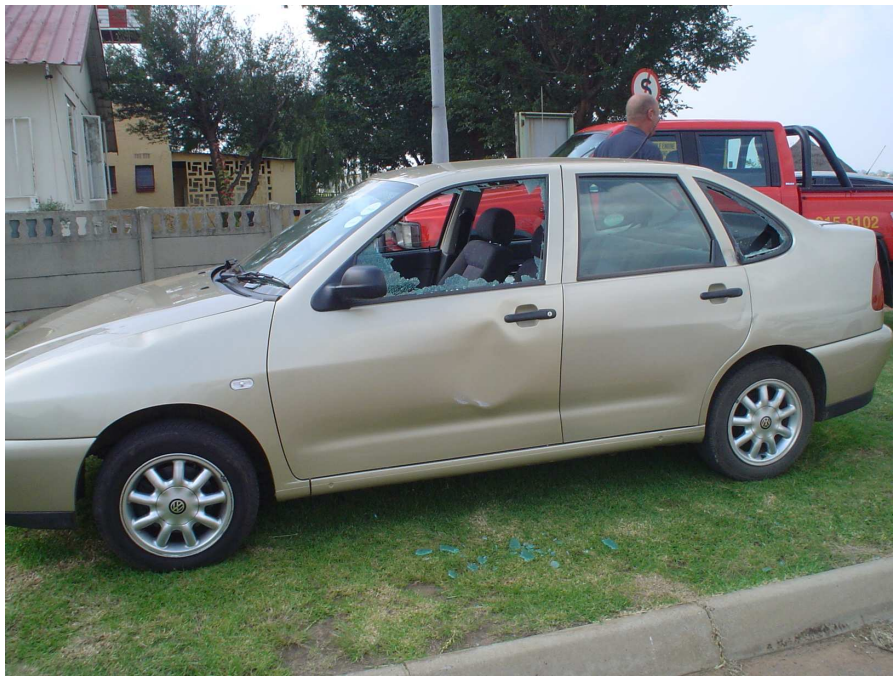
Figure 5: Damage to the vehicle that was parked on grass next to the apron area

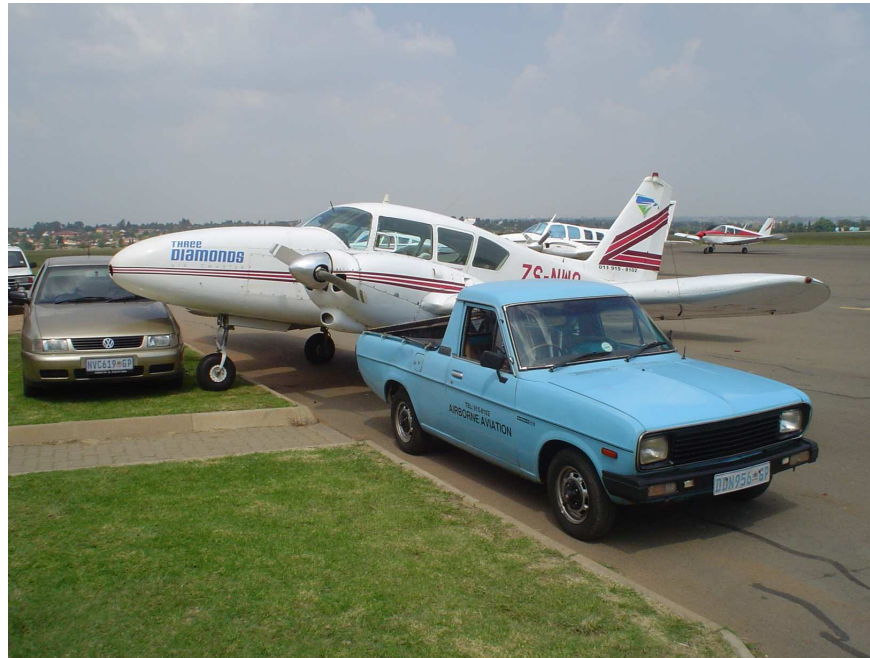
1.12.1 After the aircraft was brought to a complete stop on the apron area, the aircraft again started moving forward for 12, 5 m before it impacted two vehicles, one of which was parked on the apron, the second of which next to the apron.

Figure 6: Where the aircraft collided with the two vehicles

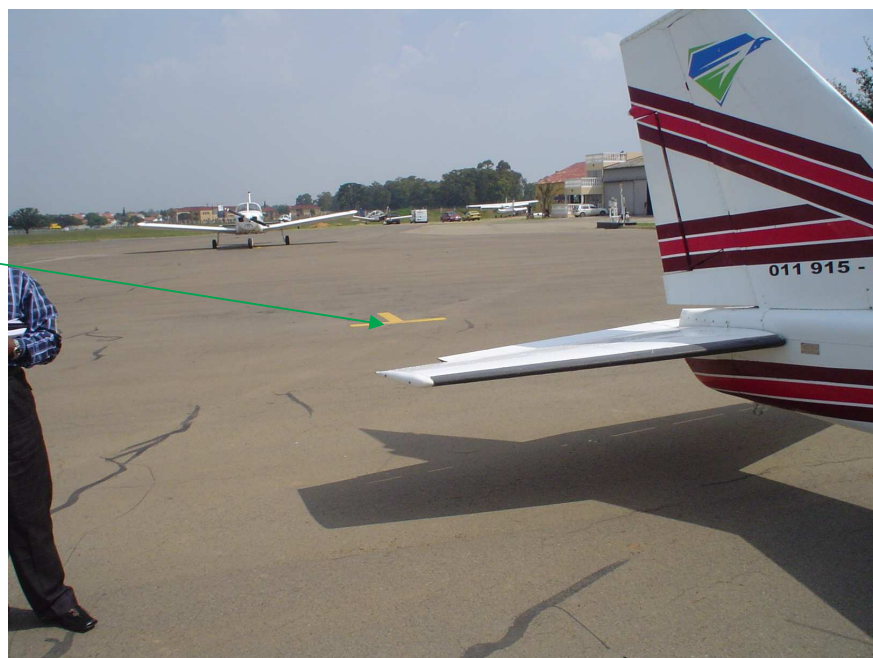
Figure 7: The yellow 'T' where the aircraft came to a complete stop before it started to move forward and collided with the vehicles

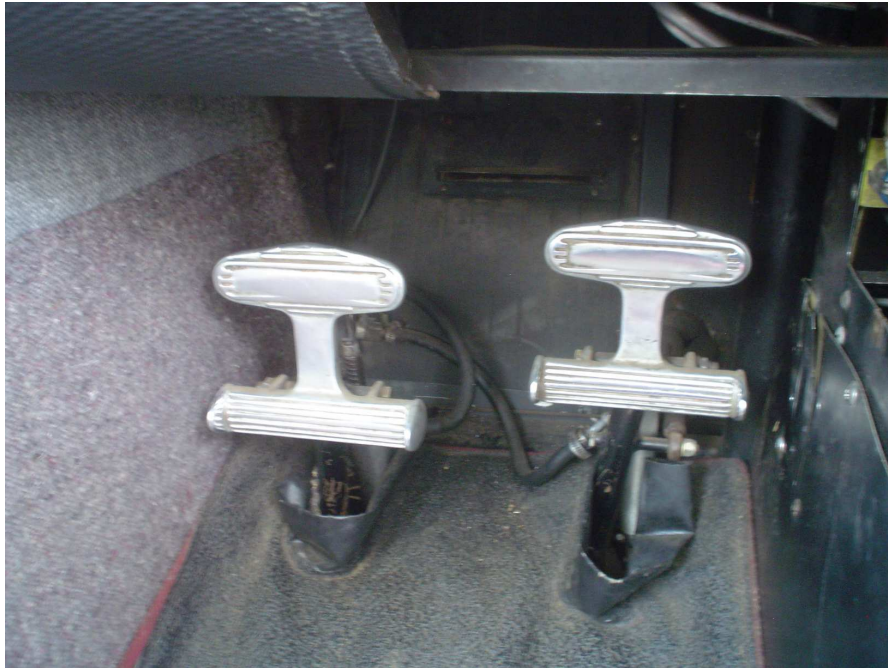
Figure 9: The on-site investigation revealed that the right rudder/brake pedal was in a slightly forward position

- 2.5 It is the opinion of the investigator in charge that the pilot might have had a lack in concentration at that specific point where she was about to commence with the shutdown check procedures. This led to the pilot stepping on the rudder pedals instead of the toe brakes.
- 2.6 It is also the opinion of the investigator that although the distance clearances as recommended in the ICAO Annex 14 were complied with, that this accident might have been avoided if the vehicles were not parked where they were.

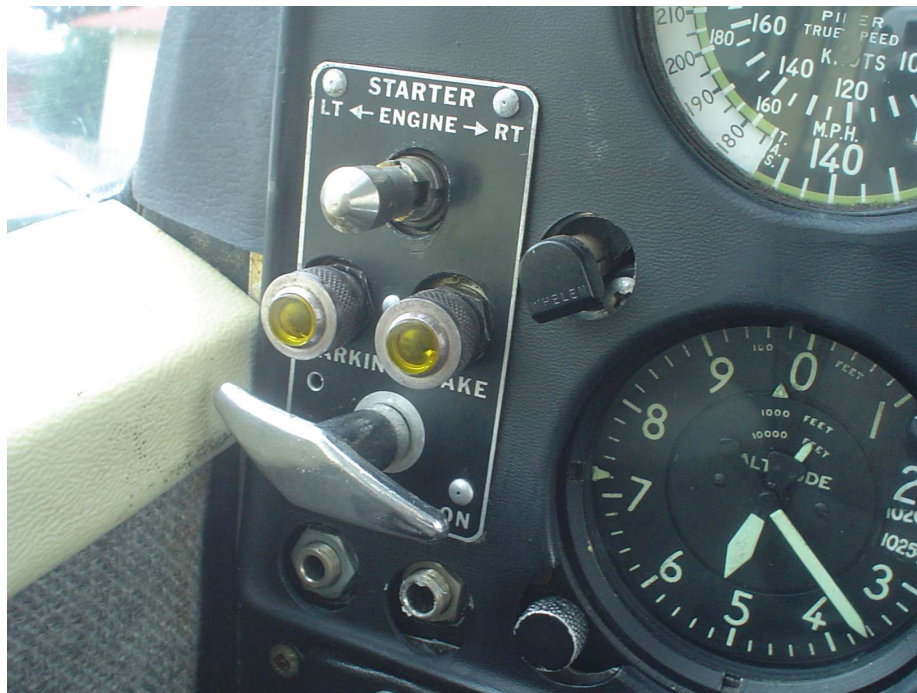
Figure 10: The park brake was found released and not applied
