Report RL 2009:15

**Accident to aircraft SE-LTF on the E 45 road
north of Kungälv, Västra Götaland county,
on 7 February 2008**

Case L-01/08

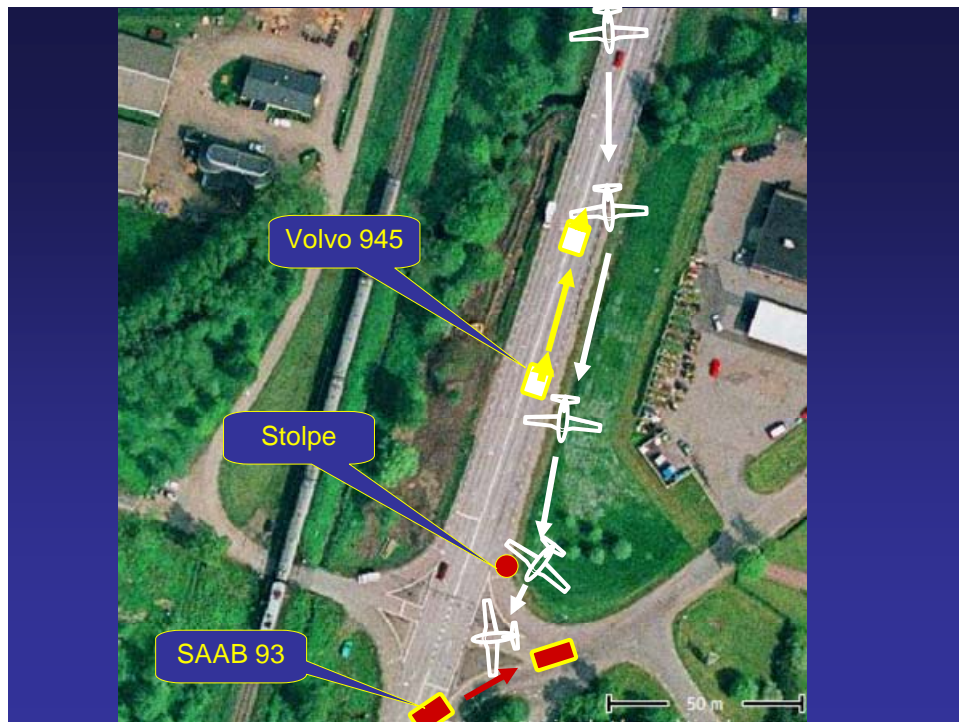
The accident took place on Europe road 45, which is a motorway with four lanes.

A schematic illustration of the accident site and the sequence of events

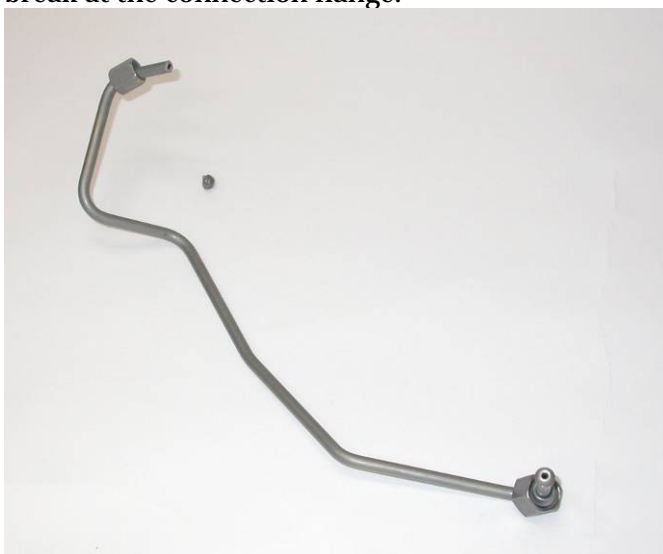
When pressure was applied to the fuel system from the pipe leading from the left tank, strong leakage occurred at the outlet pipe from the high pressure pump. The pipe was dismantled and found to be broken at the connection flange. A visual examination with the aid of a magnifying glass revealed that the broken surface showed signs of fatigue. The pipe was sent to Bodycote Materials Testing for further examination. See section 1.16.1

The fuel pipe was examined by Bodycote Materials Testing AB in respect of the break at the connection flange.

The fuel pipe is about 40 cm long and only secured by collar nuts at each end.

The engine manufacturer issued a technical message, TM TAE 125-1005 P1, on 8 February 2008. The message said that an extra securing bracket for the pipe in question should be installed within 30 flying hours.

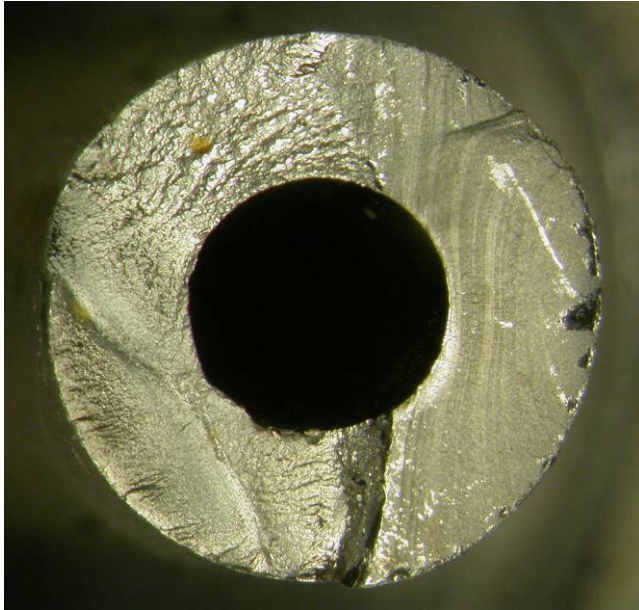
Inspection under an optical microscope showed that the break was caused by metal fatigue that began at two points approximately opposite to each other. The fatigued surfaces met at the centre of the cross-section and there was a very small amount of residual breakage.

*At the right side of the break can be seen about 60 beach marks
On the left side of the break no beach marks can be seen.*

The fuel pipe broke due to metal fatigue.

The stresses that caused the metal fatigue were forward and backward bending loads.

On the surface of the break could be seen about 60 beach marks. If each beach mark represents an engine start the crack was present for an estimated 100 engine starts.

The large proportion of fatigue in relation to the remainder of the break shows that the stresses that caused the fatigue were relatively low.

The engine stoppage was caused by the outlet fuel pipe from the high pressure pump breaking, so that the engine no longer received fuel. The fatigue failure showed about 60 beach marks, which could coincide with the approximate number of engine starts that were performed during 46 flying hours. Leakage from the pipe had probably taken place before the final complete break. After the complete break, a large amount of fuel emptied out into the engine compartment during the period that the propeller was windmilling and thereby driving the fuel pump.

The relatively long fuel pipe, that was only supported by union nuts at each end, was subjected to vibration that led to the metal fatigue. With four such

breaks occurring at the same place, it is considered obvious that there was a design deficiency.
