AIRCRAFT ACCIDENT REPORT AND EXECUTIVE SUMMARY

Reference:	CA18/2/3/8439	
Aircraft Registration	ZS-RJW	Date of Accident	13 February 2008		Time of Accident	1335Z
Type of Aircraft	Alouette III (Helicopter)		Type of Operation	Private		
Pilot-in-command Licence Type		Commercial	Age	28	Licence Valid	Yes
Pilot-in-command Flying Experience		Total Flying Hours	1 519.6		Hours on Type	352.4
Last point of departure		Overberg Fire & Rescue Station				
Next point of intended landing		Overberg Fire & Rescue Station				
Location of the accident site with reference to easily defined geographical points (GPS readings if possible)						
1km to the West of the Overberg Fire & Rescue Station (GPS position: South 34° 32.186 East 020° 02.934)						
Meteorological Information		Surface wind; 110°/5kt, Temperature; 25°C, Visibility; >10km				
Number of people on board	2 + 1	No. of people injured	0	No. of people killed	0	
Synopsis						
<p>The pilot, accompanied by a crew member and a passenger, took off from the Overberg Fire Station helipad following replacement of the rescue hoist head that had been installed on the helicopter. The purpose of the flight was to perform a function test on the operation of

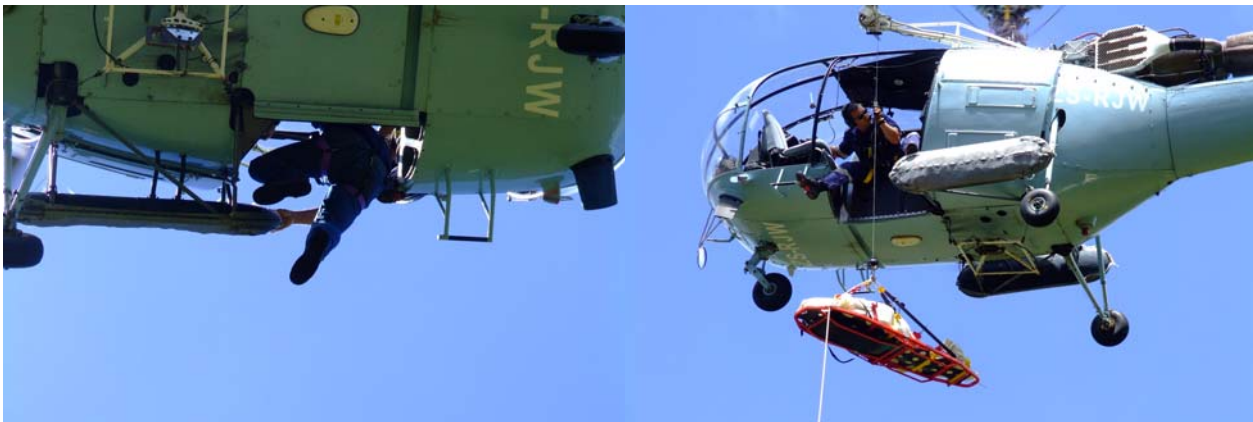
- 1.1.3 Following their return, the AME was informed that the hoist was not operating at the correct speed, and he was requested to reinstall the original hoist head. While the AME was busy replacing the hoist head, he requested his assistant to re-grease the tail rotor head that they had just replaced. In order to gain access to the grease gun that was stowed in the lubrication bin in the left-hand baggage compartment of the helicopter, the assistant had to close the left cabin sliding door, which was blocking his access to the baggage compartment door. The assistant then closed the sliding door by sliding it forward, without ensuring that the floor hatch was in position (up and latched). The floor hatch is a section of the left aft floor structure of the helicopter that gets folded away during hoisting operations. The floor hatch also contains the lower sliding door guide rail assembly.

Photo 1. A view of the helicopter from below and from the side with the floor hatch in the hoisting configuration.

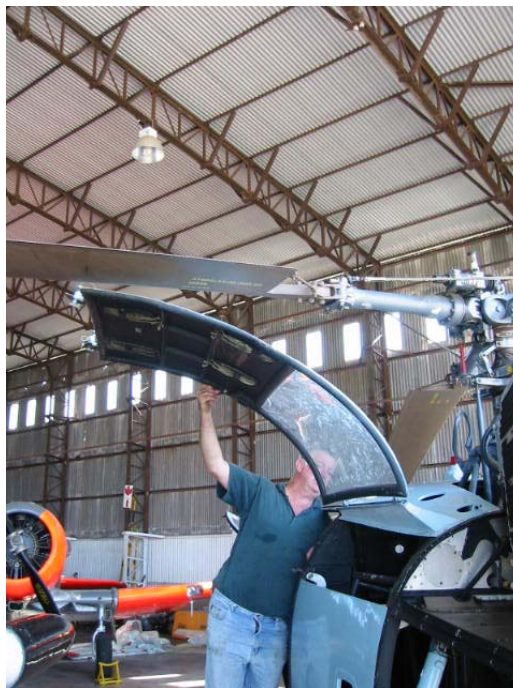
- 1.1.6 Prior to take-off, the left aft sliding door that was configured in the open position as required for hoisting had the sliding door lock mechanism in position. Following take-off at a height of approximately 400 feet AGL (above ground level) the hoist operator, who was seated in the left front seat facing aft (seat turned around) alerted the pilot that something was wrong with the sliding door. Within a split

second following his statement, the door was projected/flapped upwards and impacted with the main rotor blades.

1.3.1 Damage to the helicopter was substantial when the left aft cabin door impacted with the main rotor blades.

Photo 2. View of aft left sliding door deflected upwards towards the main rotor blades.

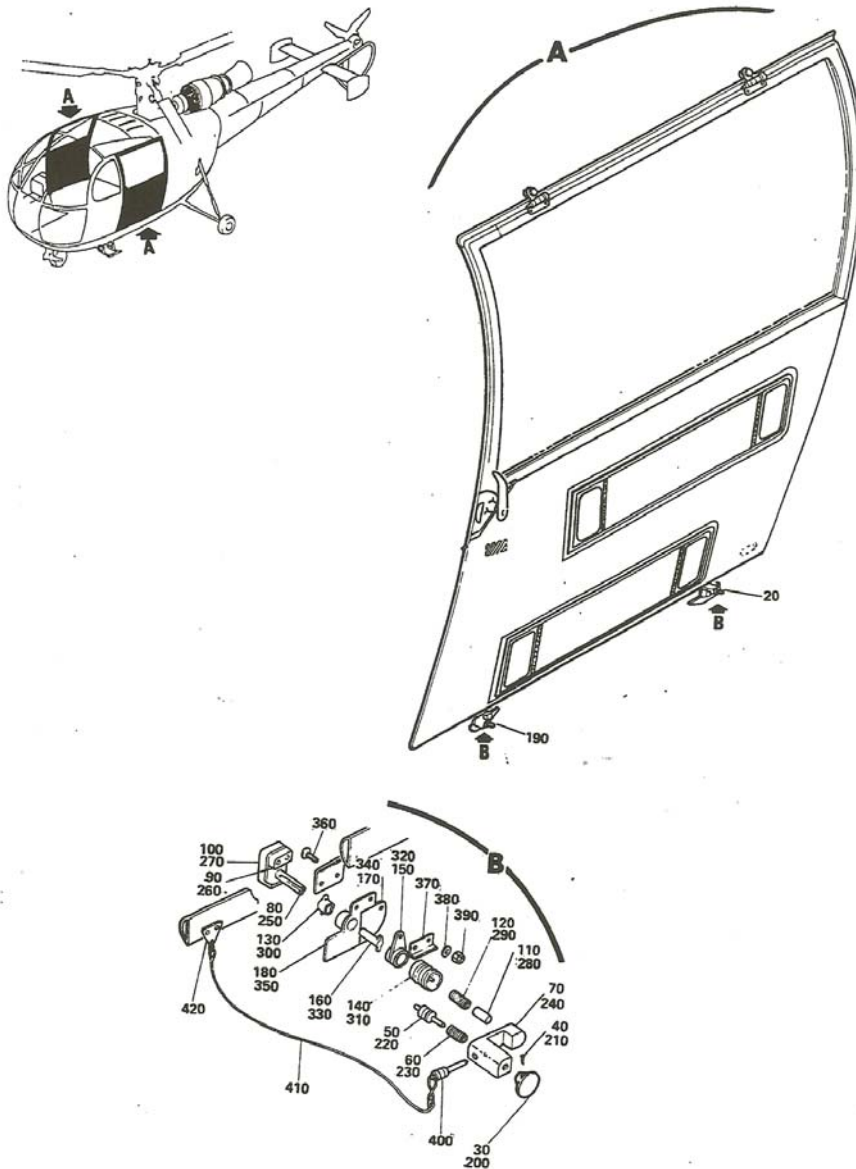
In order to open the left aft cabin door, it is required to be unlatched at the door handle, whereupon the door opens by sliding it backwards. The door consists of two roller-type brackets at the top and two teflon brackets that slide into the bottom rail. The door assembly can be unlatched at the two bottom brackets by removing the safety pins of which there are one in each bracket, (as can be seen in Figure 1 on the next page of this report) and rotating the knob on the bracket through 90°. The door then in fact hangs on the top two brackets. In Photo 2 below, the deflection of the door with the bottom two brackets unlatched, can be seen in relation to the main rotor blades. The primary reason for the design was to allow for a stretcher (maximum two) to be placed in the aft cabin area, should the helicopter be utilized in the medivac configuration with the doors close.

Figure 1. A view of the door assembly with the bottom bracket in detail.

it, without paying attention to the status of the two lower brackets, ensuring that they were properly in the bottom guide rail. It should be noted that the door could easily be slid to the open or close position, without having the two bottom door brackets secure in the guide rail.

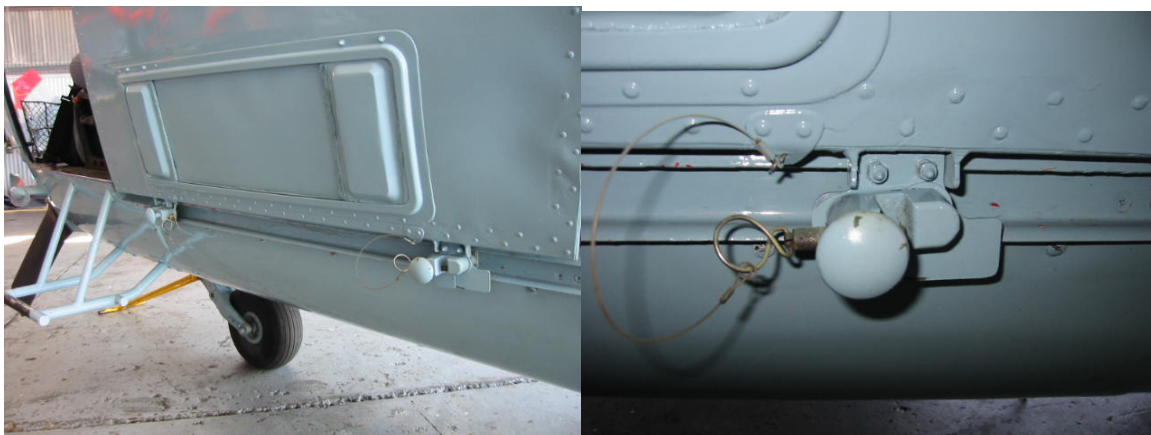
(a) Sliding door in close position, brackets in rail.

(b) A close-up view of the lower door bracket.

- 4.2 It is recommended that the CAA, Airworthiness Department issue a MAN (Mandatory Advisory Notice) calling for the lower sliding door bracket knobs to be painted in a high fluorescent colour (example: orange, yellow, red) to make the bracket/s more visible during pre-flight and maintenance inspections. With the bracket being the same colour as the door and fuselage the margin for error is just so much higher as can be seen in the photos below.
