## AIRCRAFT ACCIDENT REPORT AND EXECUTIVE SUMMARY

Reference:	<b>CA18/2/3/8440</b>	
<b>Aircraft Registration</b>	ZS-PWN	<b>Date of Accident</b>	17 February 2008		<b>Time of Accident</b>	1110Z
<b>Type of Aircraft</b>	Cessna U206F		<b>Type of Operation</b>	Domestic charter		
<b>Pilot-in-command Licence Type</b>		Commercial	<b>Age</b>	23	<b>Licence Valid</b>	Yes
<b>Pilot-in-command Flying Experience</b>		Total Flying Hours	729.9		Hours on Type	198.1
<b>Last point of departure</b>		Garonga Safari Camp (private aerodrome)				
<b>Next point of intended landing</b>		Kruger Mpumalanga International Aerodrome (FAKN)				
<b>Location of the accident site with reference to easily defined geographical points (GPS readings if possible)</b>						
Garonga Safari Camp (GPS co-ordinates: S 24° 06.236' E 030° 43.078'), elevation 1 650 ft above mean sea level (AMSL)						
<b>Meteorological Information</b>		Surface wind 190° at 10 kts, temperature 32°C, CAVOK				
<b>Number of people on board</b>	1 + 2	<b>No. of people injured</b>	0 + 1	<b>No. of people killed</b>	0

COMPILED BY  	<b>CrashLAB</b>	PAGE 1 OF 1	
COMPILED FOR: Civil Aviation Authority		DOCUMENT NUMBER MET-002-01-08	
	INVESTIGATION REPORT: P

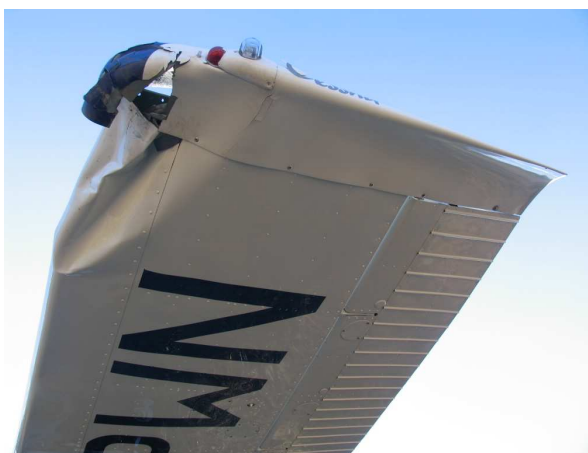
1.3.1 The aircraft sustained substantial damage when it collided with a tree and several tree stumps that were lying on the ground. The aircraft was fitted with a cargo pod, which was substantially damaged during the impact sequence. The left wing made contact with the ground, the nose gear assembly broke off at the lower end of the oleo strut and the propeller struck the ground.

Figure 1: A view of the left wing

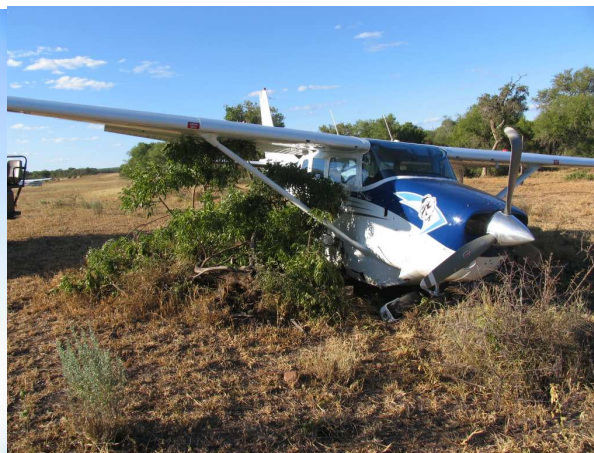
Figure 2: The aircraft in a nose-down attitude following nose landing gear separation

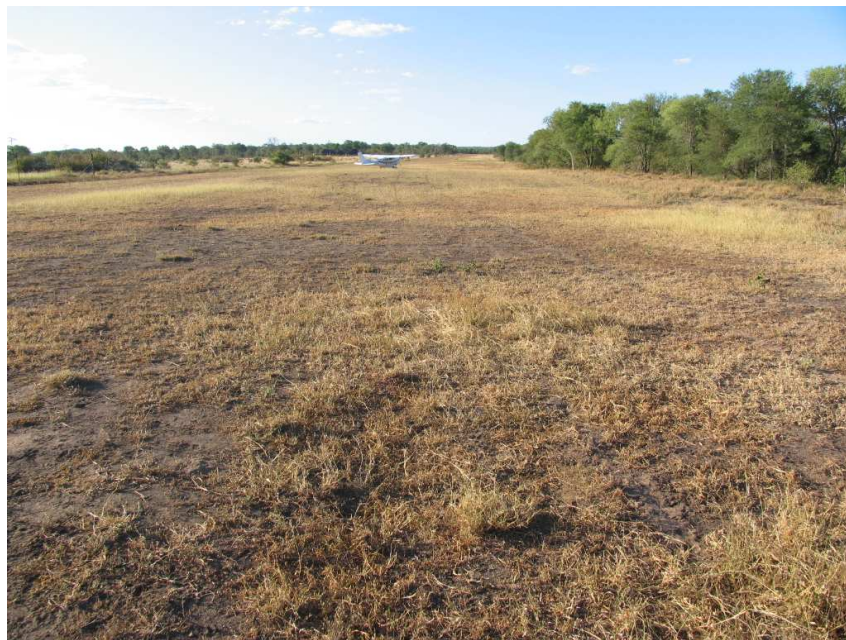
**Figure 5:** A view of the runway taken on 18 February 2008 from the threshold of runway 36

The investigator in charge (IIC) and co-investigator flew to Garonga Lodge in a Cessna 206. On joining overhead the aerodrome, it was noted that the windsock that was located on the right-hand side of runway 18 was in a dilapidated state and of no use to assist the pilot in assessing the prevailing wind at the time.

During the on-site investigation, the IIC walked a few hundred meters of the runway, which consisted of grass-covered surface. At the time of the accident, it was fairly dry in the area, which had an effect on the condition of the grass on the runway surface. It was noted that the soil surface between the grass consisted of rocks and stones of different sizes.

- 4.1 In the interests of aviation safety, it is recommended that the Commissioner for Civil Aviation in collaboration with the Aerodrome Safety Department determine a minimum standard to which all unlicensed aerodromes should adhere to.

- 4.2 It is recommended that the SACAA Aerodrome Safety Department include all unlicensed aerodromes available in their quest to register Category Z aerodromes (registered aerodromes). Charter operators are operating on a regular basis to and from these lodges. The basic requirements as requested by Category Z status aerodromes would be beneficial to the promotion of aviation safety at these locations.

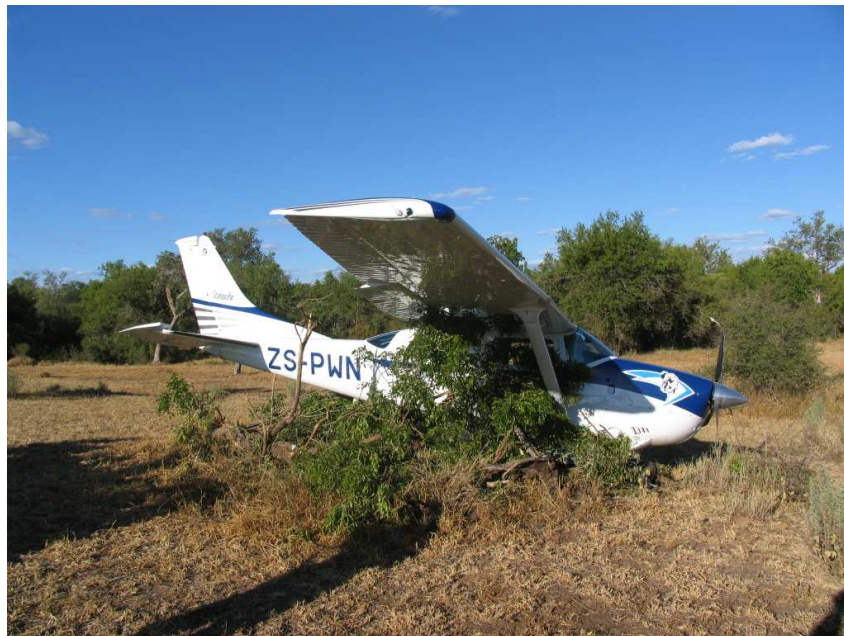
1.12.1 The aircraft veered to the left and ran off the end of the runway following an aborted take-off, and impacted with a tree approximately 80 m beyond the end of the runway. Following the impact sequence, the left wing tip made contact with the ground and bent upwards approximately 50 cm inwards of the wing tip. Two of the three propeller blades displayed bend marks near the tip area and the nose wheel collapsed as it impacted with several dry tree stumps that were lying in close proximity to the tree into which the aircraft had collided. The cargo pod that was secured to the lower fuselage of the aircraft was also substantially damaged.

**Figure 6:** The aircraft it collided with a tree and the nose wheel collapsed

Further evidence indicated that the aircraft veered to the left near the end of runway 18 and collided with a tree approximately 80 m past the end of the runway surface. The collision caused the nose landing gear fork assembly to separate from the oleo strut. The pilot was not able to identify the location on the runway where the aircraft touched down following the decision to abort the take-off, nor was it possible to determine such position due to the nature of the runway surface as well as other wheel markings caused by the manoeuvring of other aircraft that landed and took off from the runway following the accident.

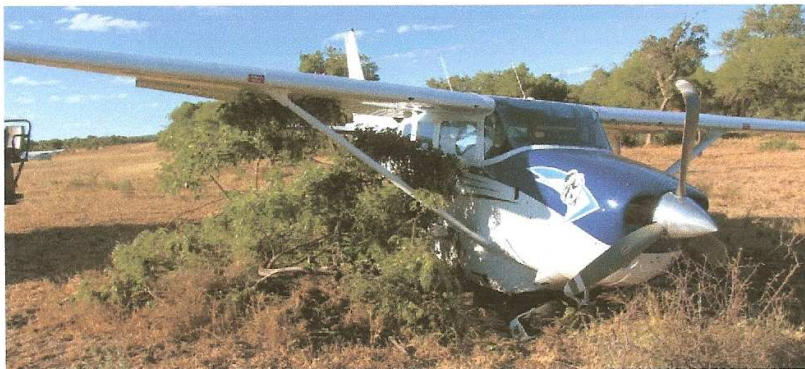
**Photo 1: Accident site (Courtesy SACAA)**

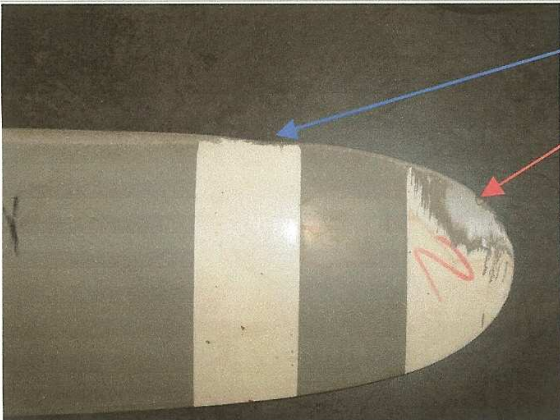
- 2.5 Examination of the propeller, and especially one of the blades, displayed evidence of damage by a foreign object that could not have been associated with the nose wheel collapse since the propeller RPM at the time of impact with the tree and tree stumps was at idle, as the pilot had closed the throttle following the aborted take-off. The engine was only switched off once the aircraft came to a halt and the pilot completed his shutdown checks. Foreign matter was detected in one of the indentations on the blade. The indentation markings were inspected on-site by making use of a magnifying glass, and appeared to be very recent in nature. The structure of the sediment type was analysed using a stereo and scanning electron microscope (SEM), and was found to be of a sediment type structure, most probably from a stone or similar sediment type of material.

Photo 2: Propeller tip area (digital)

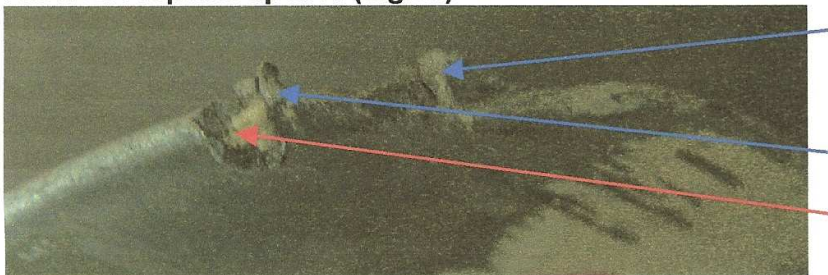
Photo 3: Impact marks, propeller tip area (digital)

7.2. Taking this into account as well as the indications of impact damages induced by a hard object under higher propeller speed, it can be derived that the impact damages to propeller C were inflicted prior to the nose-wheel collapse and tree impact.

7.3. Furthermore, if the pilot's report with regard to the position/time of change in throttle setting from full to idle is indeed correct, it can also be derived that the impact damages to propeller C was inflicted during the take-off roll phase.

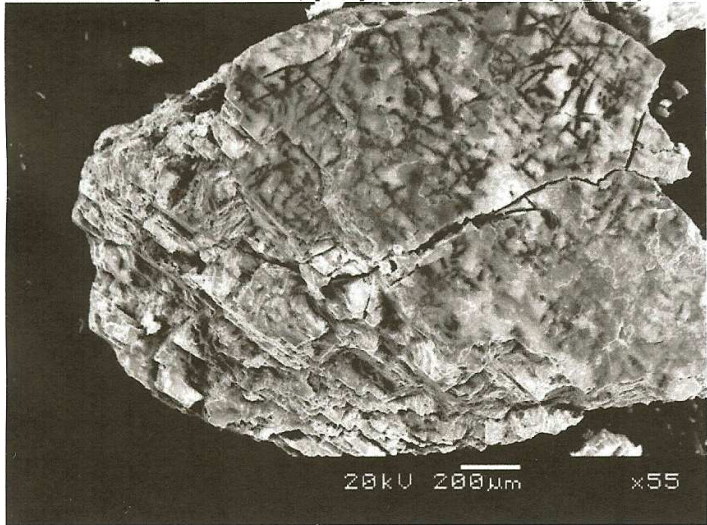
Photo 4: Foreign deposits (x55, SEM)

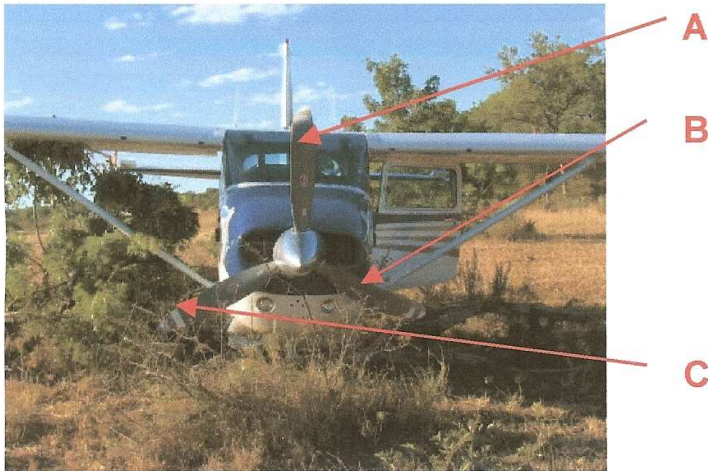
7.1. The damages to propellers A and B (Photo 5) suggest a low rpm, low power impact, most probably induced following the nose-wheel collapse. This may be confirmative of the throttle setting on impact with the tree. Propeller C, also the one under investigation, showed no clear bending damages indicating that it was not exposed to a full rotation of the assembly after the nose-wheel collapse.
