## EXECUTIVE SUMMARY - AIRCRAFT ACCIDENT REPORT

Reference:	CA/18/3/2/8446	
Aircraft Registration	ZU-DRI	Date of Accident	26 February 2008		Time of Accident	0945Z
Type of Aircraft	Jabiru J450		Type of Operation		Private	
Pilot-in-command Licence Type		Private	Age	43	Licence Valid	Yes
Pilot-in-command Flying Experience		Total Flying Hours	411.7		Hours on Type	330.6
Last point of departure		Gariep Aerodrome, Northern Cape (FAHV)				
Next point of intended landing		George Aerodrome (FAGG)				
Location of the accident site with reference to easily defined geographical points (GPS readings if possible)						
Near Somerset East (GPS co-ordinates: S 32° 36.09' E 025° 23.19')						
Meteorological Information		<p>According to the official meteorological report from the South African Weather Service, no official observation was available at the time and place of the accident. The surface trough over the central interior and the cut-off low pressure system over the Western Cape caused thundershowers to develop over the Eastern Cape, KZN, Free State and Botswana. The thundershowers were associated with heavy rain and hail in places. The most likely weather at the place of the incident was heav

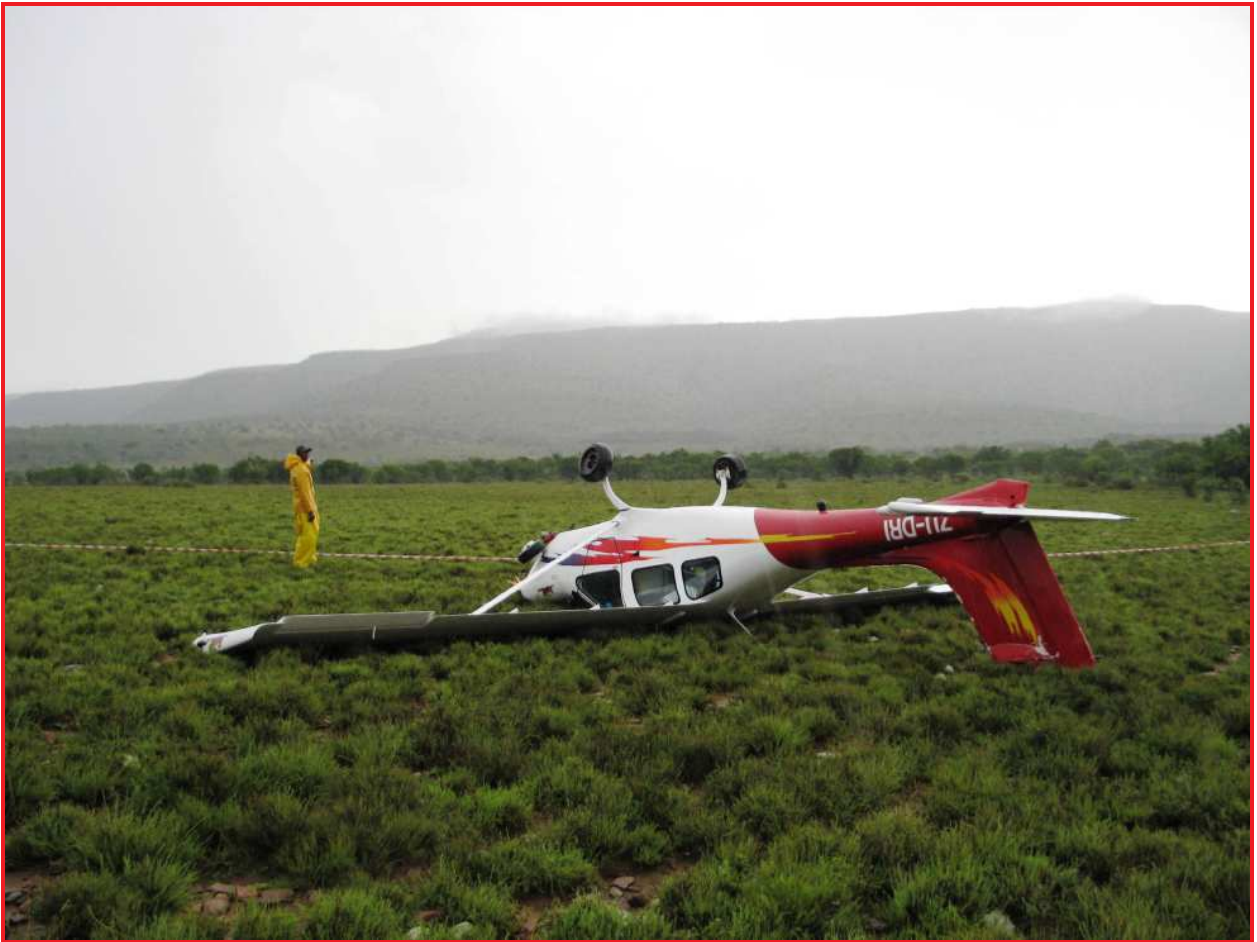
**Figure 1:** The accident site and aircraft
