AIRCRAFT ACCIDENT REPORT AND EXECUTIVE SUMMARY

Reference:	CA18/2/3/8459	
Aircraft Registration	ZS-MRV	Date of Accident	14 March 2008		Time of Accident	1345Z
Type of Aircraft	Piper PA34-200T Seneca II Aeroplane		Type of Operation	Private		
Pilot-in-command Licence Type	Private Pilot		Age	49	Licence Valid	Yes
Pilot-in-command Flying Experience	Total Flying Hours		1102.6		Hours on Type	344.9
Last point of departure	Port Elizabeth International Airport (FAPE) Eastern Cape					
Next point of intended landing	Aliwal North Aerodrome (FAAN) Eastern Cape					
Location of the accident site with reference to easily defined geographical points (GPS readings if possible)						
Grass Runway 24 at Aliwal North in the Eastern Cape.						
Meteorological Information	Surface Wind: Calm; Temperature 25°C; Visibility: CAVOK					
Number of people on board	1 + 1	No. of people injured	0	No. of people killed	0	
Synopsis						
<p>The pilot, accompanied by a passenger, departed Port Elizabeth to Aliwal North. The flight was uneventful and prior to landing at Aliwal North, he lowered the undercarriage and obtained three green down and locked light indications. After landing, he taxied the aircraft on the rem

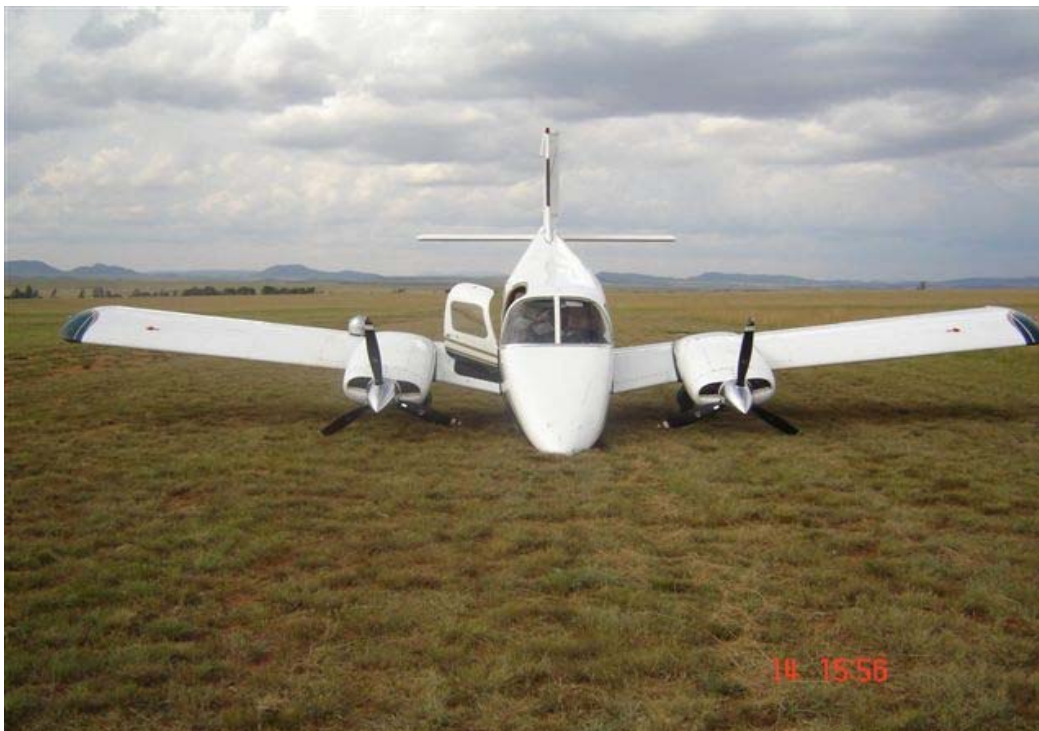
1.12.1 The aircraft landed onto the grass covered Runway 24 at Aliwal North. During taxiing on the remainder of the runway to the hangar area, the nose landing gear suddenly collapsed.

PHOTO 1: A/C NOSE LANDING GEAR COLLAPSED DURING TAXI ON GRASS.

3.1.7 According to available information from the aircraft assessor that inspected the aircraft at the site, the grass runway at Aliwal North is quite rough and the undercarriage was subjected to external forces during landing and whilst taxiing. The nose landing gear actuator rod-end was found slightly bent during landing or taxiing on the grass surface, resulting in the nose landing gear unlocking and collapsing.

3.2.1 After landing on the rough grass surface, the actuator rod-end was bent and the nose landing gear collapsed backwards.

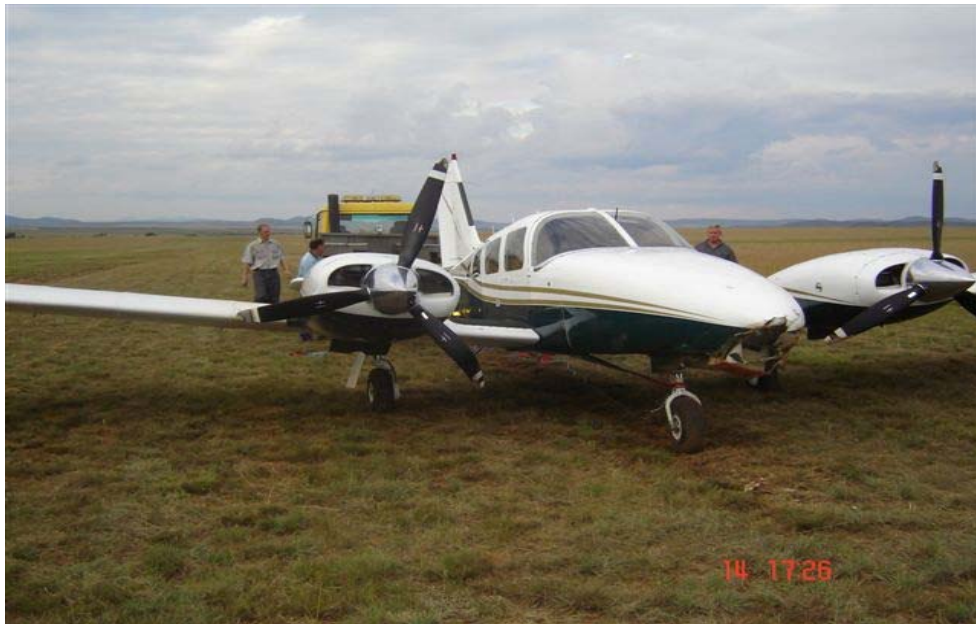
1.16.1 An Aircraft Assessor that inspected the aircraft after the accident had happened stated that the nose landing gear became unlocked during landing on the grass-covered runway, which can be classified as a rough strip, causing the nose landing gear to collapse backwards into the wheel well. He found that the nose landing gear actuator rod-end was slightly bent upon landing or during taxiing on the uneven tuft of grass runway, causing the nose landing gear to unlock. No other abnormalities on the nose landing gear were found.

PHOTO 2: AIRCRAFT BEING RECOVERED FROM UNEVEN TUFT OF GRASS STRIP.

2.5 An aircraft assessor who inspected the aircraft after the nose wheel had collapsed, stated that due to the rough grass surface during the landing and whilst taxiing, the nose landing gear was subjected to abnormal forces and forced out of the down and locked position and subsequently collapsed. A view of the grass surface can be seen on photos taken at the site.

2.6 Although holes were found on the runway by the SACAA Airport Department during an audit inspection at Aliwal North and covered with sand by the Maletswai Municipality, the Investigator is of the opinion that the runway is still very rough with tufts of grass that could result in the nose landing gear unlocking out of the down and locked position whilst taxiing.

4.1 It is recommended that the SACAA Airport Section submit a letter to the Authority (owner or aerodrome operator) at Aliwal North, supervising the aerodrome, regarding the unsafe condition of the grass of the runway and taxiways. The Municipality should improve and smoothen the surface conditions of the runway in order to prevent such an event happening again.
