## AIRCRAFT ACCIDENT REPORT AND EXECUTIVE SUMMARY

Reference:	CA18/2/3/8460	
<b>Aircraft Registration</b>	ZS-RTV	<b>Date of Accident</b>	20 March 2008		<b>Time of Accident</b>	1145Z
<b>Type of Aircraft</b>	Robinson R22 Beta II (Helicopter)		<b>Type of Operation</b>	Private		
<b>Pilot-in-command Licence Type</b>		Private	<b>Age</b>	37	<b>Licence Valid</b>	Yes
<b>Pilot-in-command Flying Experience</b>		Total Flying Hours	361.6		Hours on Type	361.6
<b>Last point of departure</b>		Brits aerodrome (FABS), North West Province				
<b>Next point of intended landing</b>		Rustenburg aerodrome (FARG), North West Province				
<b>Location of the accident site with reference to easily defined geographical points (GPS readings if possible)</b>						
Open, grassy area near the town of Rustenburg; GPS position S25° 38.765' E027° 15.040'; elevation 3 588 ft						
<b>Meteorological Information</b>		Temperature: 23°C; Wind: 135°/10 kts; Visibility: 10 km				
<b>Number of people on board</b>	1 + 0	<b>No. of people injured</b>	0	<b>No. of people killed</b>	0

**Name of Owner/Operator** : Louis Fourie Game Capture (PTY) LTD  
**Manufacturer** : Robinson Helicopter Company  
**Model** : R22 Beta II (helic

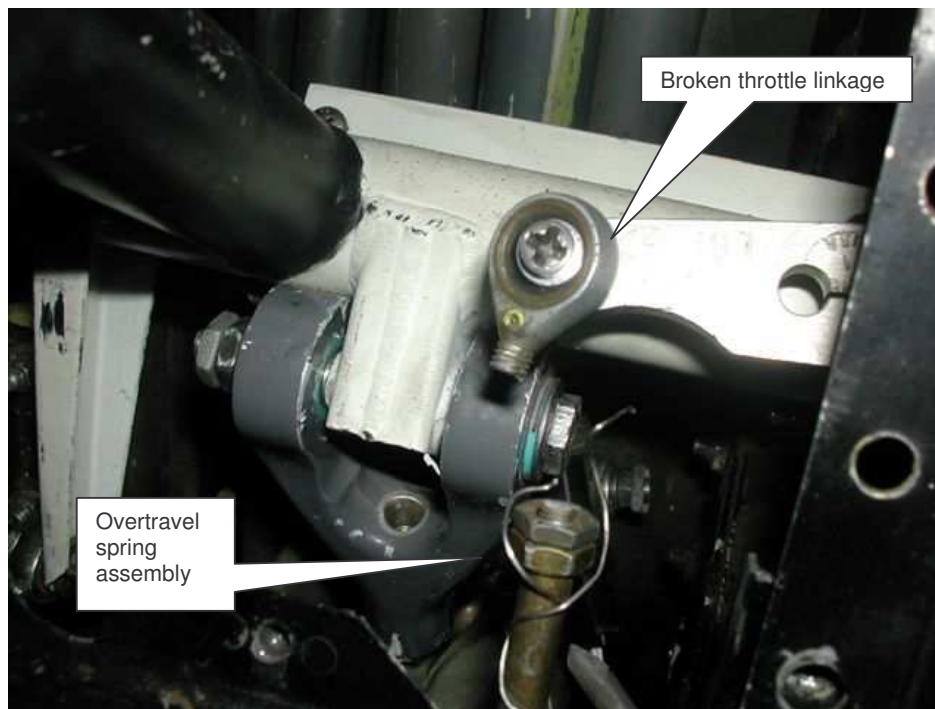
- 14 July 2007: during a game counting flight, an animal jumped into the skid gear, resulting in a hard landing and a dynamic rollover.
- 1.6.6 Following the on-site investigation, the helicopter was recovered to an aircraft maintenance organisation (AMO) at Wonderboom aerodrome where further examination showed that the throttle linkage was broken. The throttle linkage – part no. A759-1 – forms part of the engine controls. None of the other engine controls sustained damage.

**Figure 1.** The broken throttle linkage and overtravel spring assembly.

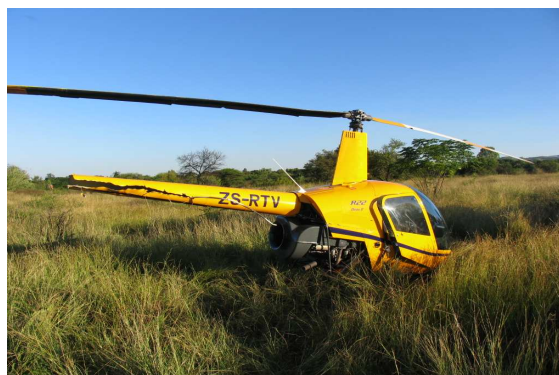
1.12.1 The wreckage was located in an open stretch of grassveld. The helicopter sustained damage to the main rotor, tail rotor, tail stabiliser and skids. The tail stabiliser and tail rotor were located approximately 3 m and 35 m from the main wreckage respectively.

Figure 2. The helicopter after the hard landing.

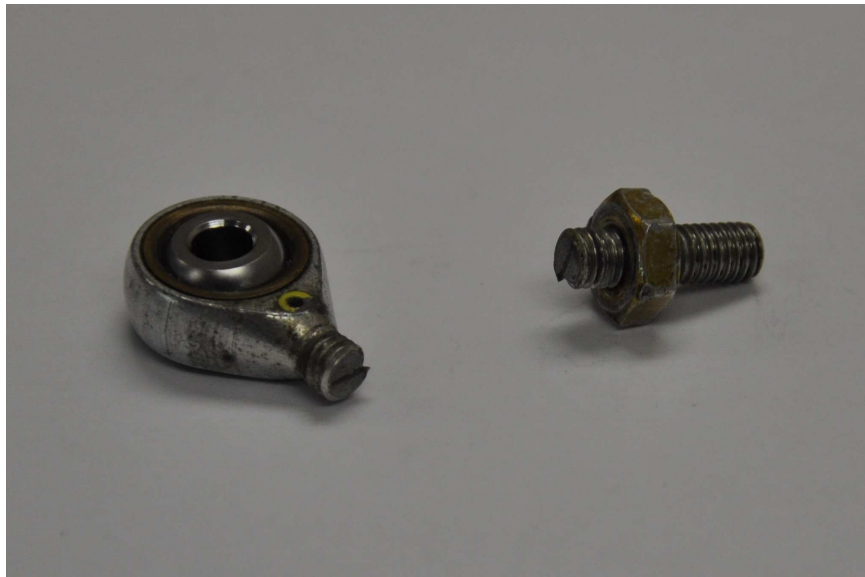
*The investigation results suggest that the component was exposed to a single (or more) tensile overload during operation/fitment resulting in the initiation of cracks in the thread root areas. These surface stress raises then enhanced the formation of fatigue-type fractures supported by vibration and operating conditions.*

**Figure 3.** The failed throttle linkage – part no. A759-1.

- 2.3 During investigation, the throttle linkage was found to be broken. This was considered to be the cause of the engine RPM decreasing to idle and remaining at idle even with inputs from the collective, throttle twist-grip and governor. No other engine controls sustained damage. The metallurgical investigation results suggest that the component was exposed to a single (or more) tensile overload during operation/fitment resulting in the initiation of cracks in the thread root areas. These surface stress raises then enhanced the formation of fatigue-type fractures supported by vibration and operating conditions.

- 2.4 No evidence was found that suggest that the throttle linkage, part no. A759-1, found fitted to the helicopter had been replaced from the time the aircraft came into service until this accident occurred. As the helicopter was involved in two previous accidents the possibility exists that the threaded part of the throttle linkage was damaged prior to this accident. The damage might have initiated fatigue cracks in the threaded part of the throttle linkage which caused it to fail following normal operation.

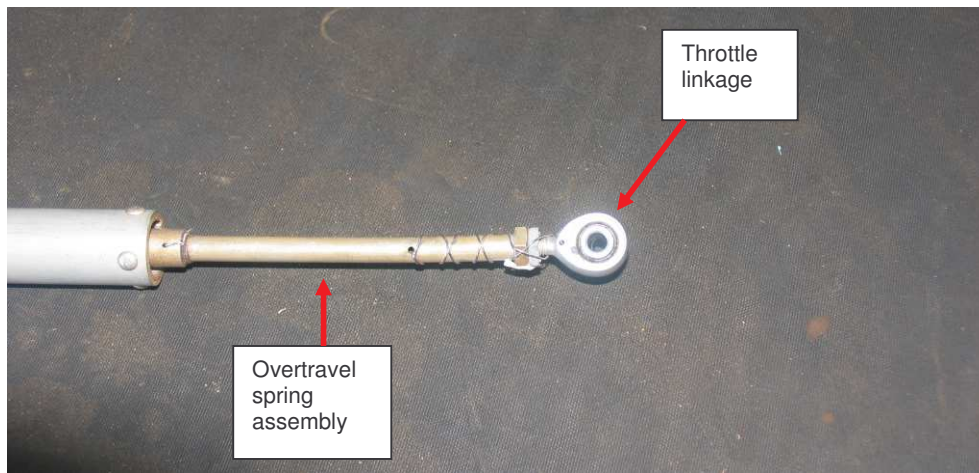
**Figure 5.** The throttle linkage on the overtravel spring assembly  
(photograph taken of similar overtravel spring assembly from different helicopter)

- 1.18.2 The throttle linkage, as shown above, is screwed onto the end of the overtravel spring rod.
- 1.18.3 Further investigation established that, during throttle movement, a small amount of longitudinal force is exerted on the throttle linkage and overtravel spring assembly. The diameter of the threaded part of the throttle linkage is very small (approximately 10/32 inches) and during operation no bending force is exerted on it as the overtravel spring protects it through dampening when the collective pitch lever movement limits are exceeded.
- 1.18.4 No evidence was found to suggest that the throttle linkage, part no. A759-1, fitted to the helicopter had been damaged prior to this accident or replaced from the time the helicopter came into service until this accident occurred.

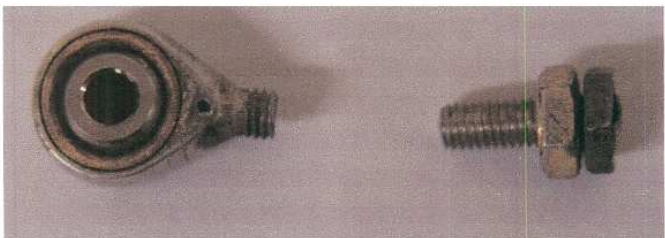
ITEM:		<b>CONNECTING ROD EYE END, THROTTLE CABLE, ROBINSON R22 HELICOPTER</b>	
<b>1. INTRODUCTION</b>			
1.1. The failed throttle control cable ball eye end (Photo 1) from a Robinson R22 Helicopter, aircraft number ZS-RTV, was submitted to determine the possible reason/s for failure during operation.

<b>Photo 1: Supplied fractured throttle cable ball eye (digital)</b>			
<b>1.2. Fatigue</b>			
<b>1.2.1. Fatigue Failures</b>			
<p><b>FATIGUE</b> is the progressive, localized, and permanent structural change that occurs in a material subjected to repeated or fluctuating strains at nominal stresses that have maximum values less than (and often much less than) the tensile strength of the material. Fatigue may culminate into cracks and cause fracture after a sufficient number of fluctuations. The process of fatigue consists of three stages:</p>			
<ul style="list-style-type: none"><li>• Initial fatigue damage leading to crack initiation</li><li>• Crack propagation to some critical size (a size at which the remaining un-cracked cross section of the part becomes too weak to carry the imposed loads)</li><li>• Final, sudden fracture of the remaining cross section</li></ul>

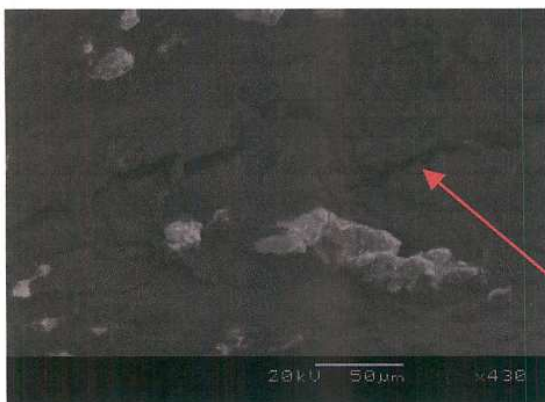
**6.1. Scanning Electron Microscope Investigation.** The SEM investigation revealed secondary crack formation in the adjacent threads (Photo 2, red arrow) indicating that the component was exposed to a possible tensile overload during operation or fitment. The fracture surfaces revealed some smearing damages as well as foreign matter deposits (Photo 3) indicating fracture propagation over a period of time. The remainder of the fracture surface showed two distinct fatigued areas (Photo 4, red arrows), opposing a central area of final fracture (green arrow).

**Photo 2: Secondary crack formation (x430, SEM)**

- 8.1. It is strongly recommended that the source of the overload as well as the fluctuating stress are determined to prevent future failures of type.

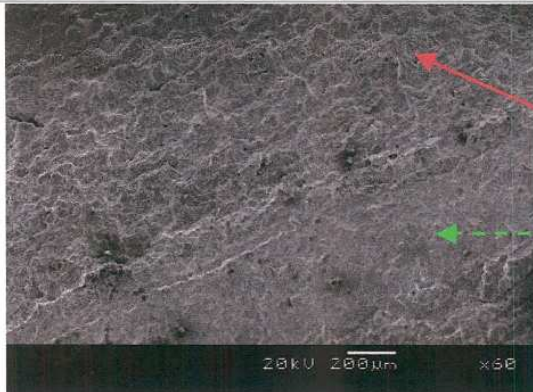
Photo 4: Fatigue and final fracture areas (x60, SEM)

- 7.1 The investigation results suggest that the component was exposed to a single (or more) tensile overload during operation/fitment resulting in the initiation of cracks in the thread root areas. These surface stress raisers then enhanced the formation of fatigue type fractures supported by vibration and operating conditions.
