## AIRCRAFT ACCIDENT REPORT AND EXECUTIVE SUMMARY

Reference:	CA18/2/3/8471	
<b>Aircraft Registration</b>	ZS-RNB	<b>Date of Accident</b>	7 April 2008		<b>Time of Accident</b>	0915Z
<b>Type of Aircraft</b>	Robinson R22 Beta II		<b>Type of Operation</b>	Demonstration		
<b>Pilot-in-command Licence Type</b>	Commercial	<b>Age</b>	32	<b>Licence Valid</b>	Yes	
<b>Pilot-in-command Flying Experience</b>	Total Flying Hours	766.7		Hours on Type	244.2	
<b>Last point of departure</b>	Grand Central Aerodrome (FAGC)					
<b>Next point of intended landing</b>	Grand Central Aerodrome (FAGC)					
<b>Location of the accident site with reference to easily defined geographical points (GPS readings if possible)</b>						
Grand Central helicopter general flying area (GPS co-ordinates: S 26°01.037' E 028°05.851'), elevation 4 625 ft above mean sea level (AMSL)						
<b>Meteorological Information</b>	Surface wind 320° at 5 kts, temperature 22°C, clouds scattered at 4 000 ft

**Name of Owner/Operator** : Hover Dynamics  
**Manufacturer** : Robinson Helicopter Company  
**Model** : R22 Beta II  
**Nationality** : South African  
**Registration Marks** : ZS-RNB  
**Place** : Grand Central helicopter general f

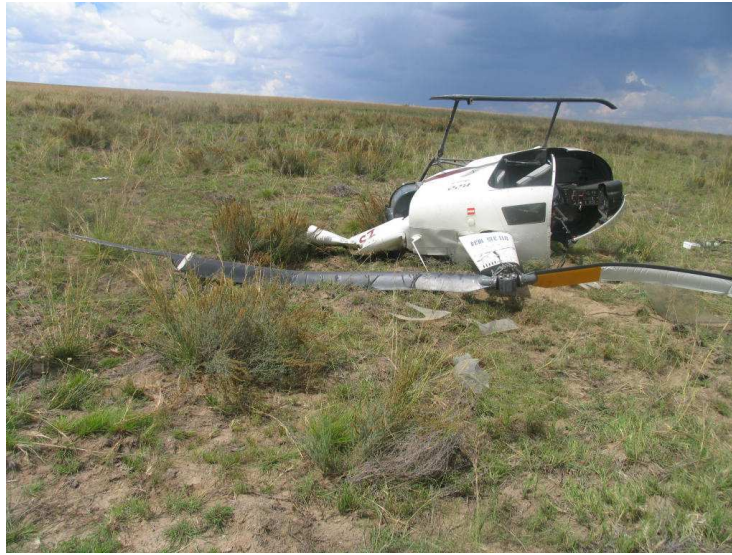
1.3.1 The helicopter sustained substantial damage to the tail boom, main rotor blades, tail rotor, windshield and skid gear.

Figure 1: The main wreckage with the tail boom severed.

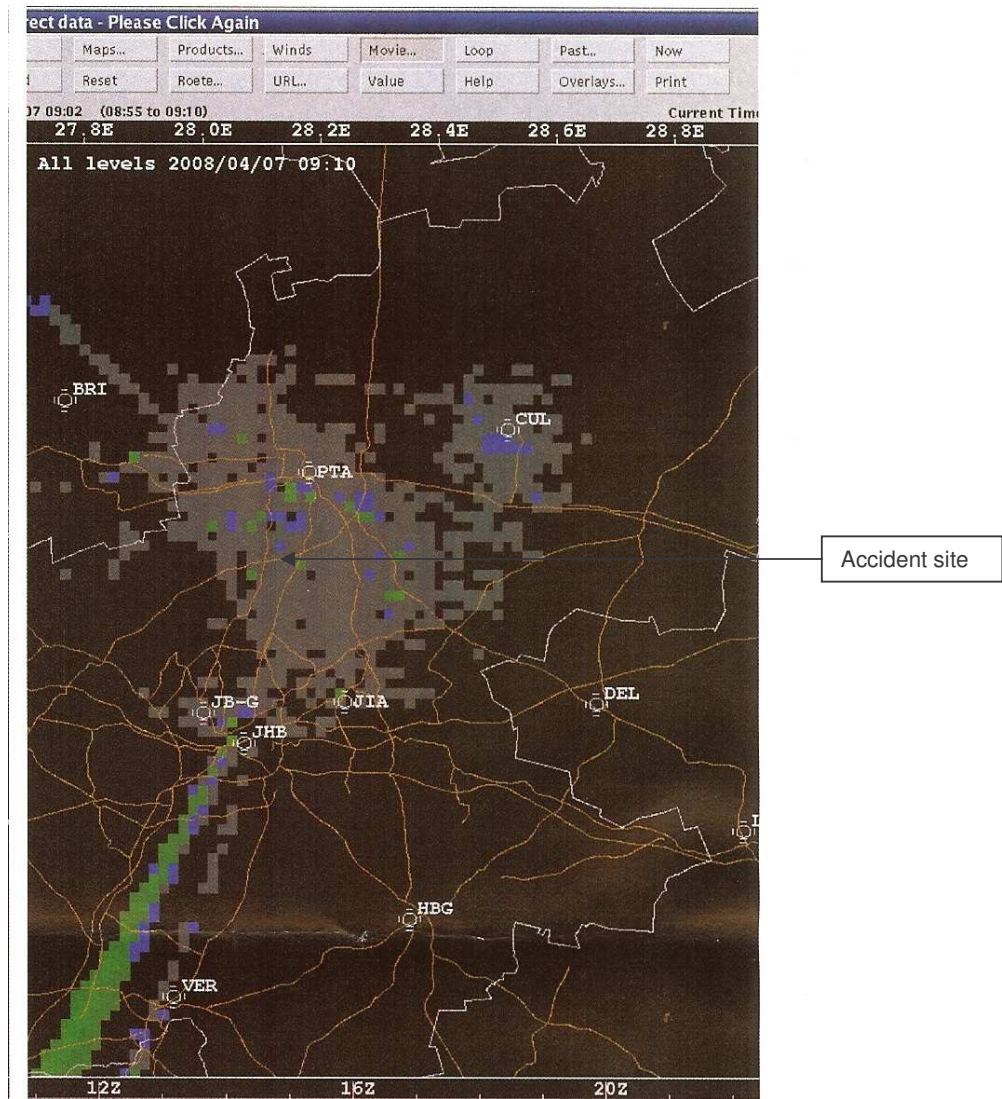
1.7.2 A radar image (Figure 3 below) for 0910Z on 7 April 2008 shows the development of isolated thundershowers to the south of the Midrand area.

- 3.1.7 The accident occurred during daylight conditions.
- 3.1.8 There was an approaching thunderstorm to the south of the helicopter general flying area when the accident occurred.

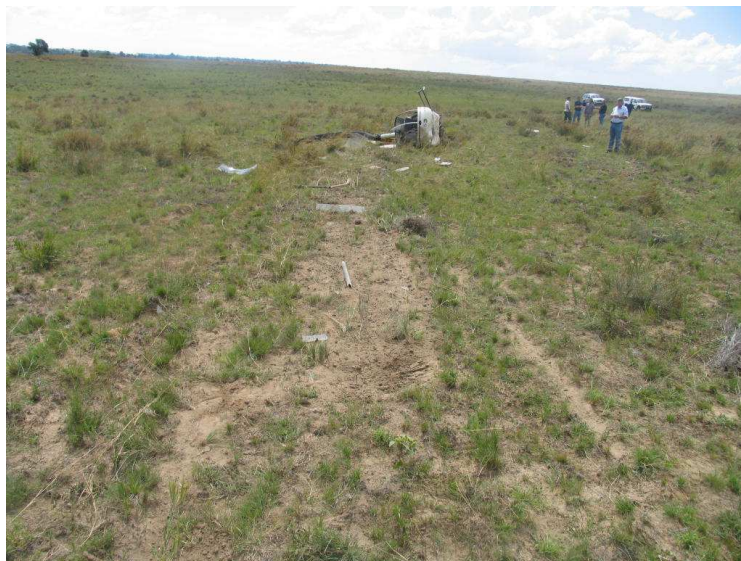
1.12.1 The helicopter impacted the ground with the left skid first, in an upright position and on a heading of 050°M. The right skid impacted approximately 1 m further on, which as a result of the substantial rate of descend, failed on impact. This caused the helicopter to nose over and cartwheel, during which the main rotor blades severed the tail boom. The main wreckage came to rest on its right-hand side approximately 15 m from the first point of impact. Pieces from the severed tail boom and tail rotor assembly were found approximately 15 m further down the wreckage trail.

Figure 4: The wreckage trail and main wreckage.
