AIRCRAFT ACCIDENT REPORT AND EXECUTIVE SUMMARY

Reference:	CA18/2/3/8479	
Aircraft Registration	ZS-RVV	Date of Accident	15 April 2008		Time of Accident	0745Z
Type of Aircraft	Schweizer 269C		Type of Operation	Private		
Pilot-in-command Licence Type		Commercial Pilot (H)	Age	25	Licence Valid	Yes
Pilot-in-command Flying Experience		Total Flying Hours	3297,9		Hours on Type	521,3
Last point of departure		Private farm near Baltimore (Limpopo)				
Next point of intended landing		Private farm near Baltimore (Limpopo)				
Location of the accident site with reference to easily defined geographical points (GPS readings if possible)						
In an open field with thorn bushes near Baltimore (Limpopo) GPS: S23° 17.513' E028° 16.552'						
Meteorological Information		The weather was fine; Temp. 28° C; Wind 12 knots; Visibility clear				
Number of people on board	1 + 0	No. of people injured	0	No. of people killed	0	
Synopsis						
<p>The pilot was on a private flight as a sole occupant when the accident occurred. He stated that he manoeuvred the helicopter at approximately 100 feet above ground level (AGL) when the engine suddenly backfired (ran rough). The helicopter was too close to the ground to

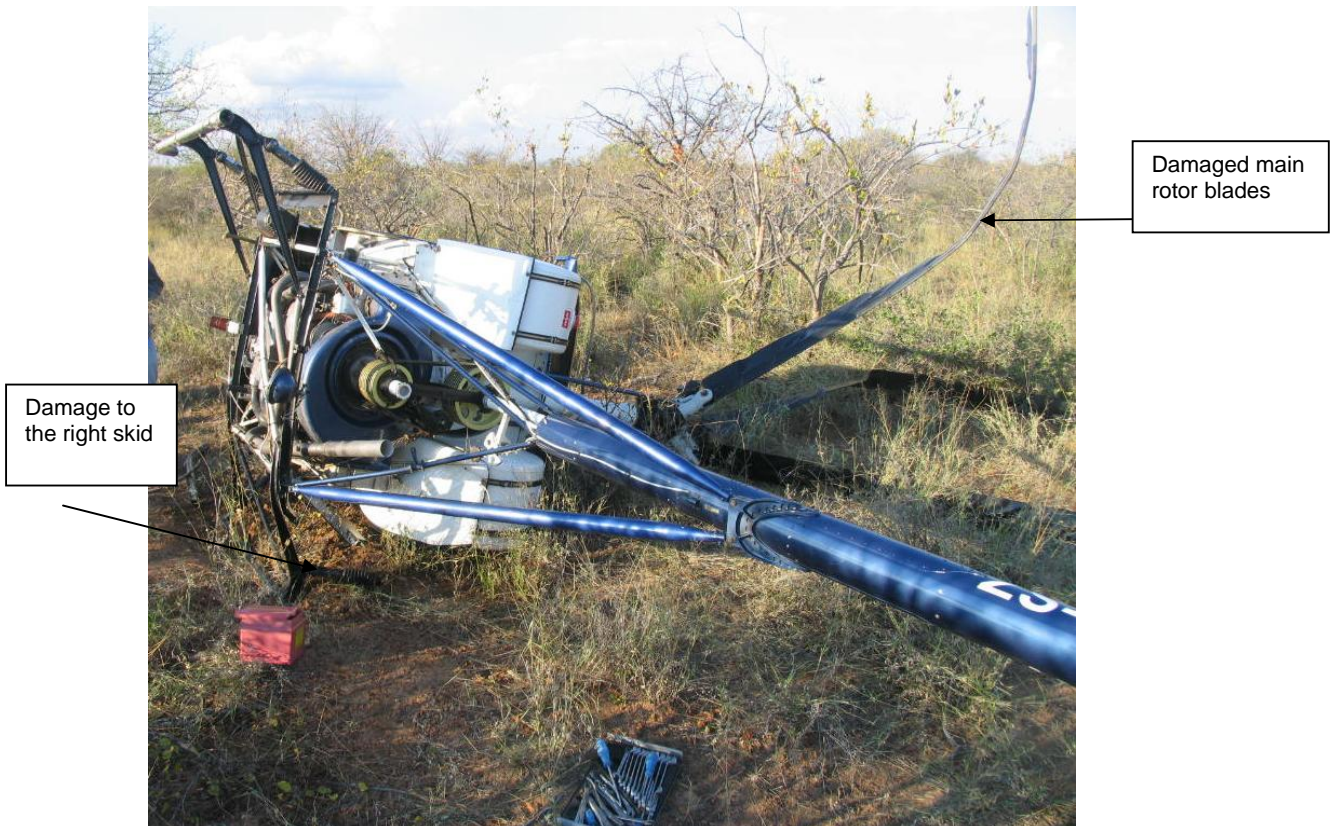
1.3.1 The helicopter sustained substantial damage in the accident.

Fig 1: Aircraft after the accident

1.12.2 The helicopter sustained substantial damage in the accident. The damage was to the main rotor blades and the right skid, and the windshield was broken.

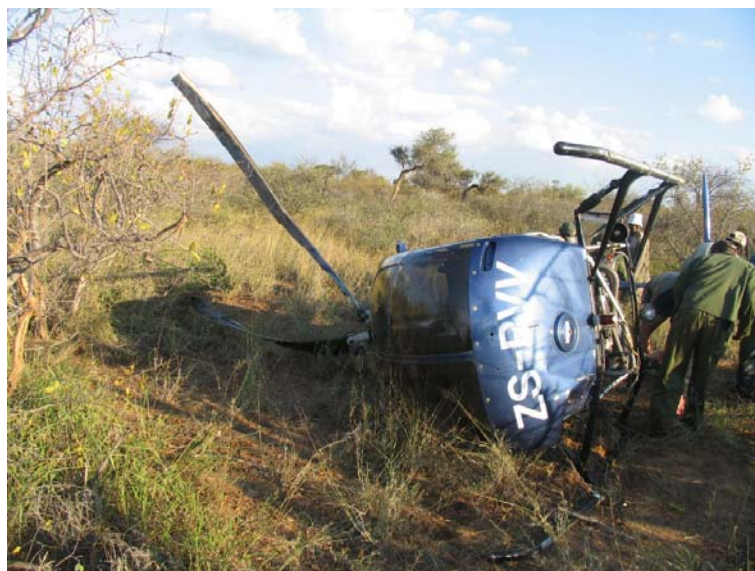
1.10.1 The accident happened on an open field near Baltimore (Limpopo). The GPS coordinates were: S23° 17.513' E028° 16.552'.

Fig 2: Open field where helicopter landed

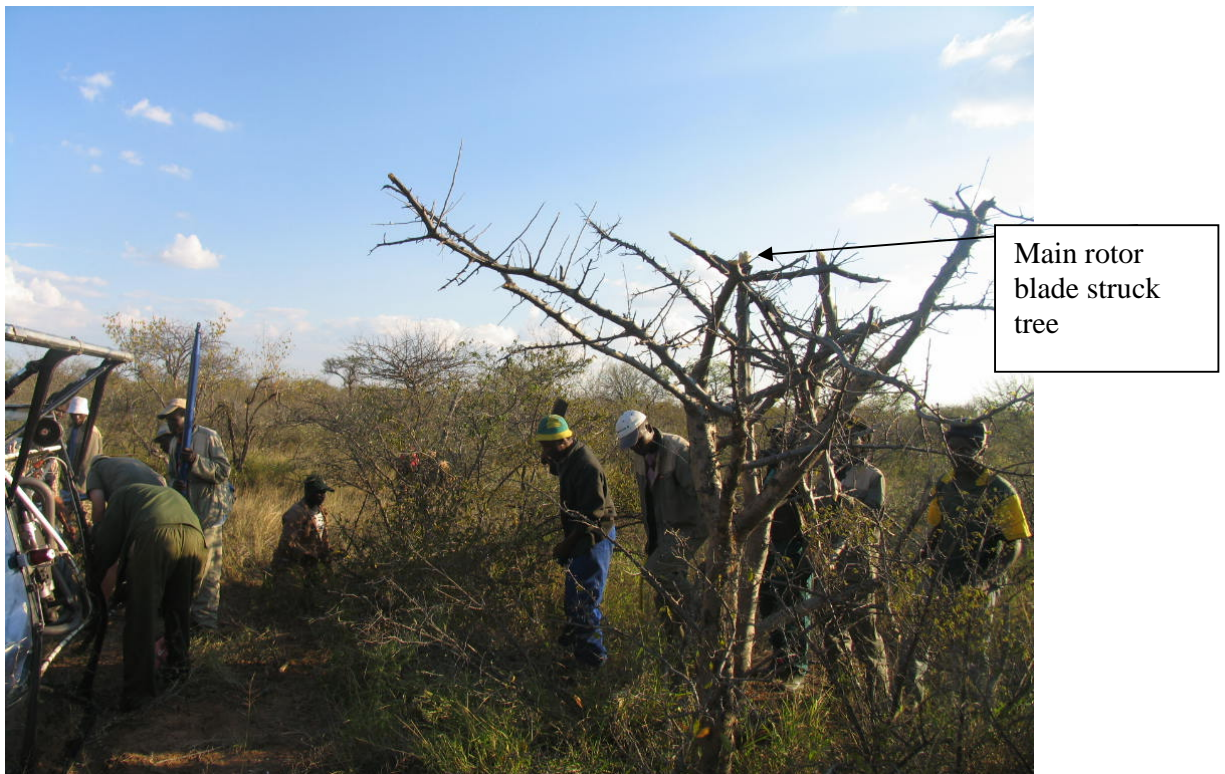
1.12.1 The pilot initiated a left turn to check the movement of what appeared to be a leopard and the engine suddenly backfired (ran rough) and stopped. The pilot was too low to initiate an autorotational landing. The main rotor blades struck a tree and the aircraft came to rest on its right side.

Fig 3: Main rotor struck a thorn tree

Upon touchdown, the main rotor blades struck a thorn tree, and the helicopter rolled over to its right.
