AIRCRAFT ACCIDENT REPORT AND EXECUTIVE SUMMARY

Reference:	CA/18/2/3/8491	
Aircraft Registration	ZU-JCR	Date of Accident	02 May 2008		Time of Accident	0655Z
Type of Aircraft	Jabiru SP		Type of Operation	Private		
Pilot-in-command Licence Type	Private		Age	57	Licence Valid	Yes
Pilot-in-command Flying Experience	Total Flying Hours	± 85.4 hours		Hours on Type	± 85.4	
Last point of departure	Morning Star Aerodrome					
Next point of intended landing	Fisantekraal Aerodrome (FAFK) (GPS co-ordinates: S33°46'00" E018°43'00")					
Location of the accident site with reference to easily defined geographical points (GPS readings if possible)						
On Buurmanskraal farm, north of Fisantekraal (GPS co-ordinates: S 33°45,568' E 018°44,262) at an elevation of 380 ft						
Meteorological Information	Fine, CAVOK					
Number of people on board	1 + 1	No. of people injured	1	No. of people killed	1	
Synopsis						
<p>The pilot and a passenger were on a private VFR flight when the accident occurred.</p> <p>The pilot intended to land on runway 32 at Fisantekraal aerodrome (FAFK), but missed the approach due to changes in the wind direction. He decided to perform a go-around. During the climbing phase of t

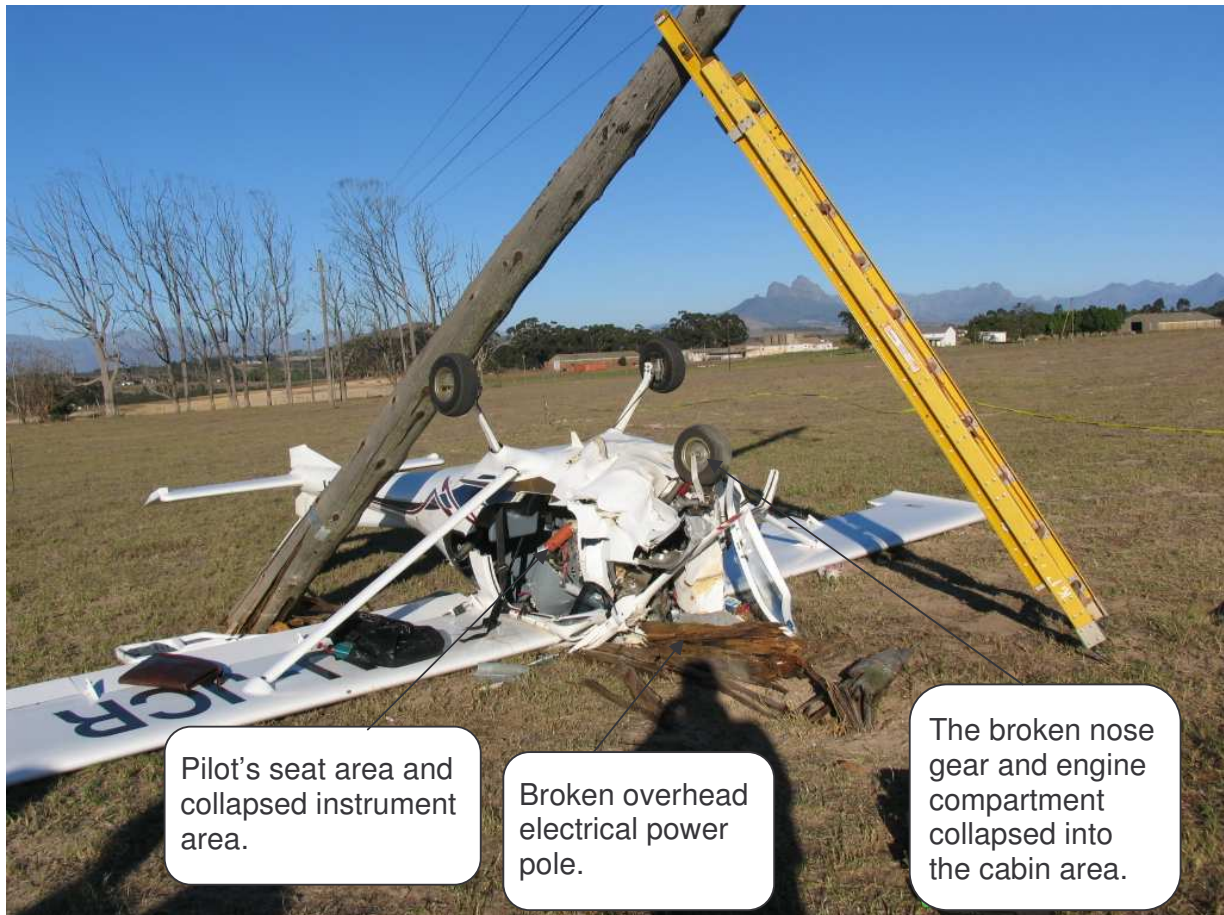
1.3.1. The aircraft was substantially damaged.

Figure 1: The extent of the damages to the aircraft

- 1.15.1. The accident was considered not survivable because of the extent of the damages to the airframe, particularly the cabin. The nose landing gear and the engine compartment collapsed and crumpled into the cabin, and this posed a danger to the occupants, namely being crushed and trapped in the wreckage.
- 1.15.2. The occupants of the aircraft were wearing their safety restraint harnesses.
- 1.15.3. The passenger was assisted out of the wreckage by the emergency medical rescue services.
