AIRCRAFT ACCIDENT REPORT AND EXECUTIVE SUMMARY

Reference:	CA 18/2/3/8504	
Aircraft Registration	ZS-DTK	Date of Accident	29 May 2008		Time of Accident	0950Z
Type of Aircraft	Piper PA23-250 Aztec		Type of Operation	Ferry Flight		
Pilot-in-command Licence Type		Private	Age	70	Licence Valid	Yes
Pilot-in-command Flying Experience		Total Flying Hours	612.4		Hours on Type	Not known
Last point of departure		FAWB (Wonderboom Aerodrome) Gauteng				
Next point of intended landing		FASI (Springs Aerodrome) Gauteng				
Location of the accident site with reference to easily defined geographical points (GPS readings if possible)						
FAWB (Wonderboom) on the right hand side of Runway 29						
Meteorological Information	Wind 110°/05kts. Visibility >10km. Temp. 19°C Cloud cover - Nil					
Number of people on board	1 + 0	No. of people injured	1	No. of people killed	0	
Synopsis						
<p>The pilot was on a ferry flight from Wonderboom Aerodrome to Springs Aerodrome when the accident happened. On take-off (just after getting airborne) the aircraft veered to the right, crashing to the right-hand side of runway 29. According to the pilot, the right-hand engine lost power as the aircraft lifted off the

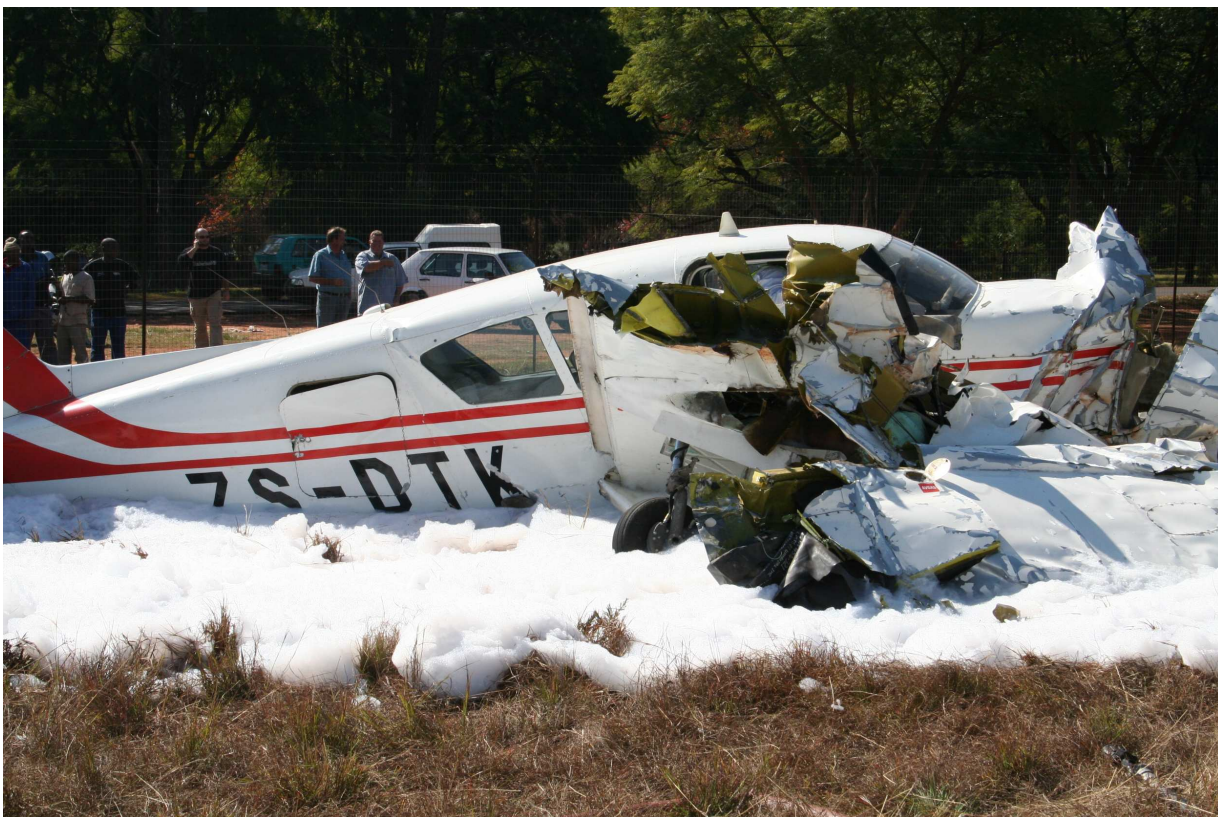
1.3.2 The nose of the aircraft and the right wing were destroyed, while the left wing broke off at the attachment point on the fuselage. The front windscreen was also broken.

1.12.1 The aircraft veered to the right of runway 29, entered into an uncontrollable spiral dive and impacted with the ground with the right wing followed by the nose dome. This caused the right wingtip and nose dome to break off, followed by the right aileron as the aircraft spun around sliding backwards with the left wing detaching at the main attachment point on the fuselage.

1.12.3 The way that the propellers were bent is consistent with a situation where both propellers were turning slowly or wind-milling. Both propellers were severely bent backwards. The propeller blades that made contact with the ground first were the ones which were bent backwards the most. These blades were bent rather than curled.

Photo 1: Main wreckage.

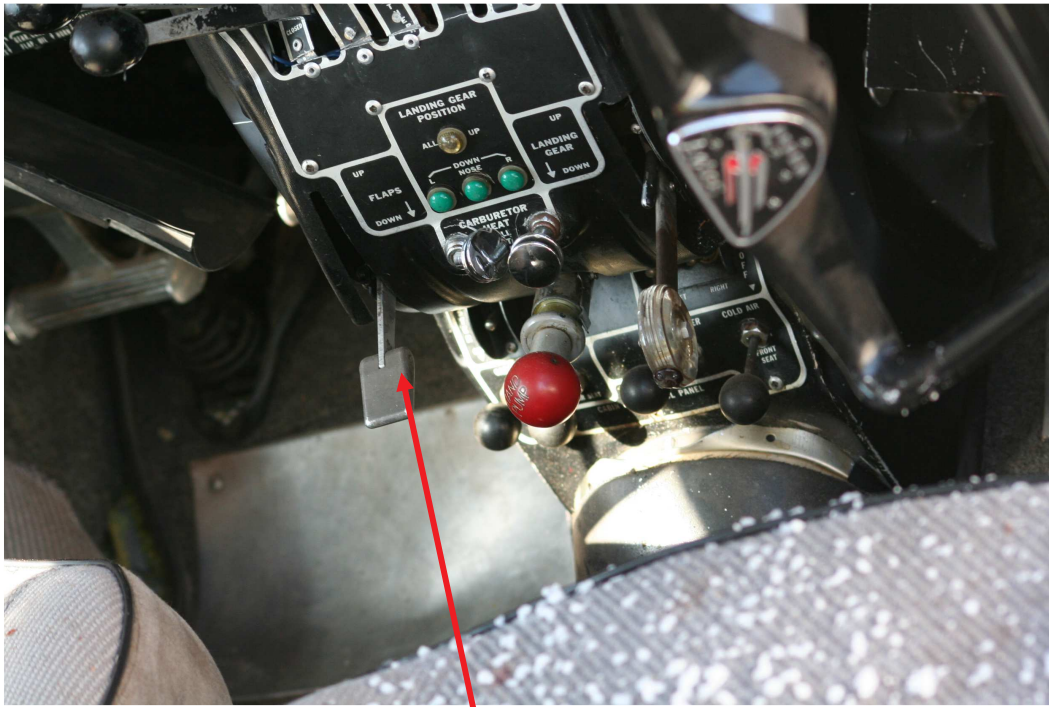
- 1.16.2 On-site investigation revealed that the flaps had been selected down (landing position). The flaps on this aircraft have two position settings, i.e. either in the up or in the down position and according to the owner's handbook, the flaps should not be used on take-off, thus should be selected to an up position. Page 30 last paragraph 'Take-Off' in the Owner's Handbook.

Photo 2: Flap lever in the down position.

- 2.7 The pilot may have selected flaps-down prior to taking off, thereby increasing the amount of drag acting on the aircraft and therefore could not gain sufficient speed and the required lift to safely take off.
