AIRCRAFT ACCIDENT REPORT AND EXECUTIVE SUMMARY

| | | | | Reference: | CA18/2/3/8507 | |
| Aircraft Registration | ZU-BCA | Date of Accident | 14 June 2008 | Time of Accident | 0715Z | |

LEADING EDGE, WINDLASS TRIKE, ZU-BCA

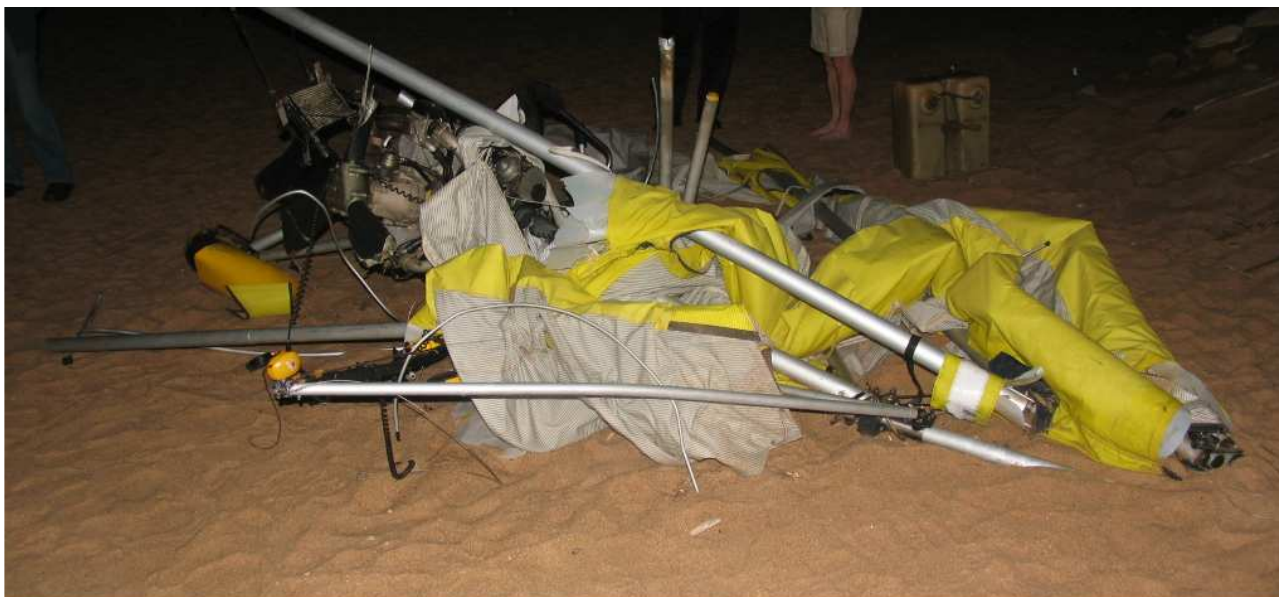
1.12.2 The end section of the aircraft's wing did not fully detach on impact, being attached to the canvas wing covering. The result was that the wreckage was confined to a small area.

Figure 1. The main wreckage.

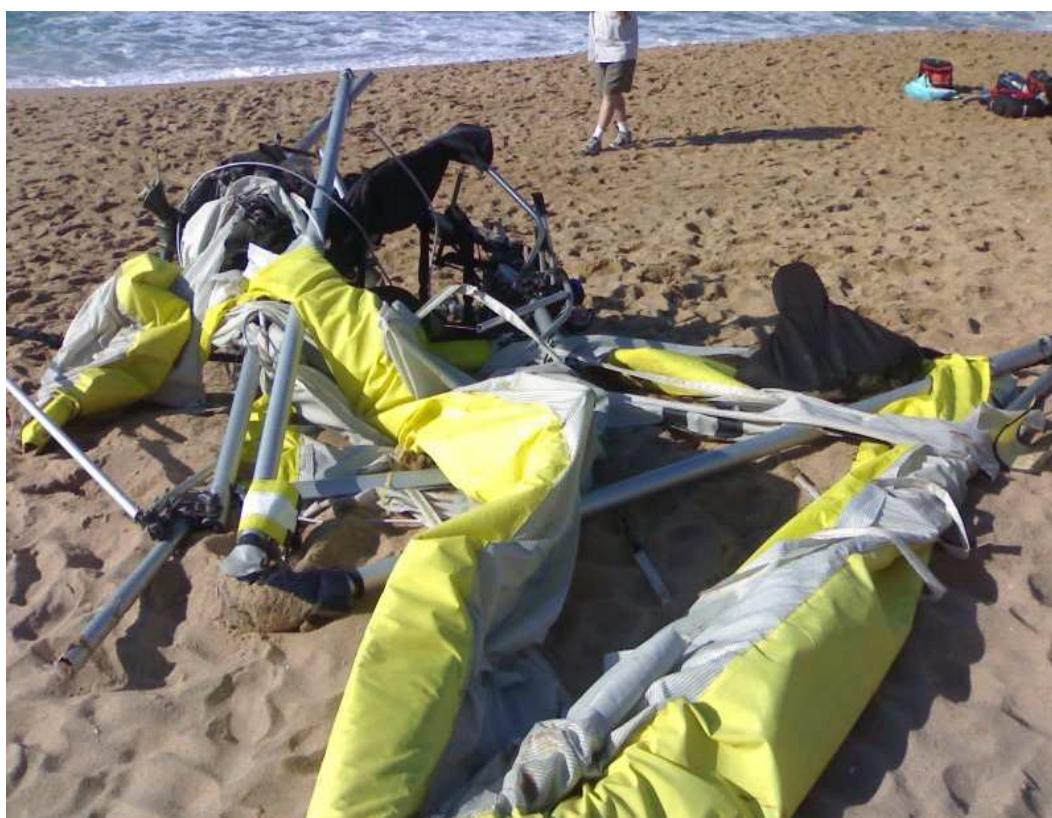
- 1.1 The fractured right-hand leading edge from a crashed Windlass Trike, aircraft number ZU-BCA (Figure 2), was submitted to determine the possible reason/s for failure during operation. The fuselage had been exposed to seawater before recovery.

Figure 2. Crash site, showing the fuselage as found

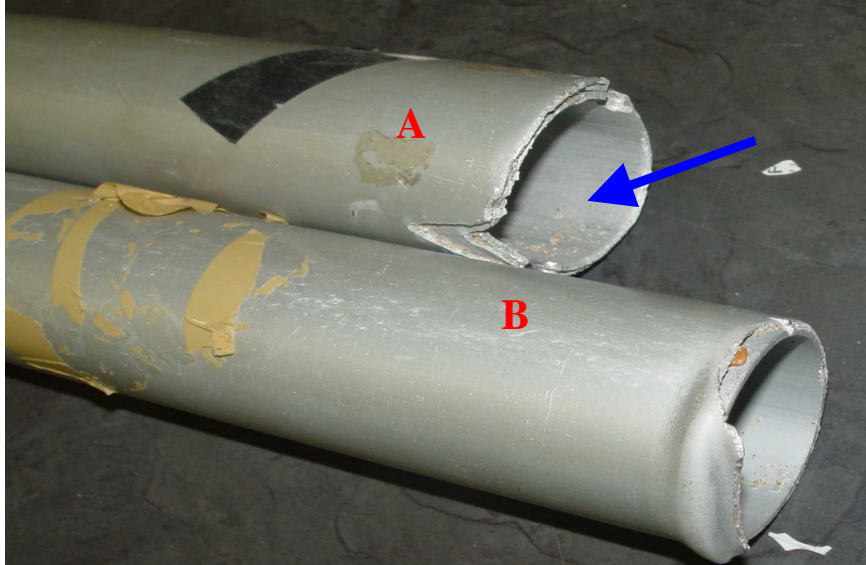
- 6.1 Visual, stereo- and SE microscope investigation. The visual inspection revealed that the three-sleeved leading edge failed at the bolt position in an outward direction (Figure 3, blue arrow). Fracture B can be attributed to impact. The relevant connecting bracket is displayed as found. Note the score marks on half of the inner contact area of the profile (Figure 4, red arrow). These can be attributed to the movement of the outer section of the leading edge after partial failure at position A. Inter-sleeve corrosion damage was detected in the vicinity of the bolthole at position A (Figure 5, blue arrows). Corrosion damage was also noted on the bracket (Figure 4, blue arrow). Although some of the bracket corrosion damage may be attributed to seawater submersion after the impact, the inter-sleeve, crevice-type corrosion damage is of concern.

Figure 3. Fracture surfaces at point A and B (digital).

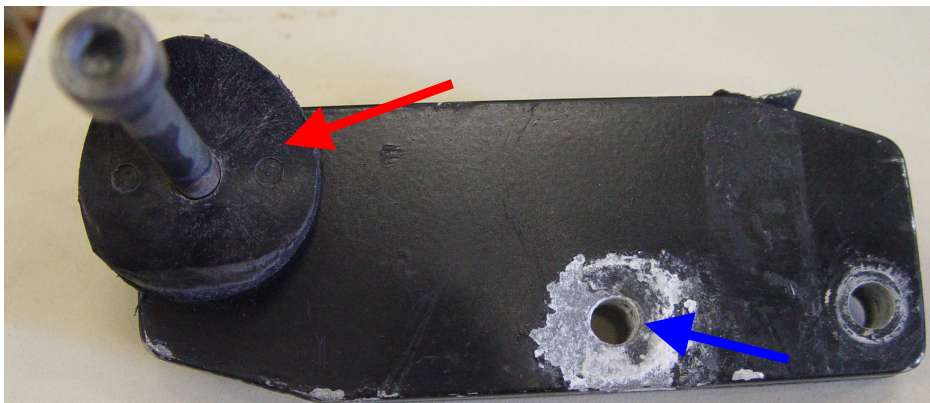
Figure 4. Connecting bracket, bolt and profile at position A (digital).

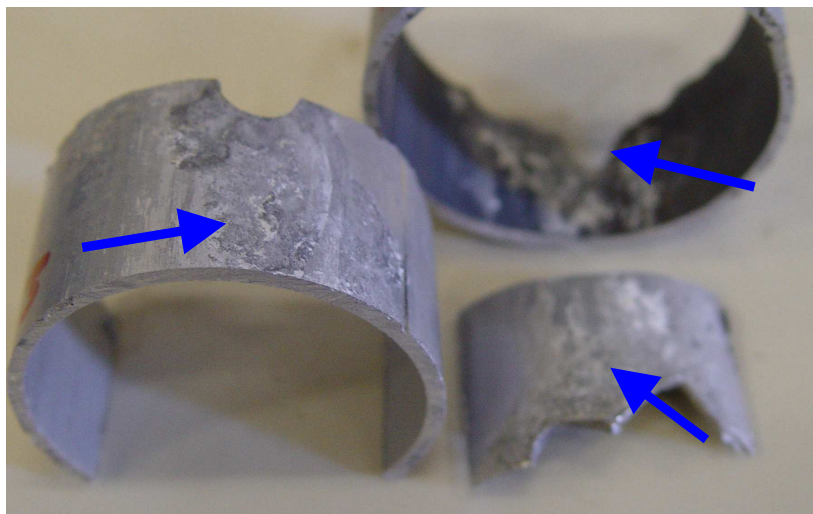
Figure 5. Corrosion damage, position A (digital).

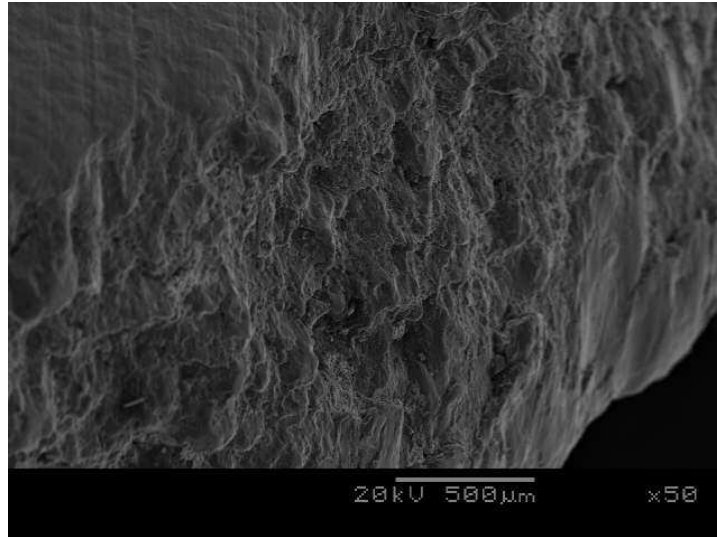
The SEM fractograph revealed some evidence of an overload type of fracture geometry (Figure 6), combined with extensive damage to most of the fracture surfaces. This included corrosion (Figure 7). The bolthole area on the innermost tri-sleeve leading edge revealed signs of secondary crack formation (Figures 8, 9 and 10). The crack geometry indicates slow propagation over a period.

Figure 6. Fracture surface adjacent to bolt hole, position A (x50, SEM).

- 7.1 The investigation revealed that the relevant component failed over an undetermined period.
- 7.2 Taking into account the amount of corrosion damage detected in the adjacent bolt hole areas (Figure 6), corrosion-induced crack formation can be considered a causal factor. Pre-failure overload damage to this vulnerable area, enhancing corrosion-induced crack formation, can also not be ruled out. This weakening of the leading edge at position A could have led to its failure under normal loading during the final flight.

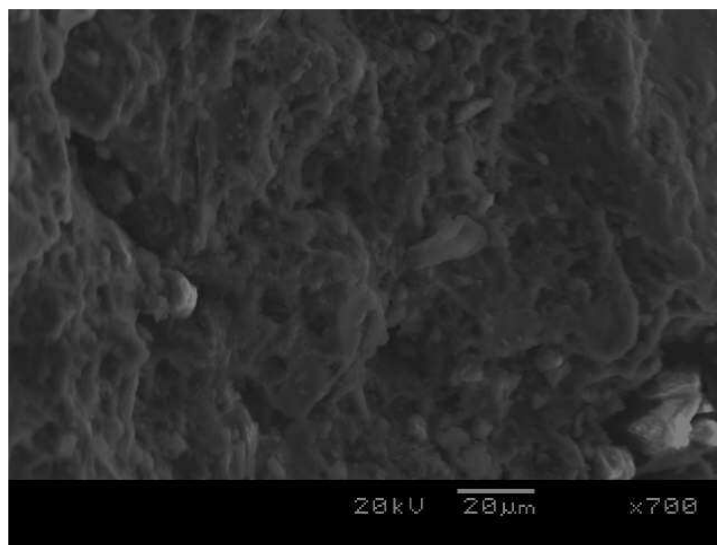
Figure 7. Corrosion products on fracture surfaces (x700, SEM).

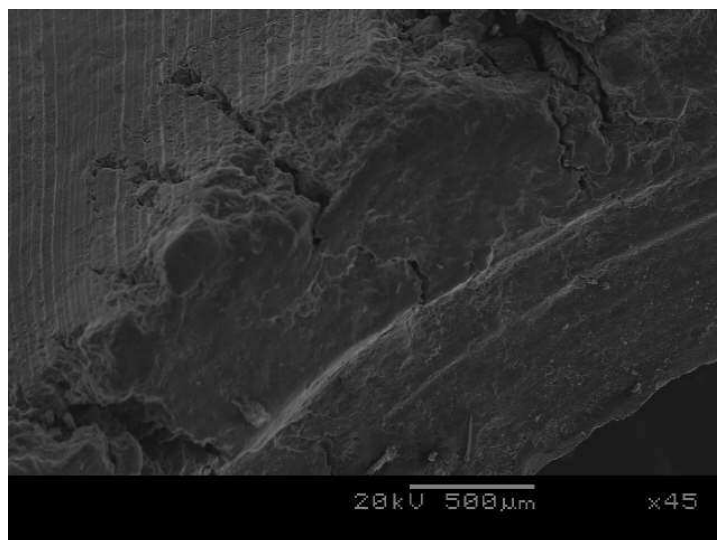
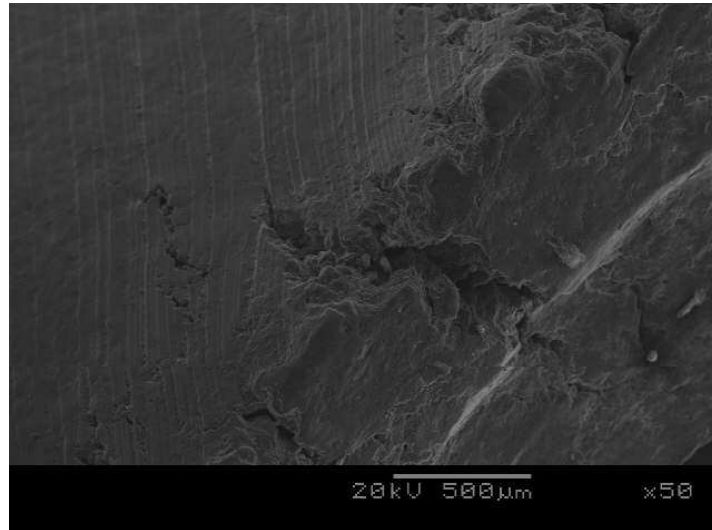
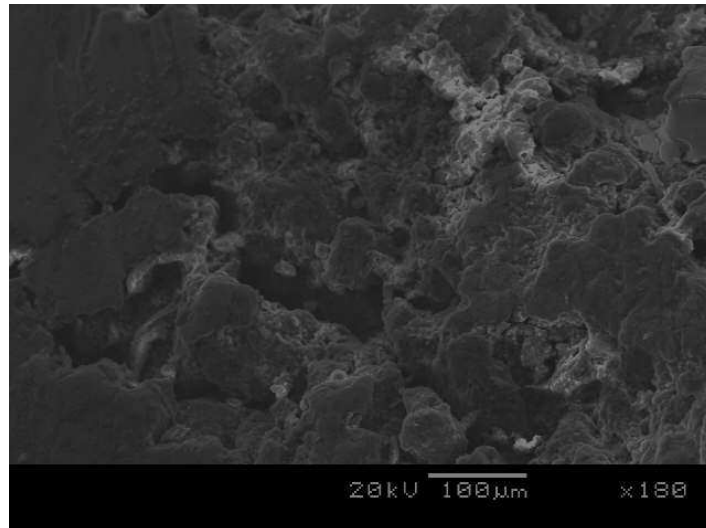
Figure 8. Secondary crack formation, inner sleeve, position A (x45, SEM)

Figure 9. Secondary crack formation, inner sleeve, position A (x50, SEM).

Figure 10. Secondary crack formation, inner sleeve, position A (x180, SEM).

- 8.1 The aircraft's operating environment was an area rated as "severe corrosive" (see CSIR ratings). Furthermore, the position of the crack formation, being the inner-sleeve areas, cannot be visually inspected during normal pre-flight inspections. It is strongly recommended that a comprehensive corrosion inspection schedule, in conjunction with the OEM, of this and other corrosion-prone areas based not only on operational hours and operating environment, but also on lifetime of the aircraft frame, be researched and implemented as soon as possible.

- 8.2 It is also recommended that the application of corrosion-inhibiting compounds (CICs) in corrosion-prone areas, particularly crevices, be researched in conjunction with the OEM.

- 8.3 Furthermore, it is suggested that all clubs and flight schools operating in corrosive environments implement a detailed corrosion control programme (CCP) to enhance flight safety.
