AIRCRAFT INCIDENT REPORT

Reference	CA18/3/2/0659	
Aircraft Registration	ZS-OKD	Date of Incident	18 June 2008		Time of Incident	0855 Z
Type of Aircraft	Boeing 737-236A (Aeroplane)		Type of Operation		Scheduled Commercial	
Pilot-in-command Licence Type	Airline Transport	Age	39	Licence Valid	Yes	
Pilot-in-command Flying Experience	Total Flying Hours	7195.7		Hours on Type	1702.5	
Last point of departure	OR Tambo International Aerodrome (FAJS), Gauteng Province					
Next point of intended landing	Durban International Aerodrome (FADN), KwaZulu-Natal Province					
Location of the incident site with reference to easily defined geographical points (GPS readings if possible)						
Partly off the runway approximately 30m from the threshold of Runway 24 at Durban International Aerodrome.						
Meteorological Information	The weather at Durban International Airport was cloudy with hard rain					
Number of people on board	2+4+87	No. of people injured	0	No. of people killed	0

Name of Owner/Operator : Comair Ltd
Manufacturer : Boeing Aircraft Company
Model : Boeing 737-236A
Nationality : South African
Registration Marks : ZS-OKD
Place : Durban International Aerodrome (FADN)
Date : 18 June 2008
Ti

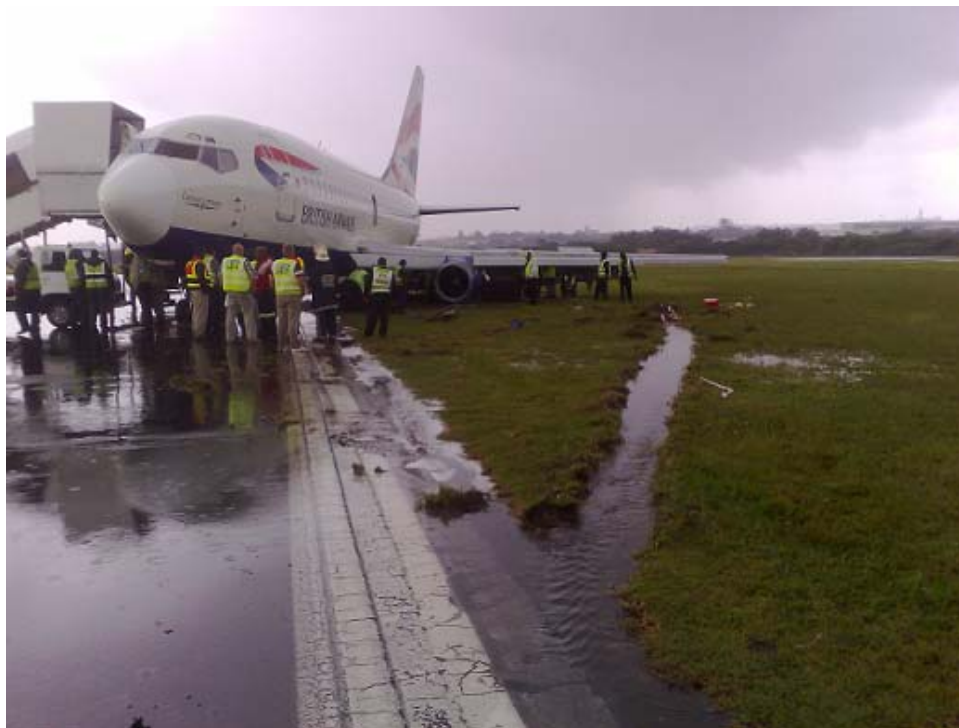
Photo1: Indicating damage to aircraft.

1.3.1 The aircraft sustained damage to the left-hand main landing gear door, main landing gear wheels and left-hand engine

Limited damage to the left wing area.

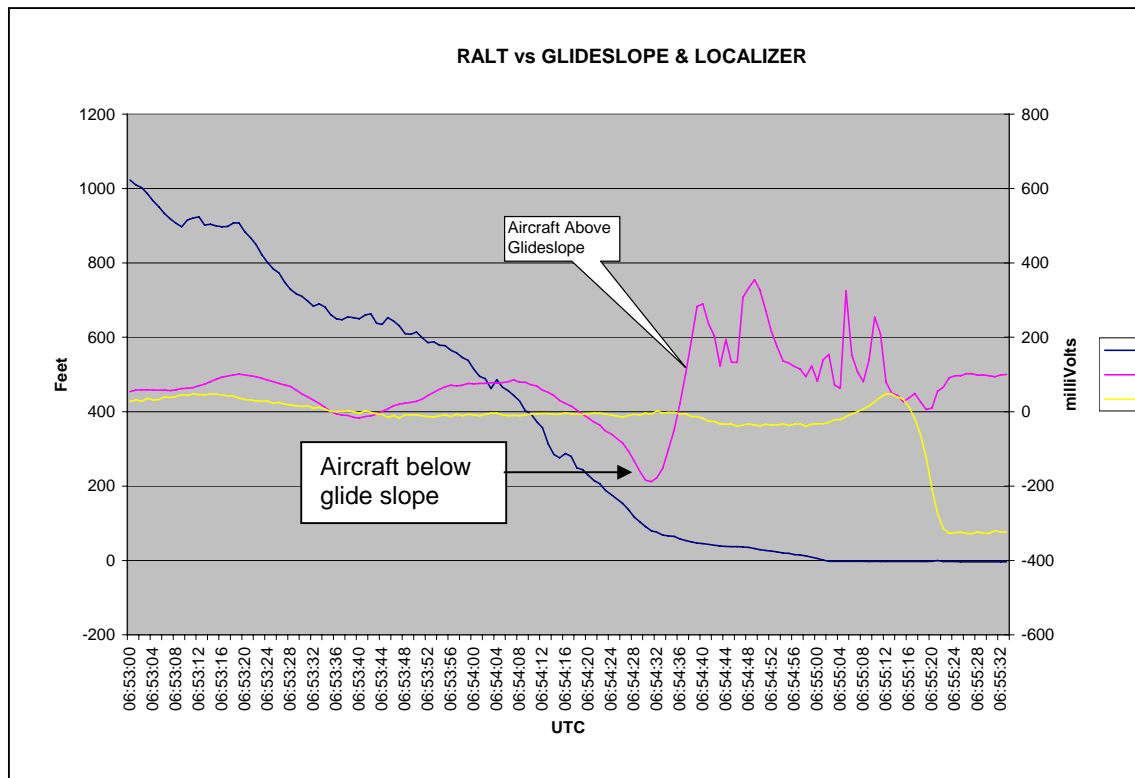
1.11.4.1 RALT vs. GS & LOC – the graph below shows the relationship between Radio Altitude and the Glide Slope and Localizer deviations. The graph shows that the aircraft was below the glide slope before the pilot attempted to correct, resulting in the aircraft being above the GS. Also, the aircraft appeared to “float” during the final stages of the landing. It is clear that the aircraft descended slowly, as it takes 30 seconds from 80 feet (RALT) to Touch-Down.

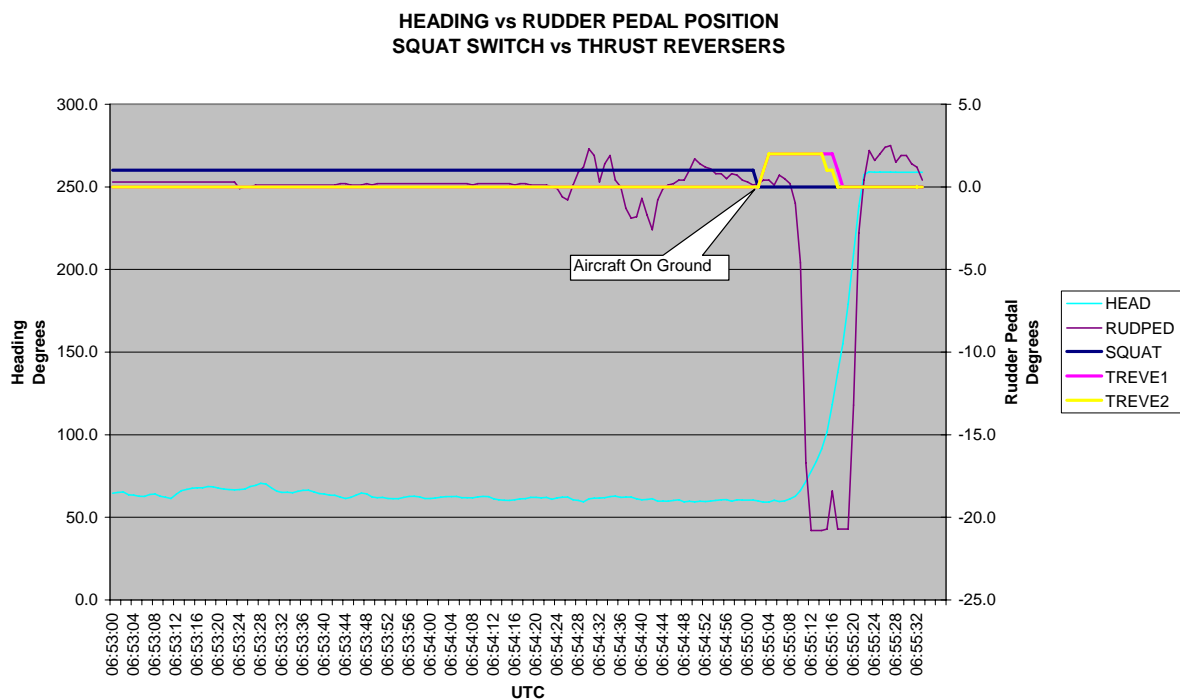
1.11.4.2 HEAD vs. RUDPED – The graph reflects information regarding Heading, plotted against the Rudder Pedal position, as well as Thrust Reverser and Squat Switch Positions. The data indicated that the aircraft had now touched down and then the Left Rudder Pedal was pushed forward, (the right pedal position is recorded, the negative values indicates that the right pedal was pushed back). However, the aircraft was turning to the right, (the value for Heading is increasing from $\pm 60^\circ$ to 259°). It can also be seen on the graph that the Engine no. 2 Thrust Reverser closed before the Engine no. 1 Thrust Reverser. The data also indicates that Maximum Thrust Reverse was selected.

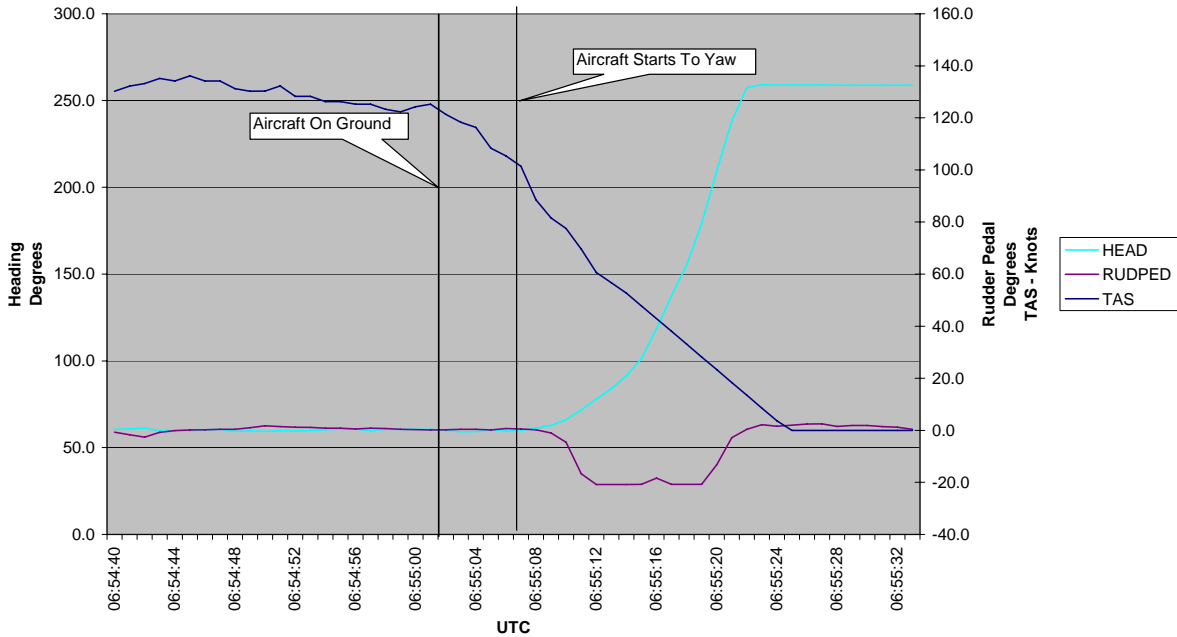
HEADING vs TAS & RUDDER PEDAL POSITION

1.11.4.3 TAS vs. RUDPED – The graph below reflects information regarding Heading plotted against the Rudder Pedal position, as well as the True Airspeed (TAS). The graph indicated that the Heading and the Rudder Pedal input started to change at almost the same point in time. The time scale covers the last 54 seconds of the event.

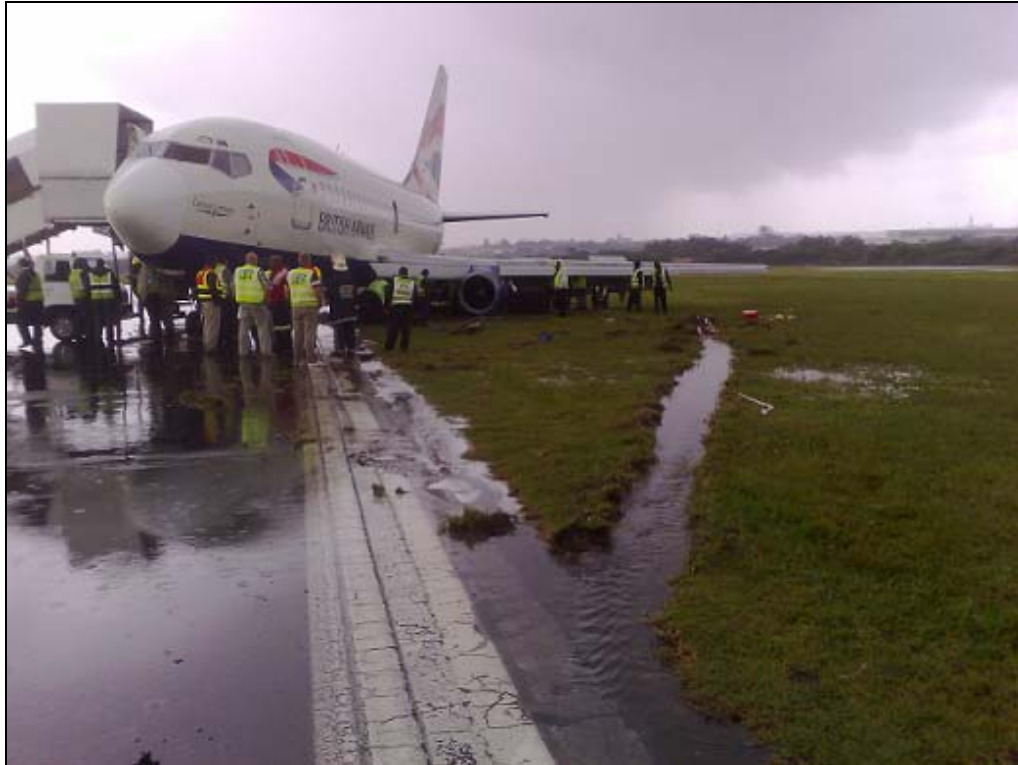
Figure 4. Shows the final position of the aircraft as it came to rest

1.12.1 The aircraft's approach was above the GS resulting in a deep landing on Runway 06. It was reported by ATC FADN that the aircraft had touched down in the middle of the runway and started to veer to the right before it groundlooped through 200°. The aircraft then partially skidded off the runway onto the grass-covered, water-logged surface on the right side of Runway 06, causing the left main undercarriage to sink into soft soil. The aircraft came to a stop at GPS Position: S29°57'41.91"E030°57'26.16" approximately 30m from the threshold of Runway 24.

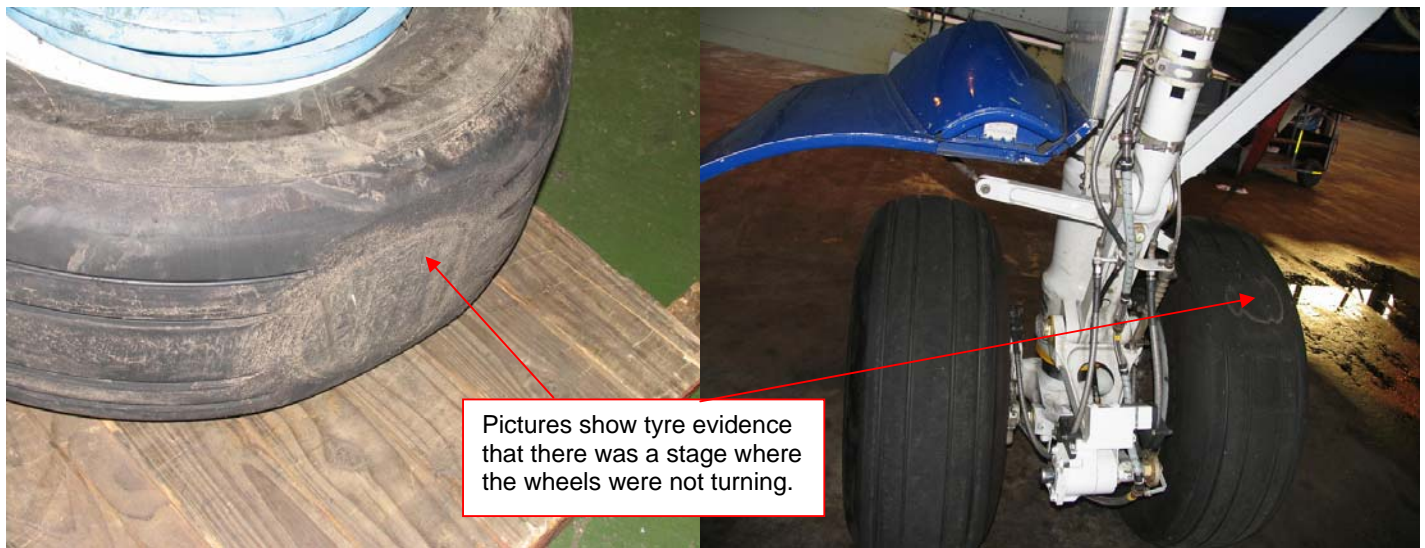
1.16.3 The inspection of the aircraft wheels during the investigation revealed flat spots on the two inner main wheel tyres. The flattened 'heated' area on the two wheel tyres appear to be consistent with a non-turning wheel (hard barracking effect), The pictures below show the flat spot on the aircraft's inner main wheels.
