AIRCRAFT ACCIDENT REPORT AND EXECUTIVE SUMMARY

Reference:	CA18/2/3/8508	
Aircraft Registration	ZU-EXT	Date of Accident	26 June 2008		Time of Accident	1240Z
Type of Aircraft	Extra Flugzeugbau 300 (Aeroplane)		Type of Operation		Private	
Pilot-in-command Licence Type		Airline Transport	Age	35	Licence Valid	Yes
Pilot-in-command Flying Experience		Total Flying Hours	12 005.0		Hours on Type	162.9
Last point of departure		Rand Aerodrome (FAGM)				
Next point of intended landing		Rand Aerodrome (FAGM)				
Location of the accident site with reference to easily defined geographical points (GPS readings if possible)						
10m to the left of Runway 11 at Rand Aerodrome						
Meteorological Information		Surface wind; 200°/7kt, Temperature; 18°C, Visibility; >10km				
Number of people on board	1 + 0	No. of people injured	0	No. of people killed	0	
Synopsis						
<p>The pilot took off from Rand Aerodrome and flew to the Syferfontein Aerobatic Area (FAD 184) with the intention of performing aerobatic flying training. While performing aerobatics, he suddenly noted that the right rudder pedal was without any authority and suspected that the rudder cable might have failed.</p> <p>The decision was ma

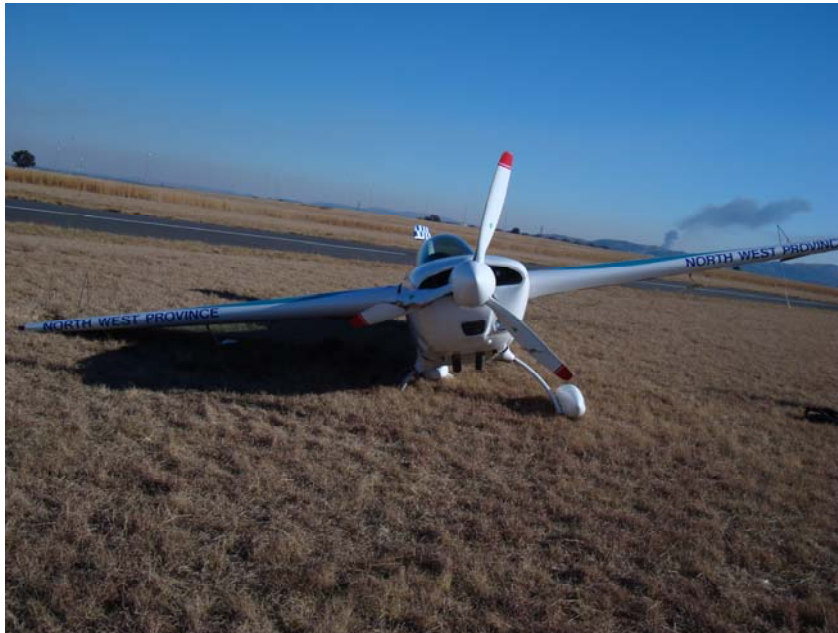
1.12.1 The pilot was able to maintain runway heading for some time following landing, but at approximately 40 knots indicated airspeed, the aircraft suddenly yawed to the left and veered off Runway 11. The aircraft ground looped, coming to rest approximately 10m from the runway edge, on the grass covered clear area next to the runway. Following the ground loop, the right main landing gear strut broke off near the fuselage attachment, which caused the right wing to impact with the ground and the aircraft to nose forward to such an extent that two of the three propeller blades made contact with the ground and were substantially damaged. The aircraft, however, did not nose over and remained in an upright position as can be seen in the picture below (Figure 1).

Figure 1: A view of the aircraft as it came to rest on the left side of the runway.

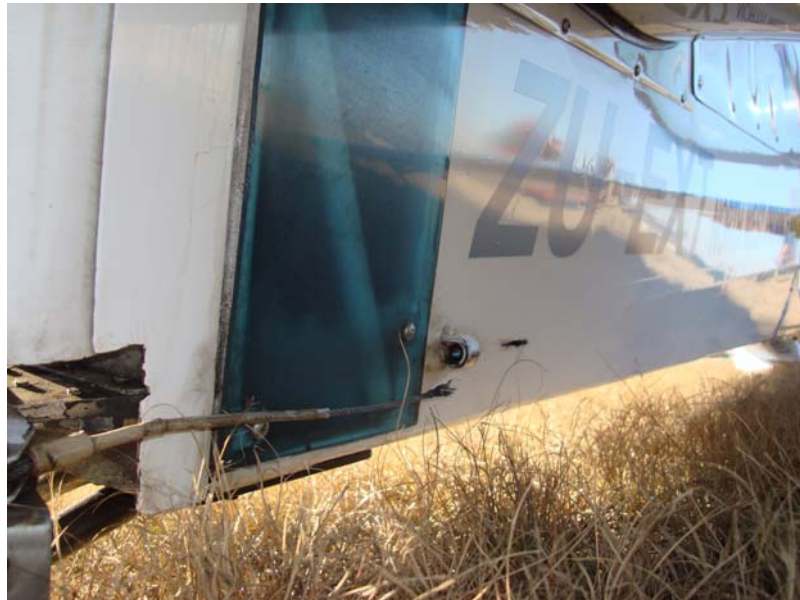
1.16.1 The aircraft was recovered to a facility at FAGM and was inspected by SA:CAA Accident Investigators. It was noted that the right rudder cable had failed and was subjected to a substantial amount of scuffing in the area of the fairlead, which guides the cable underneath the horizontal stabilizer as it penetrates the fuselage from inside to the outside.

Figure 2. A view of the failed right rudder cable in the area of the fairlead.

- 2.6 What is of some concern to the writer is that the rudder cable is at no time hidden from the view of maintenance personnel or flying crew due to the design of the aircraft. The cable is attached to the rudder pedal and ran along the inner fuselage, guided at certain intervals by sleeve/s until such point where it penetrates the canvas fuselage at the aft section of the aircraft and then goes through the fairlead, followed by the attachment to the rudder quadrant. The design makes the cable easy visible for inspection, not only during maintenance intervals but also during pilot pre-flight inspections. The fact that the wear on the cable was not detected during any of the pre-flight inspections since the last maintenance inspection was performed, is indicative of the fact that the cable was not physically inspected in that area during pre-flight inspections. The failure of the cable could most probably have been prevented, should detailed pre-flight inspections have been conducted.

- 2.9 In conclusion the failure of the rudder cable was due to collective complacency, by all role players, being maintenance personnel as well as flying crew neglecting to perform a proper visual inspection of the rudder cable in the area of the fairlead. This led to the systematic wear of the rudder cable in the area of the fairlead, which was aggravated by scuffing. Several cable strands started to fail, which most probably occurred over a period of time until the point where the cable could no longer withstand the forces it was designed for and failed, rendering the pilot

- (i) Rudder Cables: A detailed inspection of the entire rudder cable installation (both left and right rudder sides) should be performed from the attachment at the rudder pedals all the way to the attachment at the rudder control surface. The condition and integrity of the cable should be the main emphasis of the inspection and should, any abnormalities/defect(s) be found, the cable should be replaced prior to the next flight.

- (ii) Fairleads: The condition of the fairleads, which act as a guide to the cable (located below the horizontal stabilizers on each side of the fuselage) should be subjected to a detailed inspection, with special emphasis on the inner guide race condition, as well as the presence of any sharp or untoward edges that might exist, and might initiate, or contribute to the rudder cable chafing, which could result in a rudder cable failure.

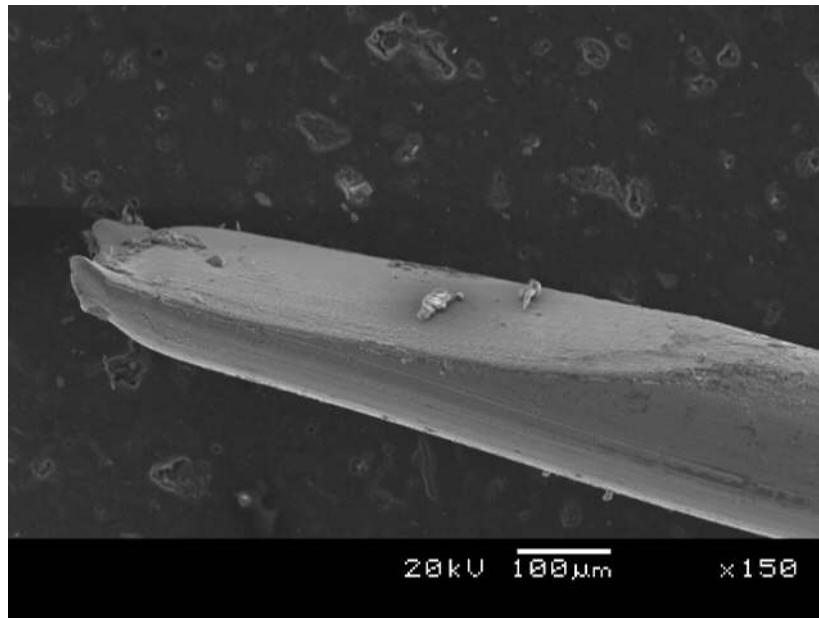
1.16.2 Both ends of the failed rudder cable were removed from the fuselage and it was subjected to a SEM (Scanning Electron Microscope) examination by a Metallurgist. Several of the failed cable strands were scanned and enlarged to x150, and all of the strands displayed evidence of scuffing, which led to the weakening of the cable to such an extent that it could no longer withstand the forces it was designed for, and failed.

Figure 3. Cable strand enlarged under Scanning Electron Microscope x150 times.

- 2.5 The SEM (Scanning Electron Microscope) examination of the cable clearly indicated that the cable had failed due to scuffing that had occurred in the area of the fairlead over a period of time. It was, however, not possible to determine the
