## AIRCRAFT ACCIDENT REPORT AND EXECUTIVE SUMMARY

Reference:	CA18/2/3/8518	
<b>Aircraft Registration</b>	ZU-CLN	<b>Date of Accident</b>	11 July 2008		<b>Time of Accident</b>	1500Z
<b>Type of Aircraft</b>	Windlass Aquilla (microlight)		<b>Type of Operation</b>	Private		
<b>Pilot-in-command Licence Type</b>	Private		<b>Age</b>	42	<b>Licence Valid</b>	YES
<b>Pilot-in-command Flying Experience</b>	Total Flying Hours	191.1		<b>Hours on Type</b>	191.1	
<b>Last point of departure</b>	Leeuwenboschfontein Farm-(Western Cape Province)					
<b>Next point of intended landing</b>	Ladysmith (FALY)-(Kwa Zulu Natal Province)					
<b>Location of the accident site with reference to easily defined geographical points (GPS readings if possible)</b>						
Leeuwenboschfontein Farm(GPS Position: S 33°33'00 E020°00'00)						
<b>Meteorological Information</b>	Surface wind: 135°/5kts, Temperature: 17°C, Visibility: 10km					
<b>Number of people on board</b>	1 + 1	<b>No. of people injured</b>	2	<b>No. of people killed</b>	0

## AIRCRAFT ACCIDENT REPORT

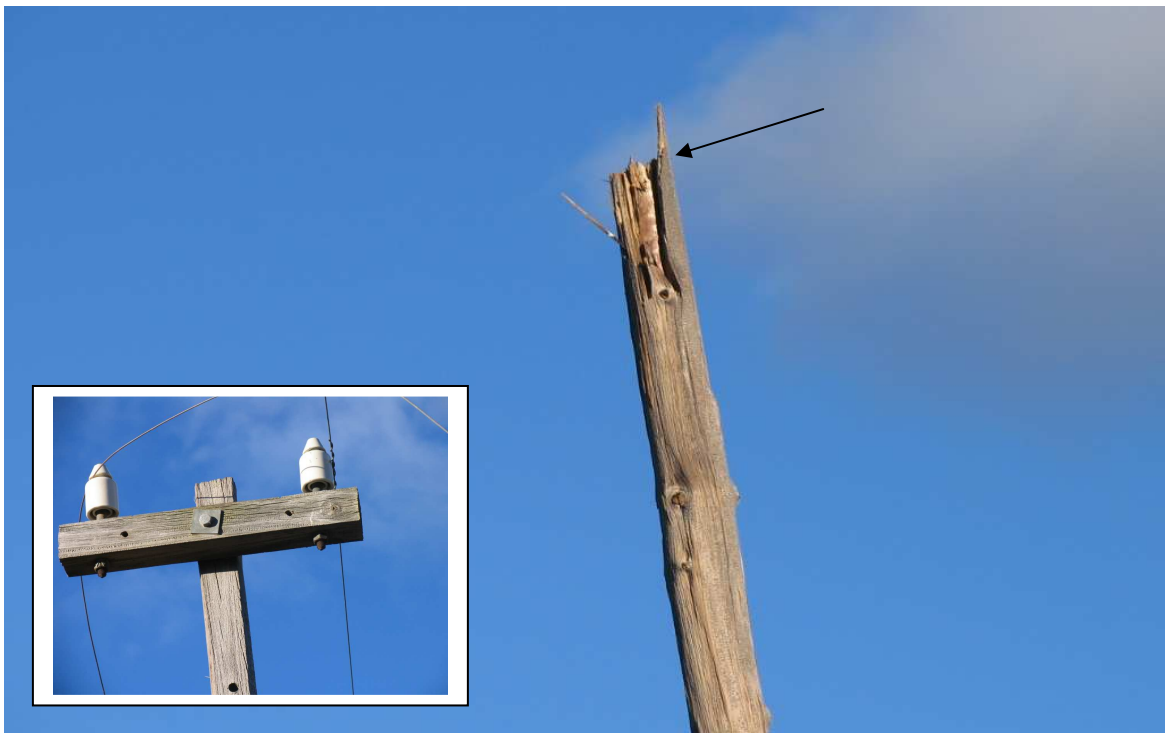
1.4.1 Damages were limited to the top of the telephone pole.

Figure 1: Damaged telephone pole  
Insert: Picture of an existing pole

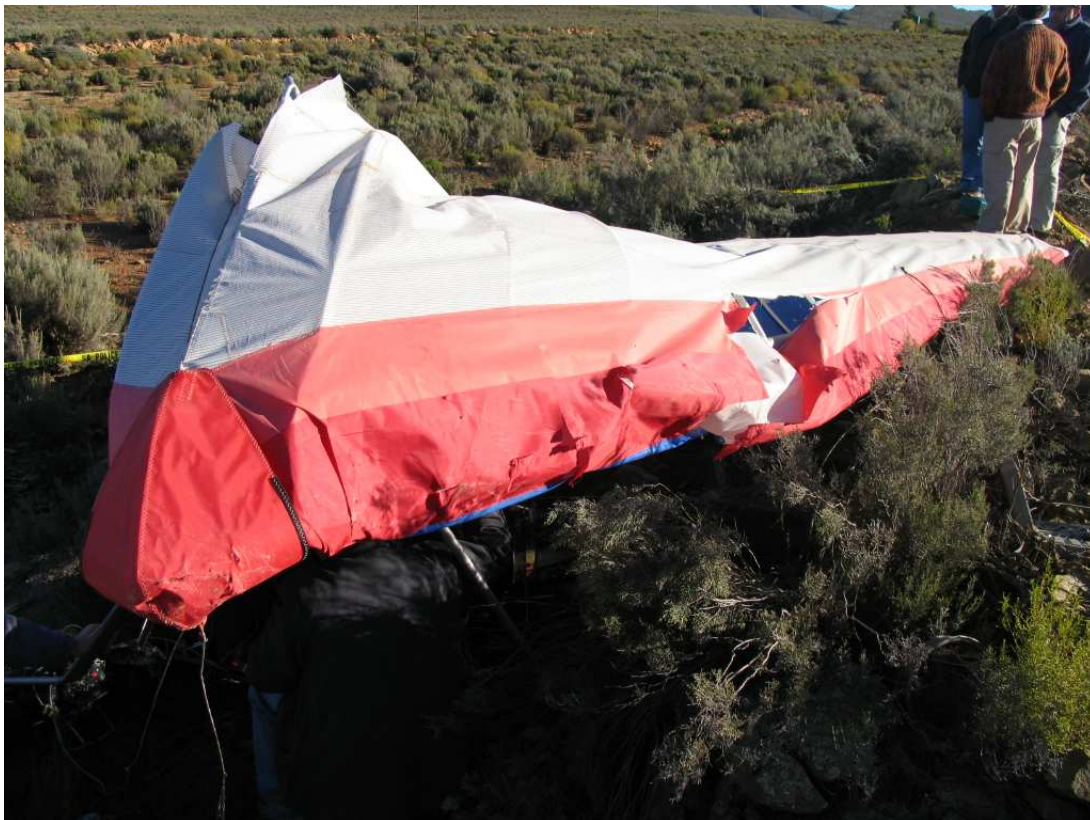
- 1.12.1 During a left hand turn the aircraft collided with a telephone pole resulting in the left main gear breaking off. The aircraft subsequently crashed onto rocky terrain.

Photo 3: View of wreckage (canopy/wings) from above

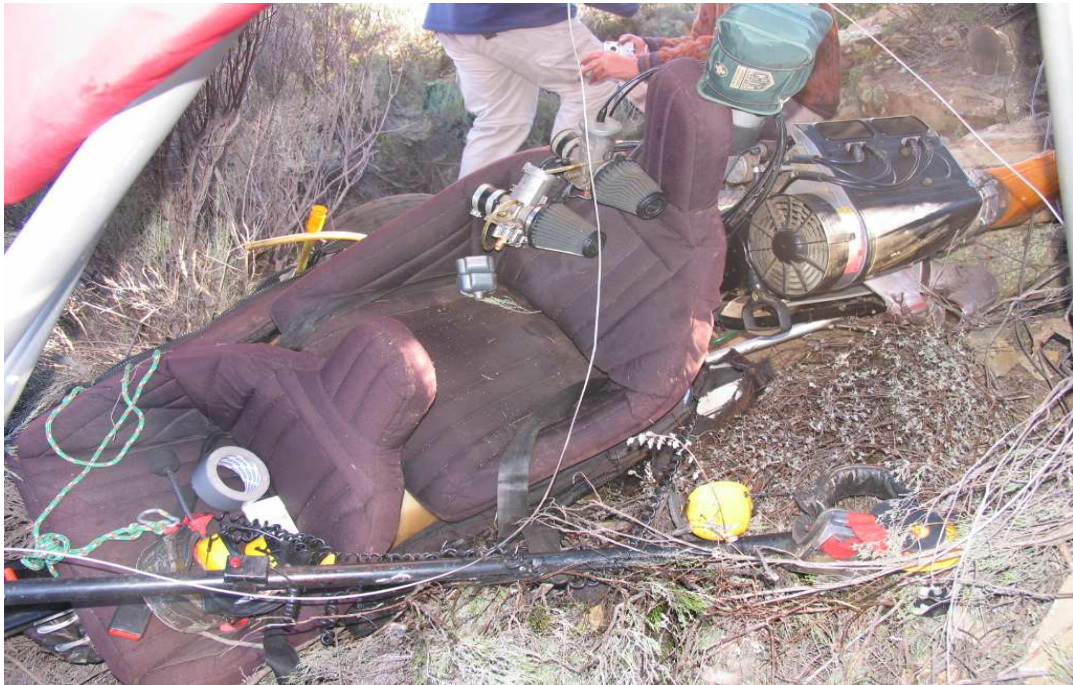
Photo 4: Seats and engine underneath canopy
