AIRCRAFT ACCIDENT REPORT AND EXECUTIVE SUMMARY

Reference:	CA18/2/3/8524	
Aircraft Registration	ZU-BEG	Date of Accident	27 July 2008		Time of Accident	1145Z
Type of Aircraft	Piper PA-22 (Fixed Wing)		Type of Operation		Private	
Pilot-in-command Licence Type		Private Pilot	Age	44	Licence Valid	Yes
Pilot-in-command Flying Experience		Total Flying Hours	122.32		Hours on Type	14.0
Last point of departure		Port Elizabeth International Airport (FAPE).				
Next point of intended landing		Port Elizabeth International Airport (FAPE).				
Location of the accident site with reference to easily defined geographical points (GPS readings if possible)						
At approximately 5 metres on the right-hand side of Runway 26 at Port Elizabeth International Airport.						
Meteorological Information		Wind Direction: 270°/ 25 Gusting 32kts, Visibility: Good.				
Number of people on board	1 + 1	No. of people injured	0	No. of people killed	0	
Synopsis						
<p>The pilot and passenger were engaged on a private, visual flight rules (VFR) flight by day. They took off at approximately 1040Z, from Port Elizabeth International Airport (FAPE) for a flight to Jeffery's Bay – Paradise Beach area. When the aircraft re

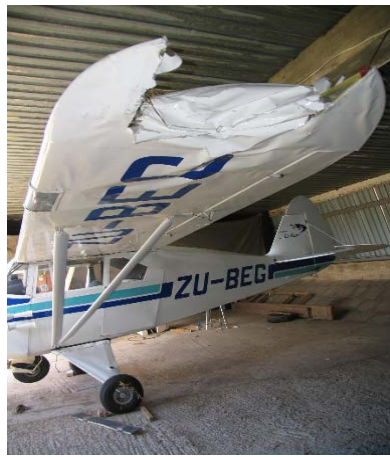
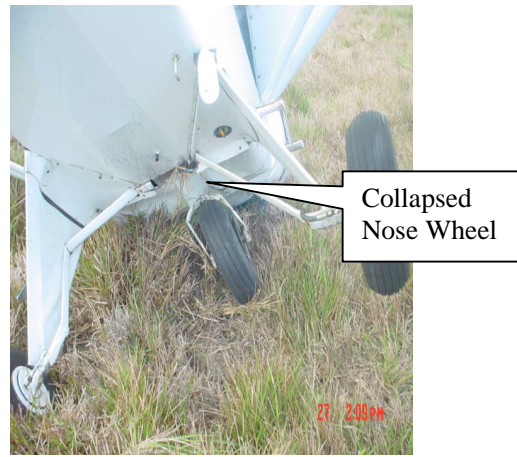
1.3.1 The aircraft sustained major damaged in the accident. (See below, photos of damage.)

Photo 1 & 2 showing substantial damage caused to the aircraft

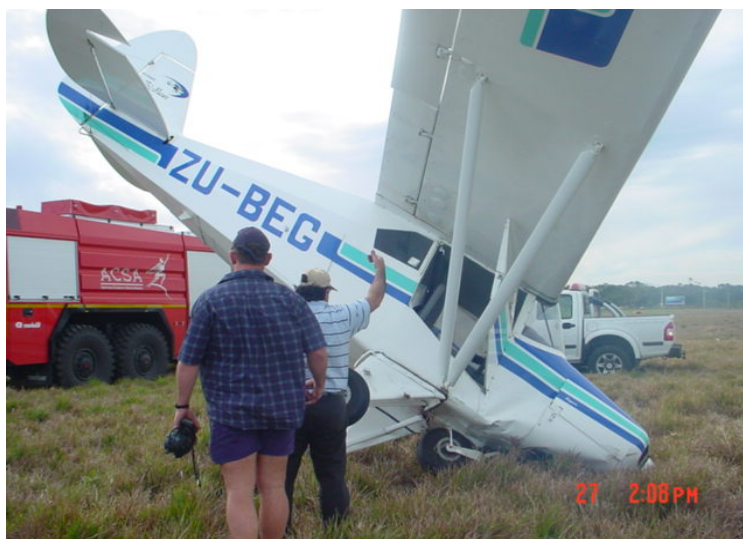
Photo 2, showing how the aircraft had impacted the ground.

1.12.2 The findings of the ACSA report were verified by examination of the aircraft wreckage and impact damage. As the aircraft came in for landing, it was subjected to gusting wind conditions and became unstable. A hard landing with subsequent ballooning followed. In the process, the right-hand side main wheel impacted with the runway surface and sustained damage. The aircraft drifted to a grass area which was towards the right side off the runway. The left-hand side wingtip impacted with the ground and the aircraft ground looped and this resulted in the collapse of the nose wheel.

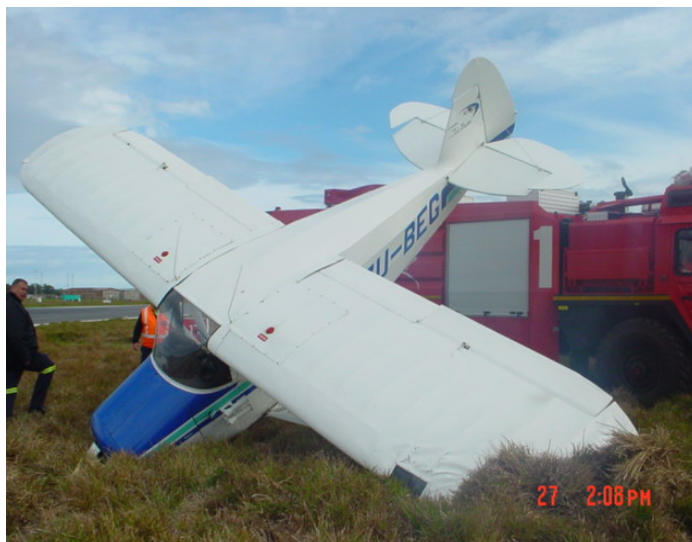
1.18.2 ZU-BEG ground looped, approximately 5 metres from the right-hand edge of Runway 26. The extent of damage caused by the ground loop to the undercarriage and left side wingtip can be seen in the photo below.

Photo: Left side wingtip digging into the ground.

- 3.1.7 The aircraft drifted towards a grass area on the right-hand side off the runway and the left wing tip dug into soil in open grass which resulted in a ground loop.

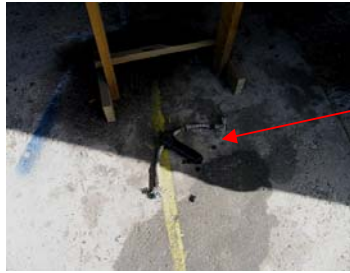
1.18.9 Left-Hand Main Landing Gear:

The left-hand side shock strut, P/N: 487558 was found broken off from the top shock strut end, P/N: 12639-00 and separated from the aircraft. The part was found

at an unidentified location on Runway 26. The RFFS found a small piece of ring shock cord (P/N: 31322-06) on Runway 26.

Broken R/H Side Shock Strut and Ring Shock Cord

- 3.1.5 The pilot stated that the aircraft ballooned during landing and was subsequently subjected to a hard landing.
- 3.1.6 This resulted in the right-hand side main landing gear ring shock cord and left-hand side shock strut failing. The identified components and/or parts then separated from the aircraft and were found lying on the runway.
