## AIRCRAFT ACCIDENT REPORT AND EXECUTIVE SUMMARY

Reference:	CA18/2/3/8525	
<b>Aircraft Registration</b>	ZU-SGG	<b>Date of Accident</b>	30 July 2008		<b>Time of Accident</b>	0945Z
<b>Type of Aircraft</b>	Jabiru J430	(Aeroplane)	<b>Type of Operation</b>		Private	
<b>Pilot-in-command Licence Type</b>		Private	<b>Age</b>	34	<b>Licence Valid</b>	Yes
<b>Pilot-in-command Flying Experience</b>		Total Flying Hours	371.1		Hours on Type	7.1
<b>Last point of departure</b>		Bethlehem Aerodrome (FABM)				
<b>Next point of intended landing</b>		Harrismith Aerodrome (FAHR)				
<b>Location of the accident site with reference to easily defined geographical points (GPS readings if possible)</b>						
4m to the left of Runway 29 at FABM (GPS Position: South 28°14.882' East 028°19.232', elevation 5 561 feet)						
<b>Meteorological Information</b>		Surface wind, 240°/ 7kt, Temperature, 15°C, CAVOK				
<b>Number of people on board</b>	1 + 1	<b>No. of people injured</b>	0 + 1	<b>No. of people killed</b>	0

**Name of Owner/Operator** : GSG Trust  
**Manufacturer** : Shadow Lite CC  
**Model** : Jabiru J430  
**Nationality** : South African  
**Registration Marks** : ZU-SGG  
**Place** : Bethlehem Aerodr

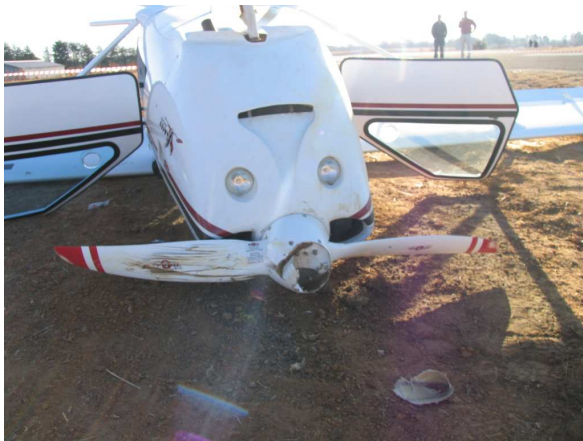
- 1.3.1 The aircraft sustained substantial damage to the vertical fin, which was found to be cracked and delaminated, the cockpit windows were shattered, the nose landing gear and the left wing strut were bent, and the propeller was also damaged.

**Figure 1.** Indicating damage to the spinner and propeller.

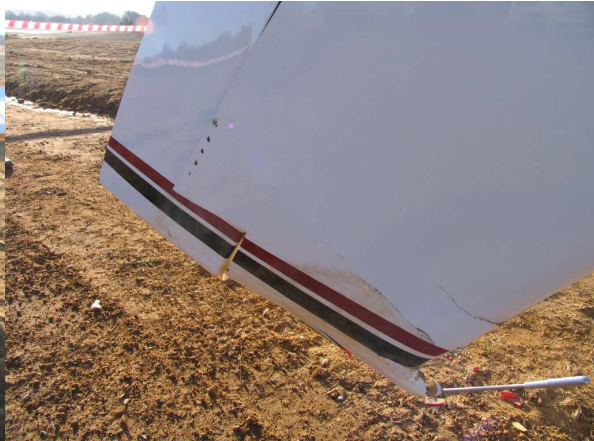
**Figure 2.** Damage to the vertical fin.

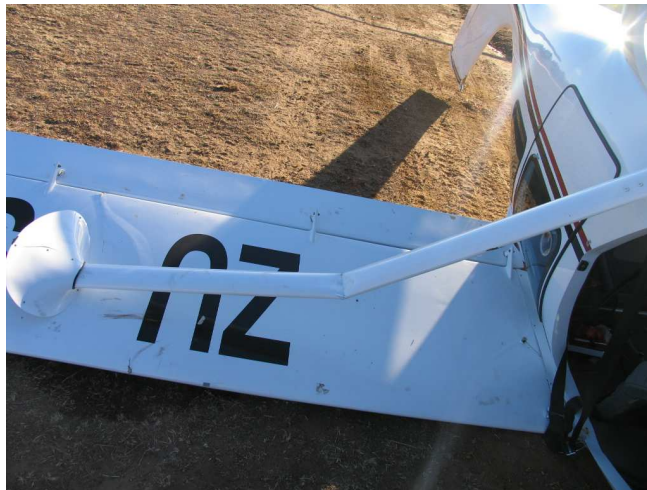
**Figure 3.** Visible damage to the left wing strut.

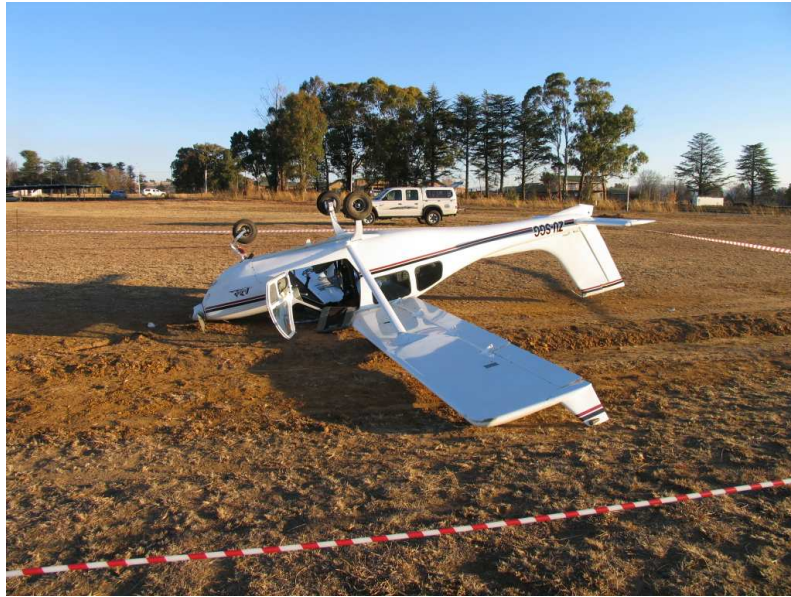
**NOTE:** Maintenance work was conducted at Bethlehem Aerodrome prior to the accident flight, which required the replacement of the runway light electrical cabling. As a result of the excavations associated with this type of operation the soil was not compressed after the cables were replaced, which resulted in a windrow, which was approximately 15 to 20cm in height and about 4m from the runway edge.

1.12.1 The aircraft departed Runway 29 to the left, approximately 40m before the end of the runway surface. Tyre markings on the runway indicate that the left turn induced by the pilot was at an angle of between 45° to 60°. Approximately 4m from the runway edge the nose wheel collided with a windrow approximately 15 to 20cm in height, which caused the aircraft to nose over and come to rest in an inverted attitude, as can be seen in Figure 4 and the next page of this report.

**Figure 4.** A view of the aircraft as it came to rest with the windrow also visible.

- 2.6 It is the opinion of the investigating team that if maintenance practices at the aerodrome had been conducted properly, meaning the ground that was excavated during the cable-laying process had been properly flattened and compressed, the accident could have been prevented. If the ground was compacted and flat as it should have been, the aircraft most probably would have been brought to a halt in the open area available, which consisted of a hard gravel surface.

- 4.1 It is recommended that the CAA, Aerodrome Safety Department engage with the aerodrome licence holder in order to rectify the hazard that existed at the aerodrome at the time and date of the accident. The windrow that came about following maintenance intervention next to the runway, should be properly compacted and flattened to avoid any potential hazard to aircraft that make use of the aerodrome. This recommendation should be dealt with as a matter of urgency.
