AIRCRAFT ACCIDENT REPORT AND EXECUTIVE SUMMARY

Reference:	CA18/2/3/8533	
Aircraft Registration	ZS-RMA	Date of Accident	15 August 2008	Time of Accident	1010Z	
Type of Aircraft	Beechcraft F33A		Type of Operation	Private		
Pilot-in-command Licence Type		Private	Age	27	Licence Valid	Yes
Pilot-in-command Flying Experience		Total Flying Hours	436.7		Hours on Type	268.3
Last point of departure		Tzaneen Aerodrome (FATZ) – Limpopo Province				
Next point of intended landing		Tzaneen Aerodrome (FATZ) – Limpopo Province				
Location of the accident site with reference to easily defined geographical points (GPS readings if possible)						
At Appelfontein farm near Dendron, GPS Position: S23°23.296 ' ; E029°11.743 ' , Elev = 3397ft						
Meteorological Information		Surface wind, 020°5kt, Temperature, 28°C, Visibility, CAVOK.				
Number of people on board	1+1	No. of people injured	0	No. of people killed	0	
Synopsis						
<p>The aircraft was participating in an air race (Race of Champions) which commenced from Tzaneen Aerodrome (FATZ) and was to end at FATZ. Approximately an hour and ten minutes into the race, flying between Marble Hall and Vivo, the pilot experienced a sudden loss of engine pow

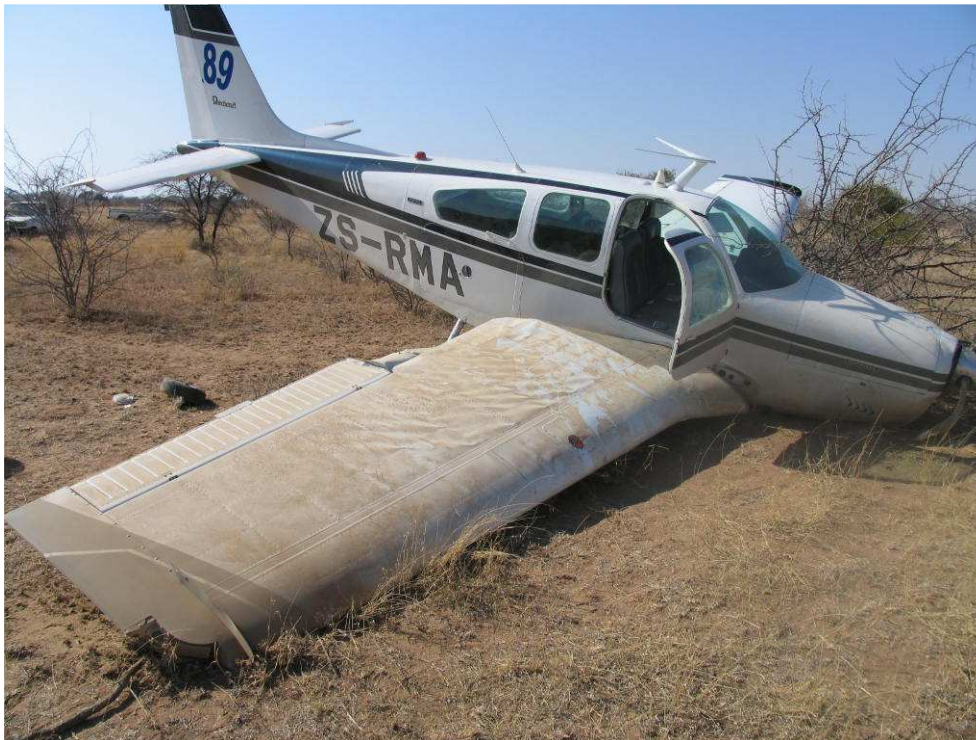
- 1.1.4. During the accident sequence, the aircraft sustained substantial damage to the right wing and flaps, as well as the propeller, which made contact with the ground. The nose and the right main landing gear also broke off on impact with the ground.

1.3.1 The aircraft was substantially damaged.

Picture 1: A View of the damaged aircraft

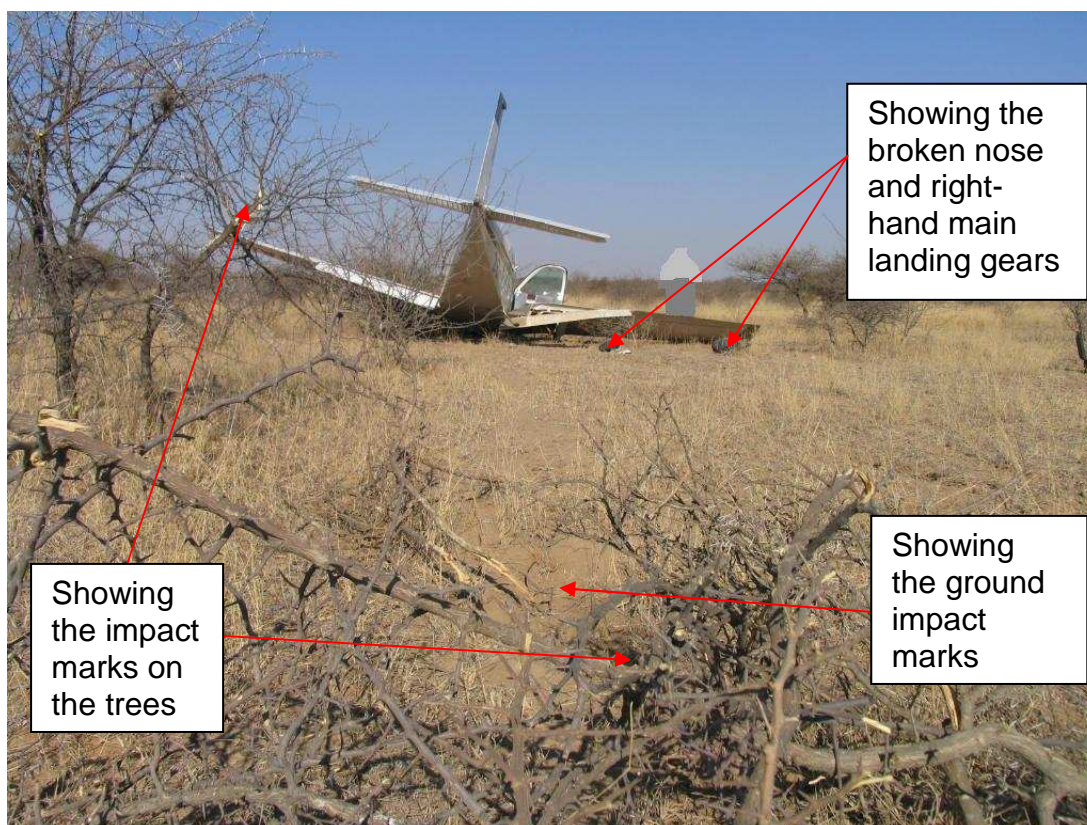
1.12.1 The aircraft impacted the terrain at a high speed on a heading of 150°M (Magnetic). The aircraft was in a wings level attitude when it first impacted a 1 metre high ridge which broke off the nose landing gear and caused the aircraft to bounce. The aircraft then impacted three thorn trees approximately 10 meters further on. The nose and the right main landing gears broke off on impact with the ground. The aircraft came to rest in a right wing low attitude, approximately 55 metres from the initial point of impact. The right wing and flaps sustained substantial damages.

Picture 2: Showing impact and skid marks.

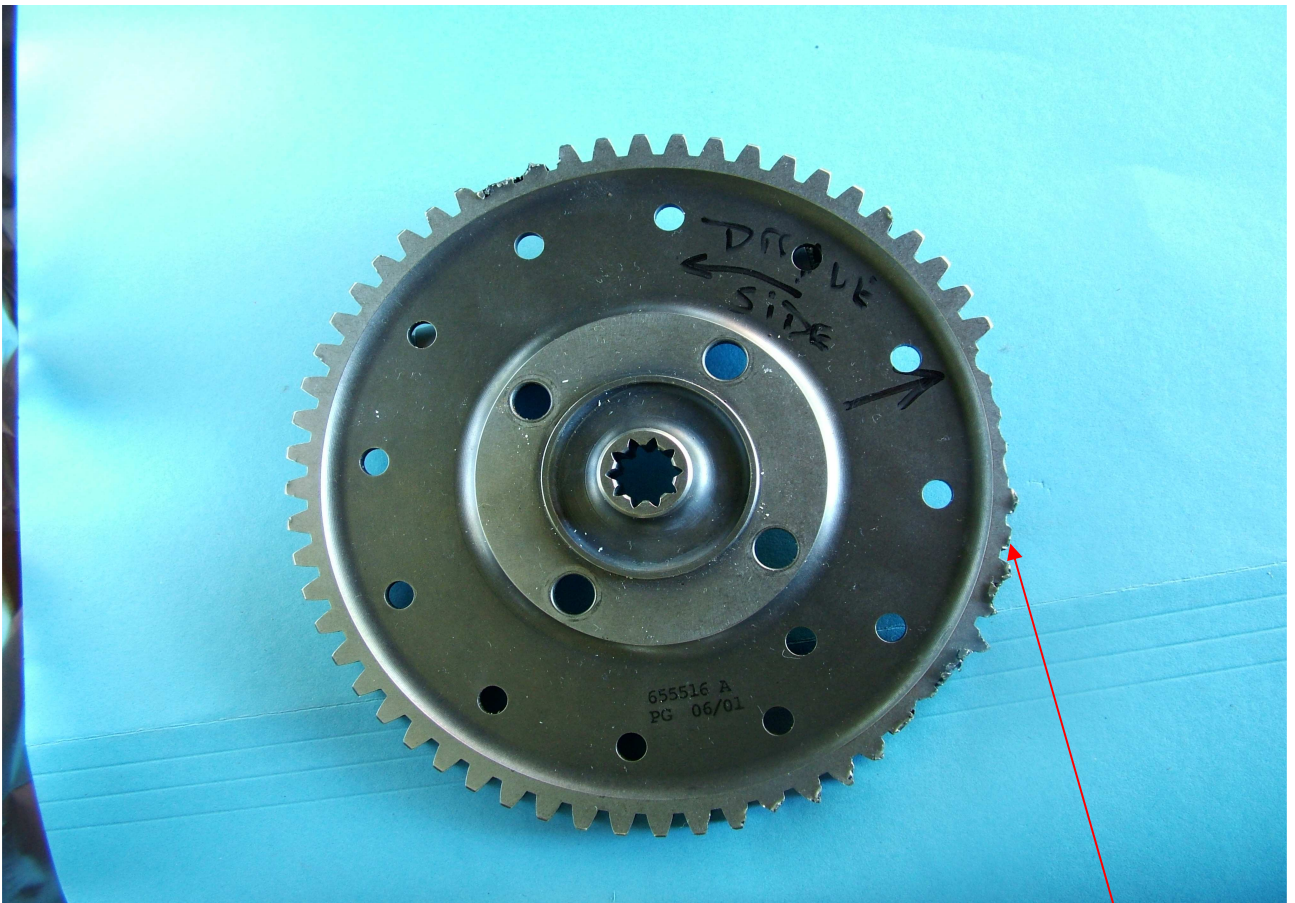
- (ii) Conclusions based on that examination are as follows:
 - The cam drive gear failed in fatigue, causing four adjacent teeth to become detached. These detached teeth then caused further consequential damage to both the cam drive and idler gears.

- The cam drive gear was of a suitable material for the application, but the nitriding treatment (a heat treatment process to increase the endurance limit in fatigue) had failed to give the surface hardness expected. This would result in a low tensile strength on the surface, and thus a reduced resistance to fatigue.

- The root radii on the cam drive gear were smaller than those on the idler gear. This would have given a stress-concentrating effect in this area in service, further adding to the likelihood of fatigue initiation. The full metallurgical report is attached to this report as Appendix A.

Picture 3: showing cam drive gear with failed teeth

- 4.1 It is recommended that the SACAA airworthiness department notify the airworthiness authority of the engine manufacturer of the defective manufactured camshaft and idler gear items, and the lack of traceability thereof, to enable introduction of improved quality control during the manufacturing process.

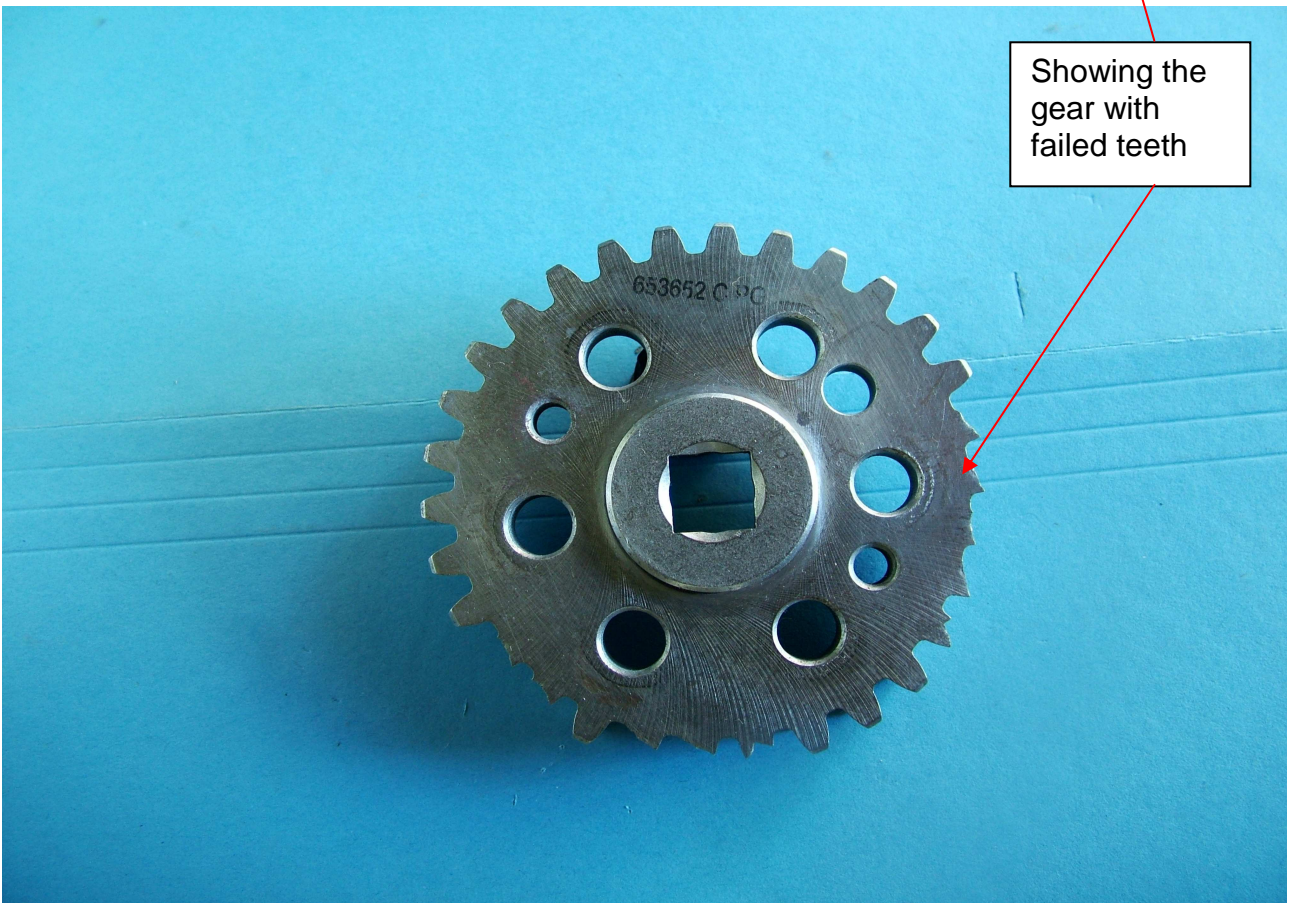
Picture 3: Showing the idler gear with failed teeth.

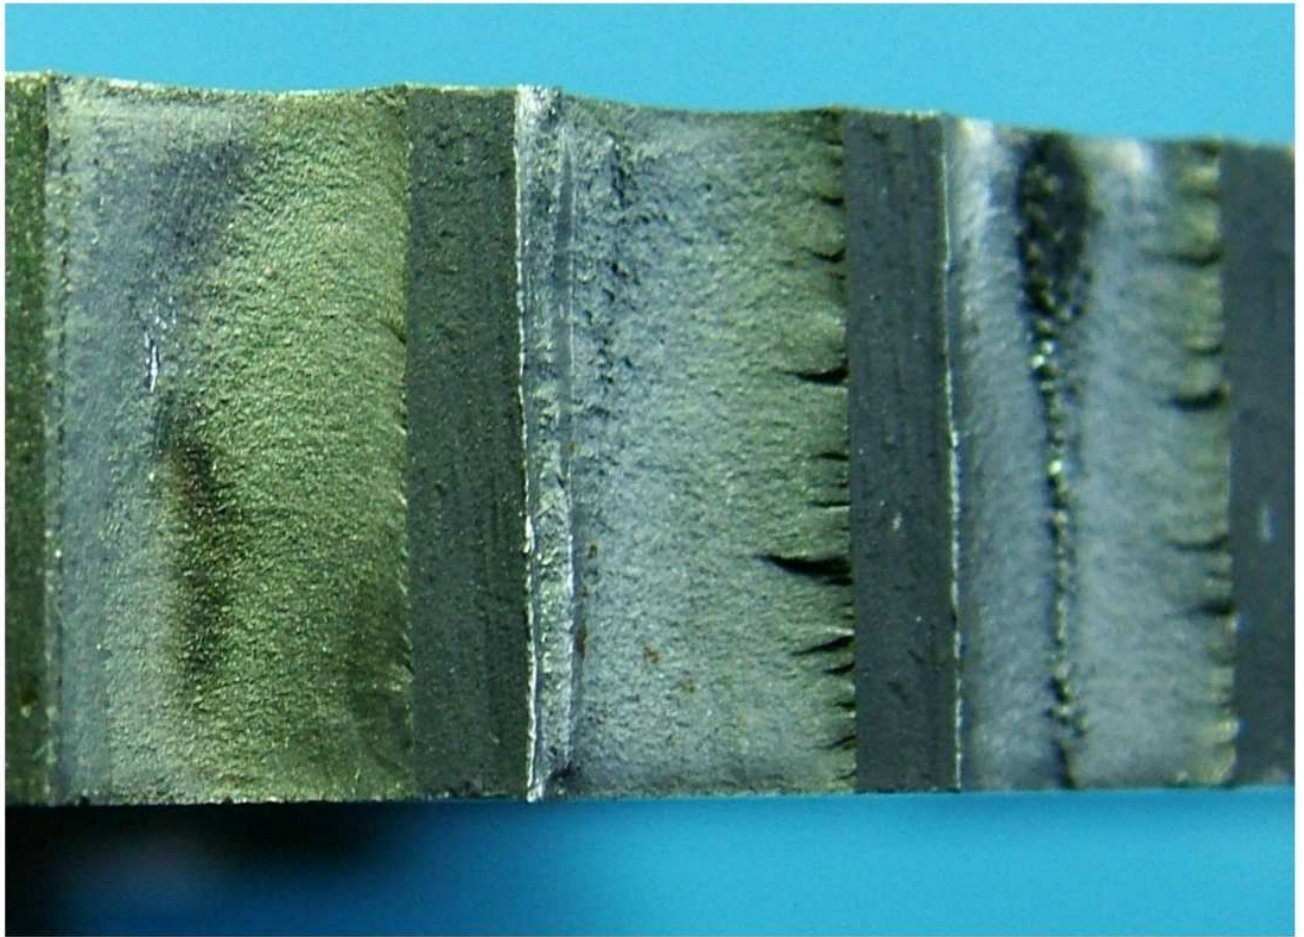
Picture 4: showing fatigue progression on the damaged teeth of the cam drive gear

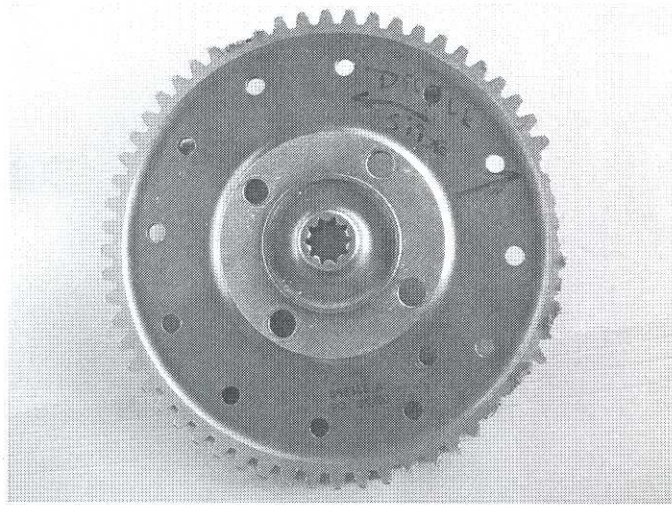
The cam drive gear had lost a number of teeth, figure 1, by two distinct mechanisms. Four of the missing teeth were adjacent, and the fracture surfaces showed characteristic features indicating fatigue, figures 2 & 3. The remaining damaged teeth showed a different mechanism, typical of material being trapped in the gear bite as the gear revolved, figure 4.

Figure 1. The cam drive gear as received, showing missing teeth.

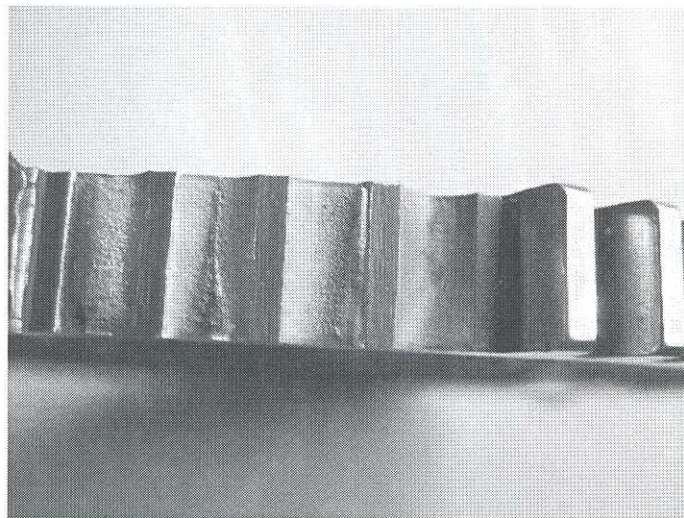
Figure 2. Characteristic fatigue features on the cam drive gear.

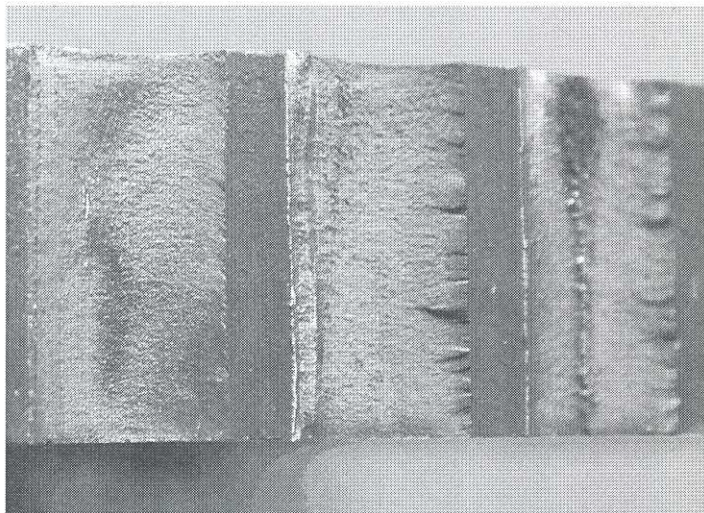
The cam drive gear has failed in fatigue, initiating in the drive-side root radius, which has resulted in four adjacent teeth breaking away. The resulting debris has caused further, consequential damage to both the cam drive gear and the idler gear with which it meshes.

Figure 3. Ratchet marks and beach marks on the cam gear fractures, indicating origin of fracture in tooth drive side root radius.

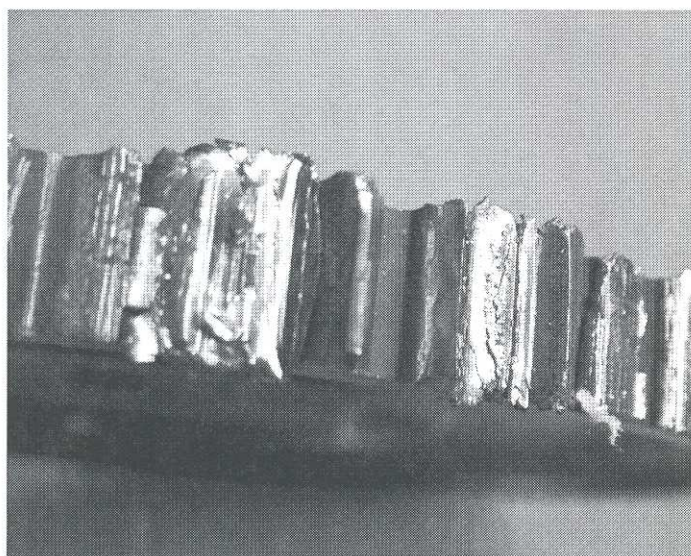
Figure 4. Consequential damage to the cam drive gear caused by debris.

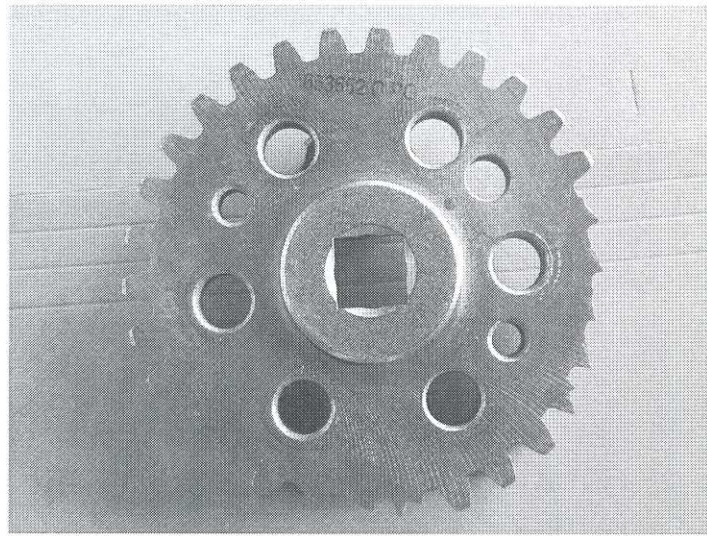
The idler gear had also lost a number of teeth, figure 5. All of these appeared to have been caused by material trapped in the gear bite.

Figure 5. The idler gear showing missing teeth.

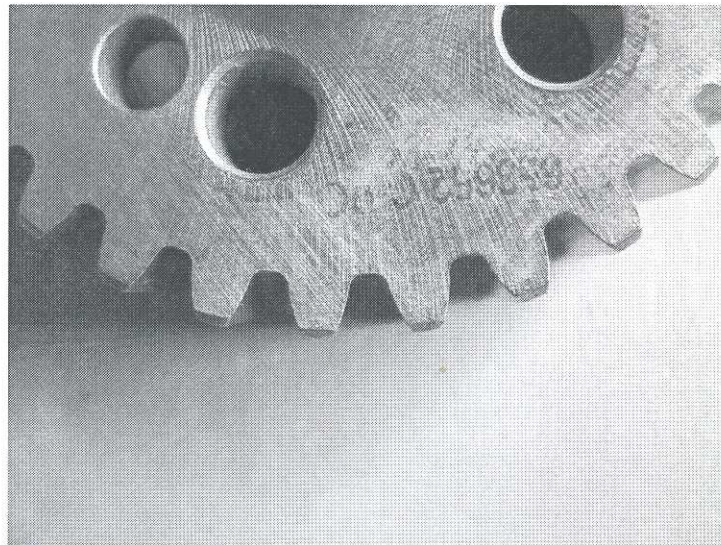
It was noted that the tooth profile on the two gears differed in the root area, with the cam drive gear having much smaller root radii than the idler gear, figures 6 & 7.

Figure 6. Tooth profile of the idler gear.

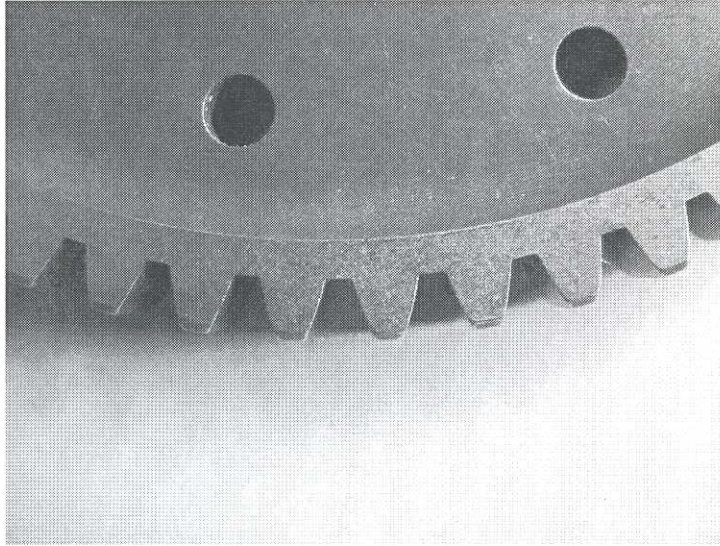
The principal effects of such a low surface hardness would be a reduced tensile strength, leading to a lowered fatigue strength. This will be exacerbated by the smaller root radii on the cam drive gear, resulting in an increased loading through the stress concentrating effect of the smaller radii.

Figure 7. Tooth profile of the cam drive gear, note the smaller root radii.

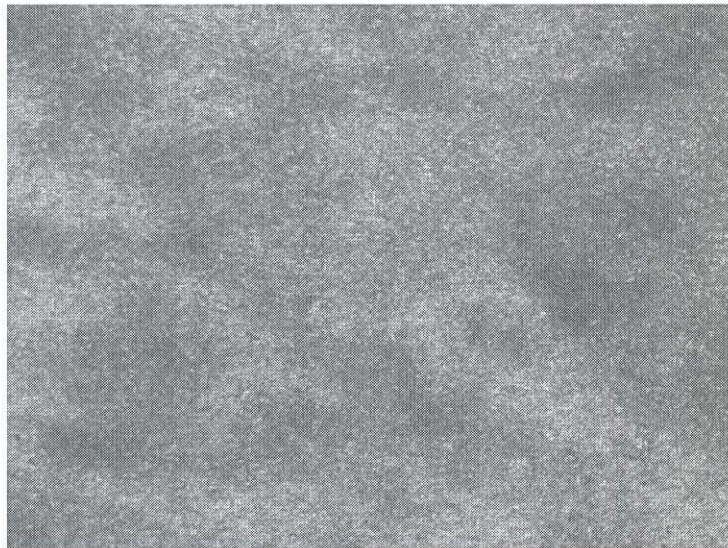
nitric acid in ethanol) a microstructure of quenched and tempered martensite was observed in the core of the gear, figure 8. At the surface of the gear teeth, a distinct white layer was observed, figure 9, together with grain boundary networks, figure 10.

Figure 8. Microstructure of the cam drive gear core showing tempered martensite. Etched Nital-2, approx x 400.

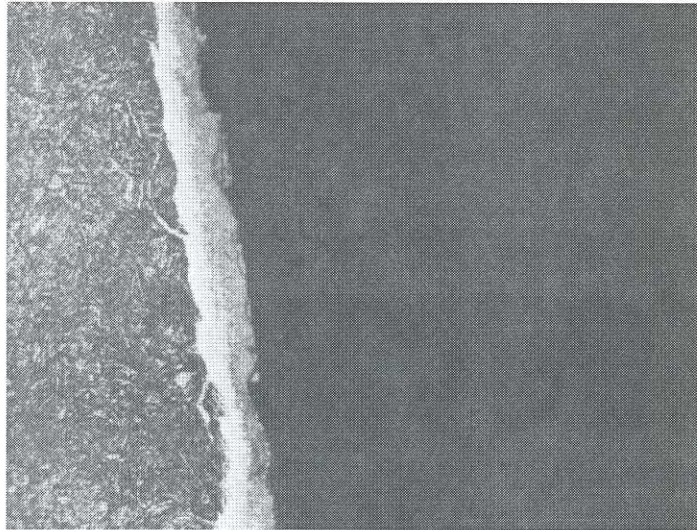
The cam drive gear has been manufactured from a chromium-molybdenum alloy steel with a fairly high carbon content. As such, it is considered an appropriate material for the manufacture of a gear. It appears that an attempt has been made to surface harden the gear by nitriding, however, the hardness in the surface layer is well below the level which would

Figure 9. White layer on surface of tooth indicating nitriding process. Etched Nital-2, approx x 400.

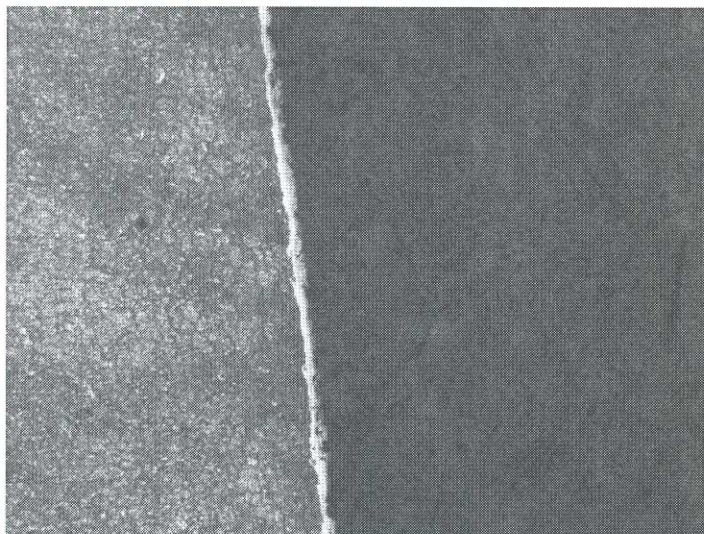
Figure 10. Grain boundary networks in area adjacent to surface. Etched Nital-2, approx x 100.
