AIRCRAFT ACCIDENT REPORT AND EXECUTIVE SUMMARY

| | | | | Reference: | CA18/2/3/8543 | |
| Aircraft Registration | ZU-RAT | Date of Accident | 30 August 2008 | | Time of Accident | 1450Z |
| Type of Aircraft | Rotorway Executive 162 F (Helicopter) | | Type of Operation | Private | | |

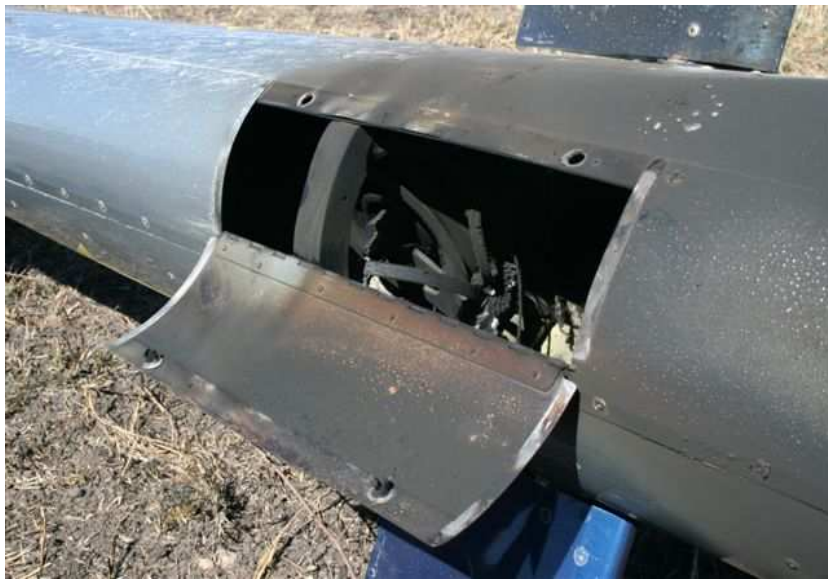
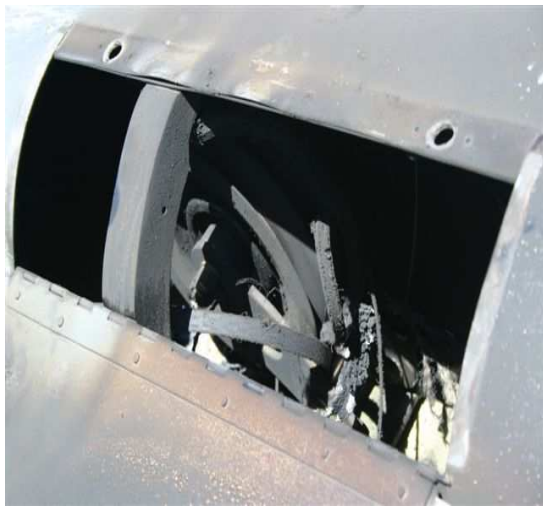
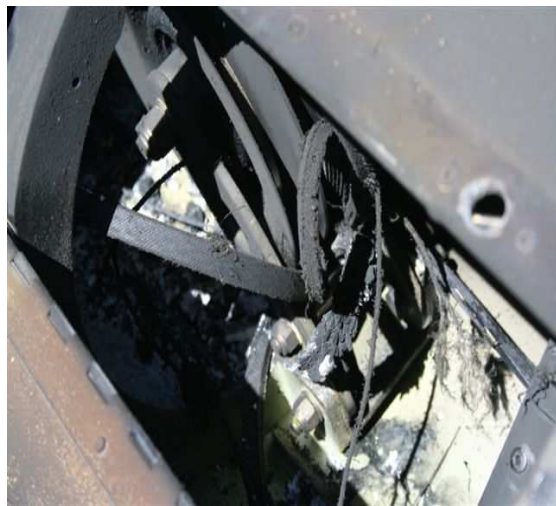
Figure 2. Views of the damaged tail rotor drive-belt.

1.6.5 After the accident, the pilot performed a visual inspection of the wreckage and found that the centre tail rotor drive-belt had sustained a catastrophic failure. The belt was twisted and broken and had become entangled in the centre pulley. This section was not damaged by the post-impact fire.

- 2.5 The pilot followed appropriate procedure by using engine power to control his heading. The aircraft responded effectively and the pilot once again maintained straight and level flight. After the accident, it was found that the tail rotor drive belt had failed, and it is possible that the loss of tail rotor effectiveness might have been caused by this failure.

- 2.8 It was found that the accident aircraft still had the Gates belts installed. The service bulletin had therefore not been complied with. The result was exactly as predicted by the manufacturer: "Loss of your tail rotor will most likely result in significant aircraft damage".

- 3.1.15 The wreckage was inspected by the pilot after the accident and evidence was found that the centre tail rotor drive belt had failed.
- 3.1.16 The emergency was determined to be the result of tail rotor failure.

- 3.2.1 The pilot experienced a centre tail rotor drive belt failure in flight, which resulted in an unsuccessful precautionary landing.
- 3.2.2 The pilot landed the aircraft short of the selected landing zone.
- 3.2.3 The helicopter's left skid dug into a mound of soil and the aircraft rolled over.

- 4.2 It is recommended that the Commissioner for Civil Aviation (CCA) in consultation with the aircraft manufacturer investigate the possibility of upgrading the relevant tail rotor drive system service bulletin A - 12 to be a mandatory airworthiness directive.

- 4.3 It is recommended that the Commissioner for Civil Aviation (CCA) require that the aircraft manufacturer make contact with all the owners and operators who have the Gates brand tail rotor drive belts (part numbers: E18-1150 and E18-1160) fitted on their aircraft, to comply with the applicable service bulletin A-12 (dated 8 September 1992) requirement immediately, i.e. before their next flight.
