AIRCRAFT ACCIDENT REPORT AND EXECUTIVE SUMMARY

Reference:	CA18/2/3/8541	
Aircraft Registration	ZS-OZM	Date of Accident	30 August 2008	Time of Accident	1407Z	
Type of Aircraft	Ayres S2R-T34 Fixed Wing Aircraft		Type of Operation	Aerial Fire Fighting		
Pilot-in-command Licence Type		Commercial Pilot	Age	68	Licence Valid	Yes
Pilot-in-command Flying Experience		Total Flying Hours	23163		Hours on Type	Unknown
Last point of departure		Kataza Aerodrome, Melmoth, Kwazulu-Natal				
Next point of intended landing		Kataza Aerodrome, Melmoth, Kwazulu-Natal				
Location of the accident site with reference to easily defined geographical points (GPS readings if possible)						
In a tree plantation in Havemanshoogte area, Melmoth, Kwazulu-Natal GPS S28°30.349 E031°15.611 at 3589 feet elevation.						
Meteorological Information		Temperature: 25.4°C; Dew point: -15°C; Wind: 300°1 5-35knots; Cloud cover: None; Visibility: 3km				
Number of people on board	1	No. of people injured	0	No. of people killed	1

Name of Owner/Operator : Osmond Aerial Spray (PTY) LTD
Manufacturer : Ayres
Model : S2R-T34
Nationality : South African
Registration Marks : ZS-OZM
Place : Havemanshoogte area, Melmoth, Kwazulu-Nata

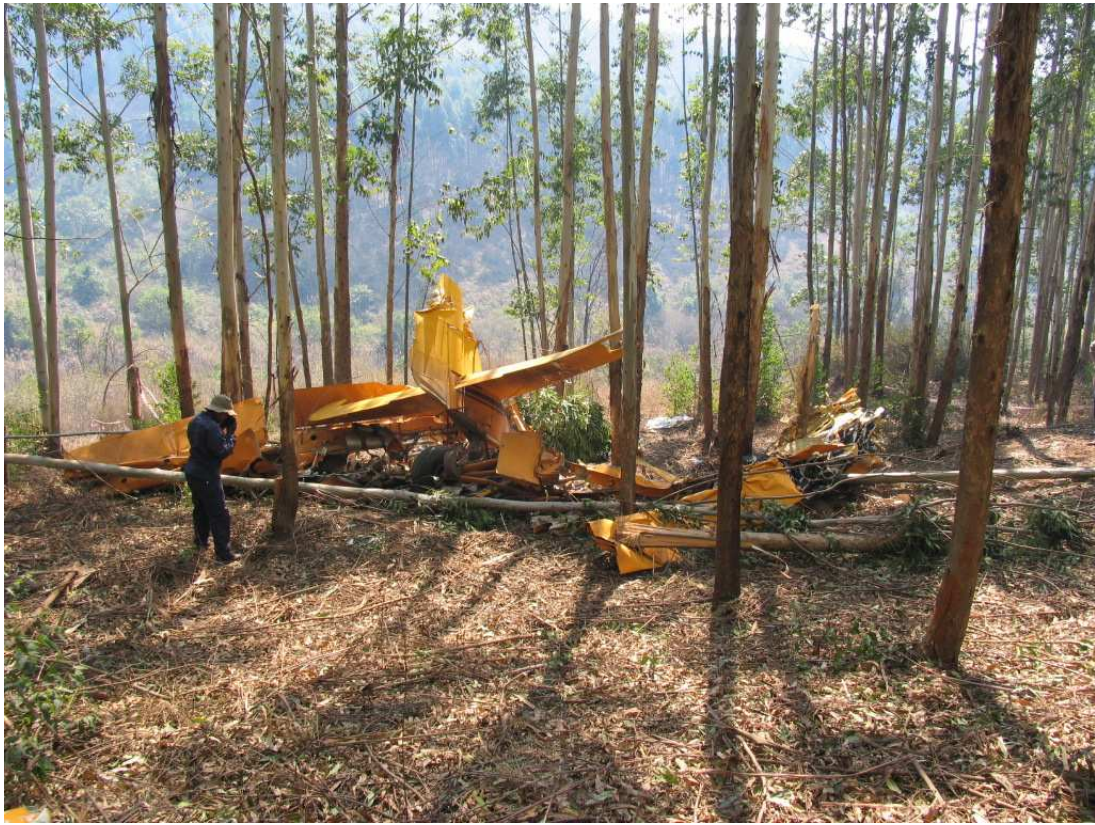
1.3.1 The aircraft was destroyed in the accident sequence.

1.3.2 A day after the accident of ZS-OZM, the fire reached the accident site and consumed the wreckage causing fire damage to the already destroyed aircraft.

Photo 2: View of the aircraft wreckage

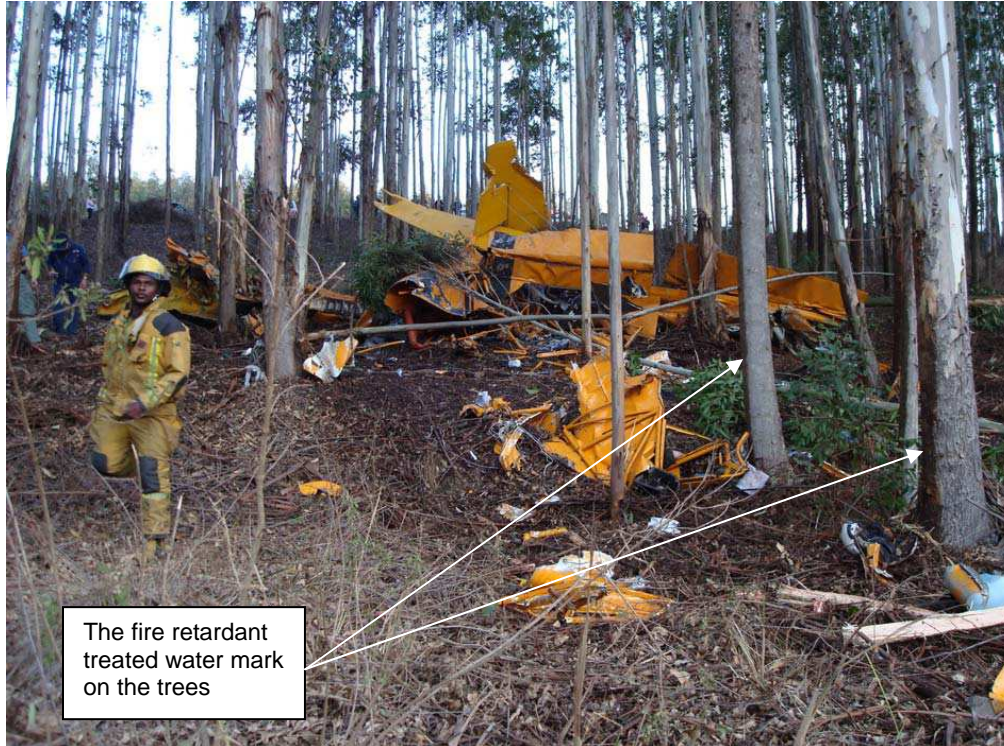
- 1.12.3 The wreckage was very compact and showed a burst pattern with the debris field all within 50m radius from point of impact. There were fuel spray patterns forward of the wings and a strong smell of fuel in the vicinity. There were pieces of the hopper and aircraft instruments up to 50m down slope. Wet water marks were found on

trees indicating that the aircraft water load burst at impact. The water mark on the trees was from the fire retardant treated water as the treated water remains wet for at least 45 minutes.

Photo 6: View of fire retardant treated water at the wreckage after the water load burst at impact
The photo was taken minutes after the accident occurred

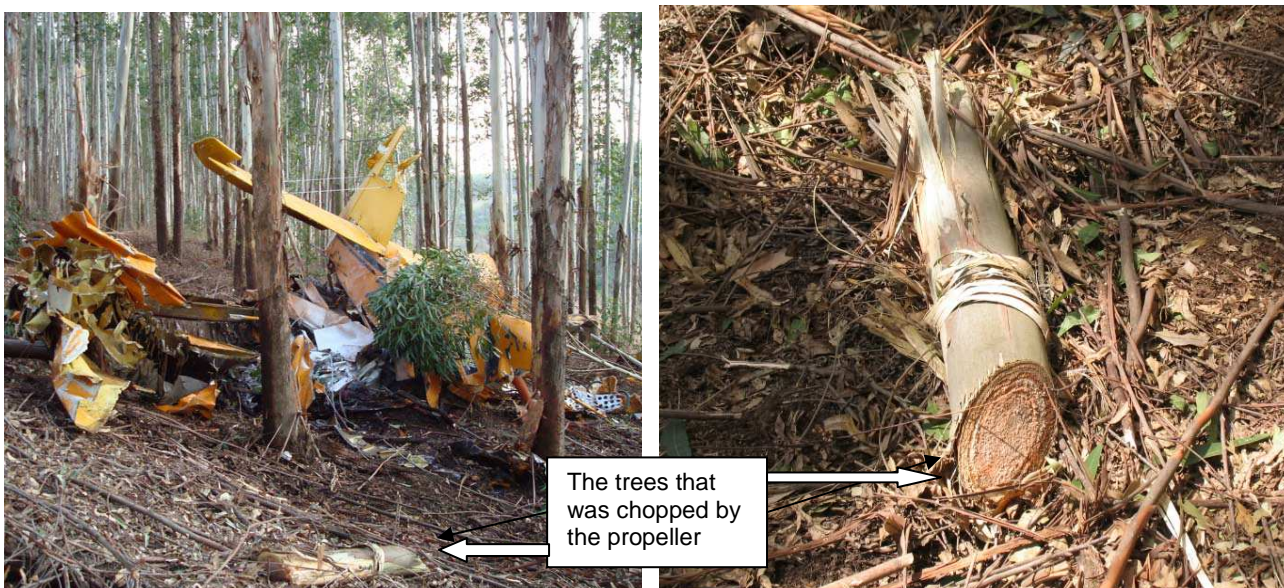
- 1.12.2 There was little damage to the tree canopy and the wreckage showed no sign of slide or bounce after impact. There was no sign of forward ground speed or yaw/spinning action. Some of the trees had been chopped up into sections by the propeller. One tree was cut cleanly off at the base / stump with the stem diameter about 200mm. This was indicative of the engine producing power at impact.

Photo 7 & Photo 8: View of the trees that was chopped by the propeller

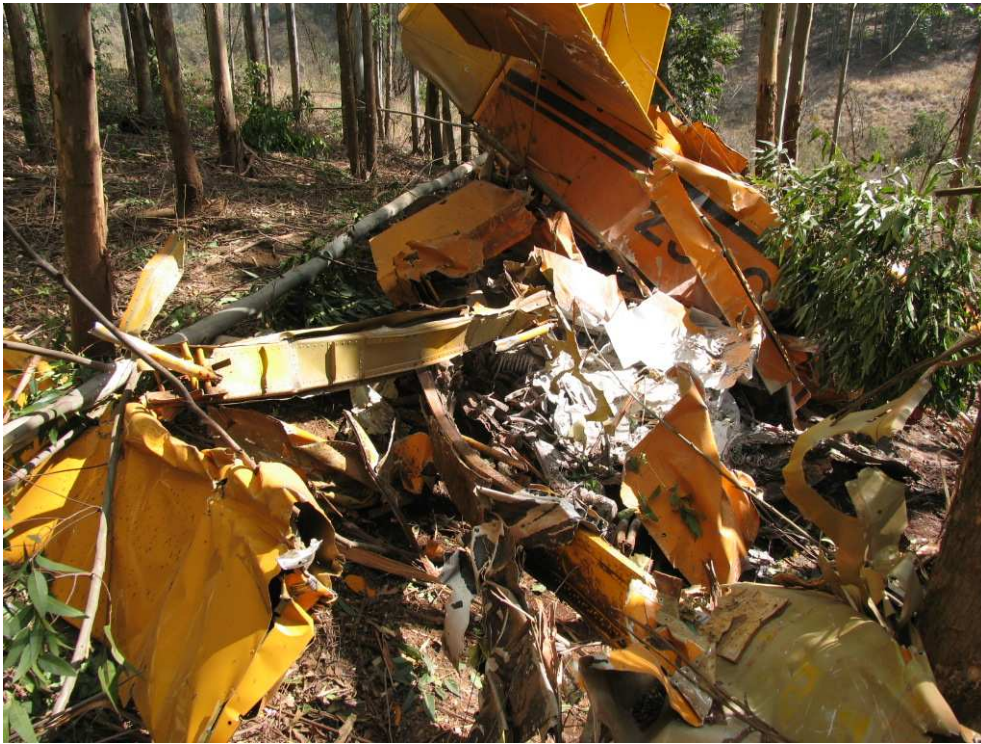
1.14.1 There was no evidence of pre- or post-impact fire. The water load from the aircraft hopper burst at impact and in all probability prevented a post-impact fire. The first responders at the accident site also sprayed the aircraft's fire extinguisher on the hot engine as a precautionary measure.

Photo 9: A section of the engine that was sprayed with the fire extinguisher

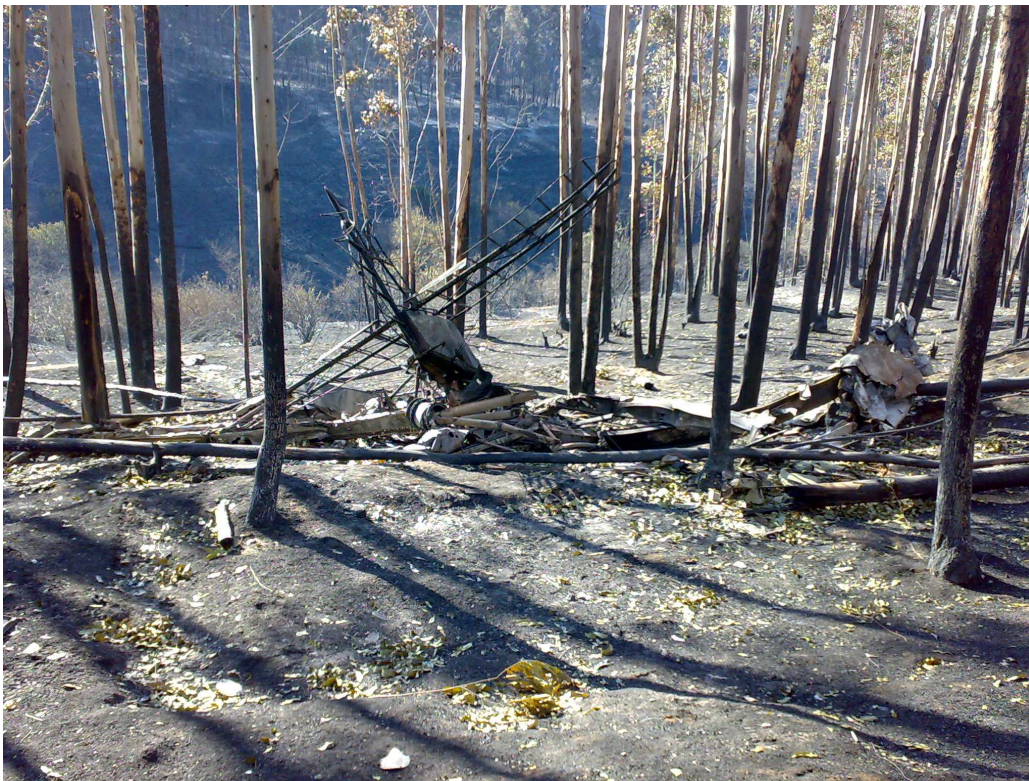
1.14.2 Approximately 24 hours after the accident the forest fire reached the accident site and consumed the wreckage causing fire damage to the already destroyed aircraft.

Photo 10: The tree plantation and wreckage was destroyed by fire a day after the accident occurred
