## AIRCRAFT ACCIDENT REPORT AND EXECUTIVE SUMMARY

Reference:	CA 18/2/3/8548	
<b>Aircraft Registration</b>	<b>ZS-NZU</b>	<b>Date of Accident</b>	11 September 2008	<b>Time of Accident</b>	0900Z	
<b>Type of Aircraft</b>	<b>AIR TRACTOR 502B (Aeroplane)</b>		<b>Type of Operation</b>	Agricultural		
<b>Pilot-in-command Licence Type</b>		Commercial	<b>Age</b>	67	<b>Licence Valid</b>	Yes
<b>Pilot-in-command Flying Experience</b>		Total Flying Hours	21000		Hours on Type	4000
<b>Last point of departure</b>		Caledon Aerodrome (Western Cape)				
<b>Next point of intended landing</b>		Caledon Aerodrome (Western Cape)				
<b>Location of the accident site with reference to easily defined geographical points (GPS readings if possible)</b>						
Cornfield on the farm Franskraal in the Caledon area (Western Cape) (S 34° 14.833 E 019° 20.247)						
<b>Meteorological Information</b>		Temperature: 14°C, Visibility: >10 km, Dew point: 1°C, Surface wind: 04006KT

## AIRCRAFT ACCIDENT REPORT

**Name of Owner/Operator** : AG-Sprayers (PTY) LTD  
**Manufacturer** : Air Tractor  
**Model** : AT-502B  
**Nationality** : South African  
**Registration Marks** : ZS-NZU  
**Place** : Caledon (Western Cape Provin

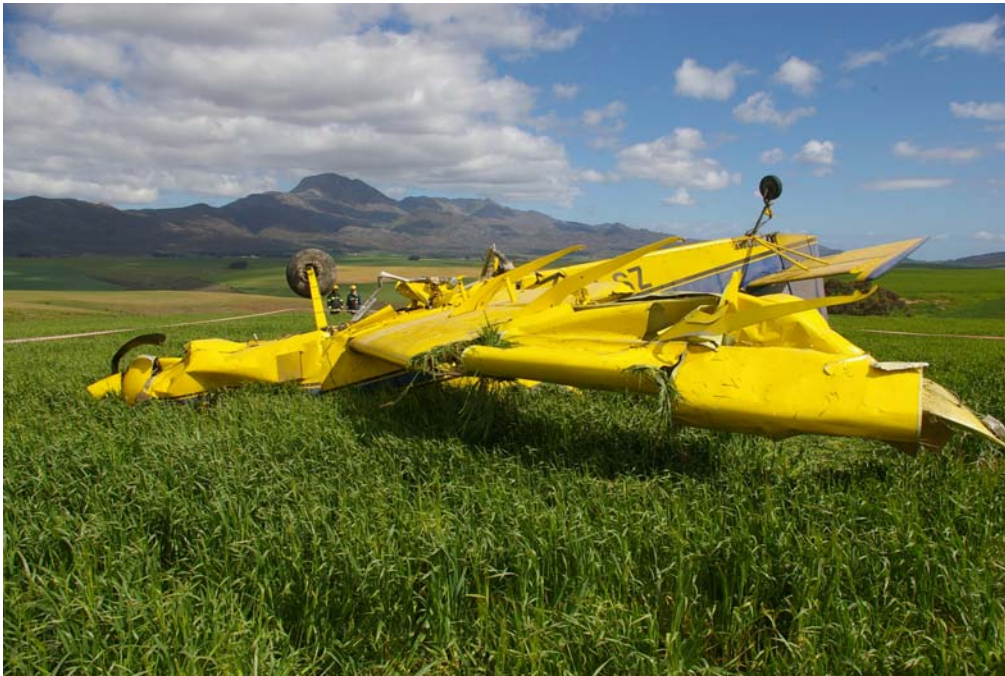
Except for the wing tips, left-hand aileron and the right-hand landing gear, the aircraft was structurally intact when it came to rest. **(Figure 1)**

**Figure 1 Damage to the aircraft.**

The aircraft was found to be structurally intact except for the left aileron, both wing tips and the left main landing gear that separated from the aircraft during the impact sequence.

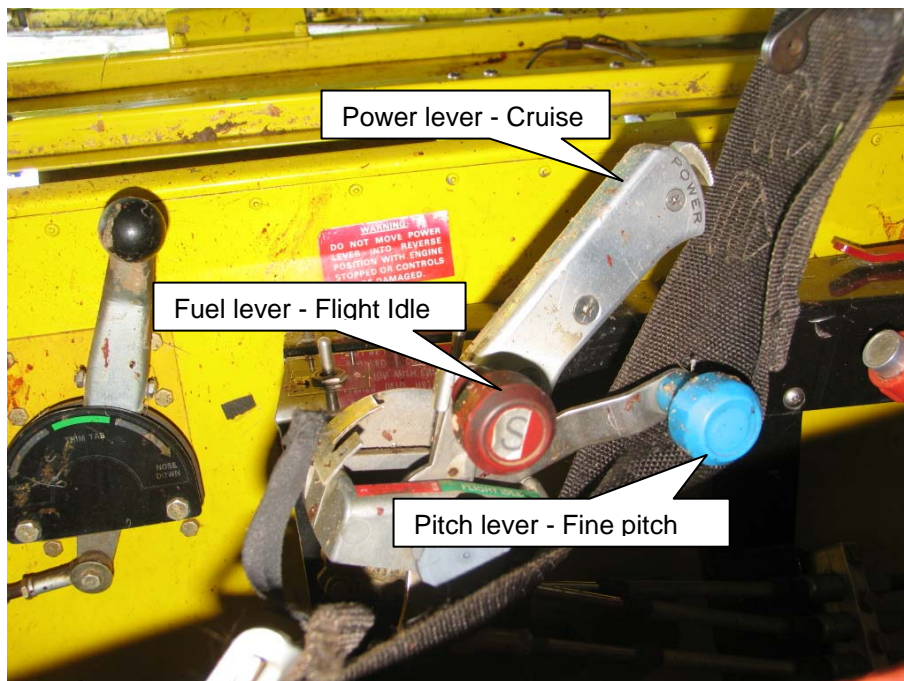
The flaps were found retracted and the flap selector switch was in the neutral position. The elevator trim lever was set for a slight nose-down attitude. The engine control pedestal was not damaged. The power lever was set to a cruise power setting. The fuel lever (red) was set in flight idle which was normal for flight operation. The propeller pitch lever (blue) was fully forward, indicating that the propeller was in full fine pitch. **(Figure 2)**

**Figure 2 Power lever quadrant settings**

1.16.5 Slash marks on the ground were measured and used to determine the ground speed at impact. Evidence shown, (Figure 2) indicates that the power lever was at a cruise throttle setting and according to the Pilot Operating Manual, at cruise throttle setting the propeller produces 2000 rpm.

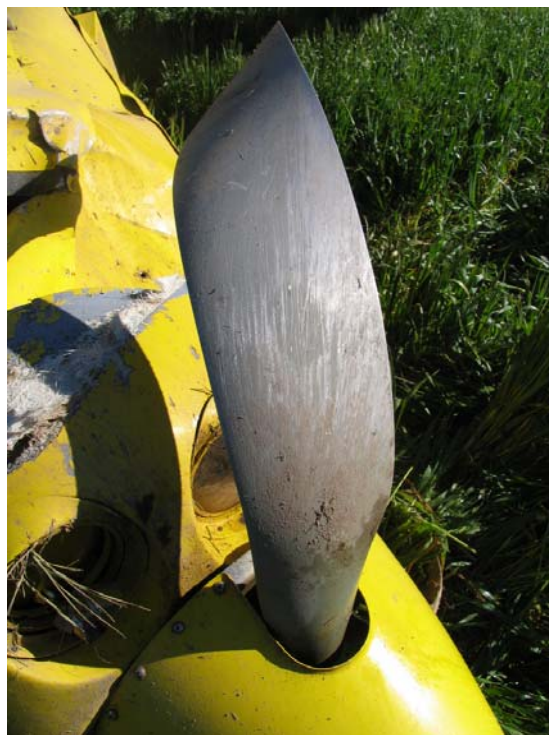
The propeller was still attached to the engine. Ground slashes, which could be associated with rotation of the propeller, were found. The slashes were respectively 600, 550, 680, 700, 850, 920 and 1500 millimetres apart. The blade tip of each blade was broken off approximately 100-150 millimetres from the blade tip. All the blades were bended towards the aircraft and opposite to the direction of rotation. Scoring marks were evident on all three blades along most of the span, slightly from the leading edge to the trailing edge of the blades. **(Figure 3)**

**Figure 3 Scoring marks on the blades.**

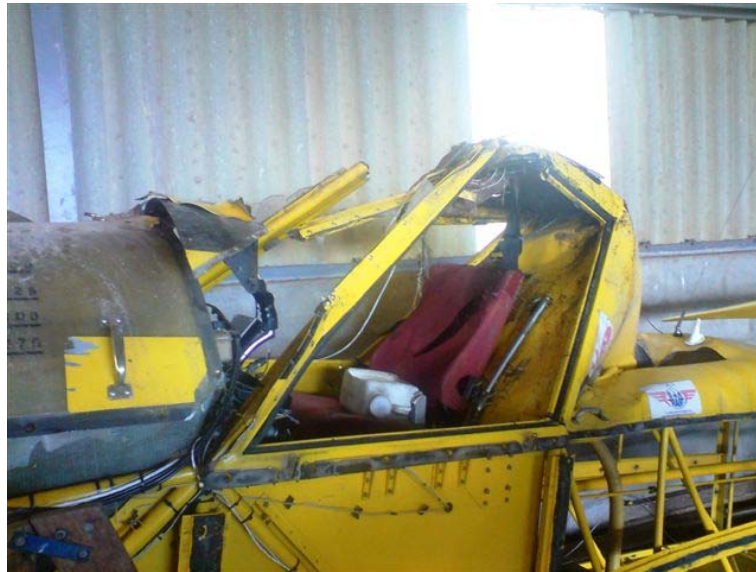
1.15.1 This accident was considered not survivable, due to the high vertical and longitudinal impact loads on the canopy of the cockpit. A contributing factor to the non-survivability of this accident was the fact the pilot was not wearing his shoulder harness, only the lap strap.

There was no post- or pre-impact fire. The entire canopy of the cockpit was deformed backwards. The roof had separated from the front window pillars where it is attached to the roof structure.

There was no damage to the lower seat frame and cushion. The frame of the backrest is attached to a sub-frame, which is attached to the bulkhead at the rear of the cockpit. As the backrest was attached to the bulkhead, it also deformed backwards during the accident sequence. The seat frame was not damaged, only the material cover was torn.

No evidence was present that the frame of the lower cabin structure had been subjected to high vertical and longitudinal impact loads. **(Figure 4)**

**Figure 4 Damage to the cockpit.**

a) Require the Air Tractor manufacturer to investigate the possibility of replacing the existing windshield with a thicker, stronger windshield to be used by clients operating these aircraft in areas of high bird activity.

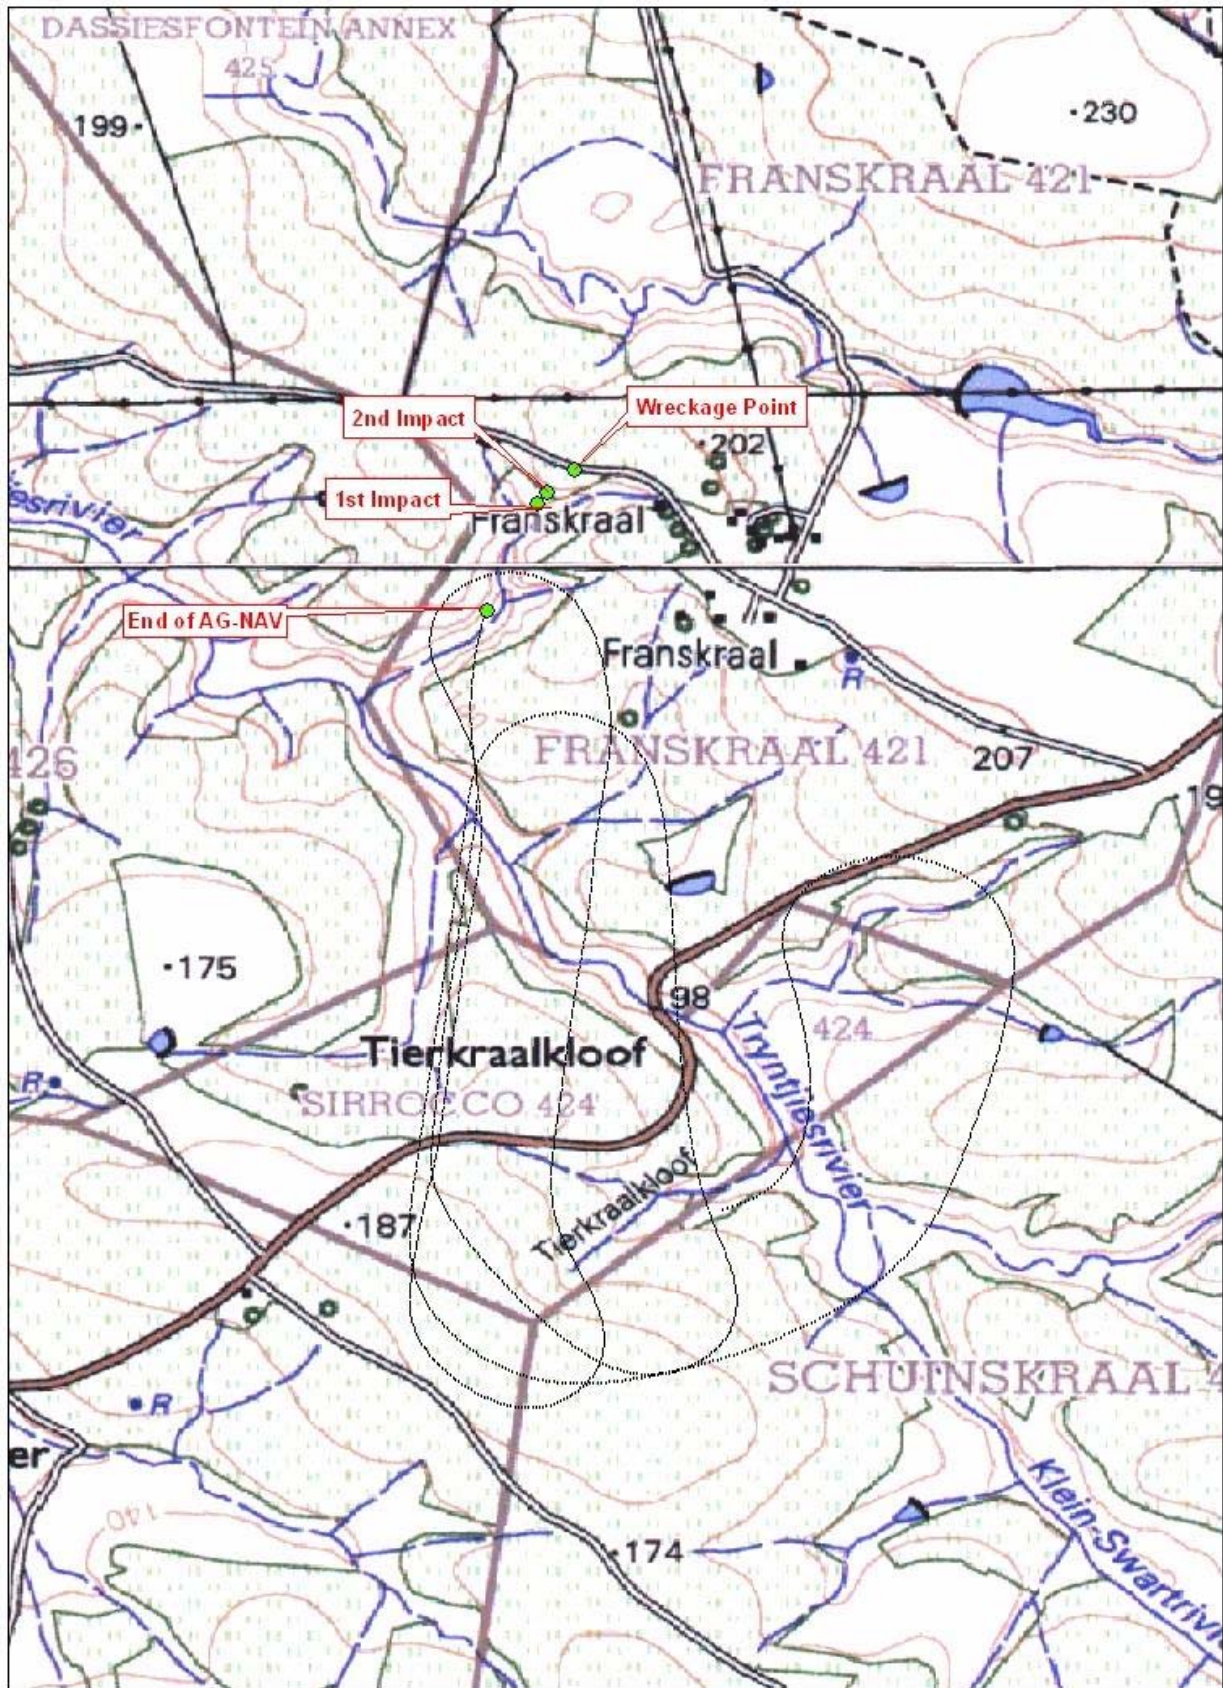
Appendix A

1.18.1 The aircraft was equipped with an AG-NAV2 Silver series system. The AG-NAV system is a DGPS navigation system designed for crop spraying and forest protection. It provides the pilot with swath and directional guidance and other navigational information required to carry out precision applications. After the accident, the information from this system was downloaded, according to which it was possible to see the coordinates, track, height and speed of the aircraft until approximately 370 metres before the impact point. **(Appendix A)**

1.18.2 The last recorded point of the aircraft before the impact point was at position S 34° 15.080' E 19° 20.093'. The aircraft track was 013° magnetic, and the aircraft was at an altitude of 212 meters (695.53 feet), at a speed of 225.3 km/h (121.65 knots).

1.18.3 The initial point of impact was at a point 370 metres after the AG-NAV system had stopped operating and at a height of 547 feet; approximately 148.53 feet lower than the last known height of the aircraft.

Flight path as recorded by the AG-NAV system.
