**CIVIL AVIATION
DIRECTORATE
OF THE REPUBLIC OF SERBIA**

**AIR ACCIDENT AND INCIDENT
INVESTIGATION COMMISSION**

SERIOUS INCIDENT FINAL REPORT

Aircraft:	BOEING 737/800
Aircraft registration marks:	D-AXLF
Operator:	XL Airways Germany
Place of incident:	Airspace under the jurisdiction of ACC Belgrade
Date of incident:	18 October 2008.
Time of incident:	05.19 (UTC)

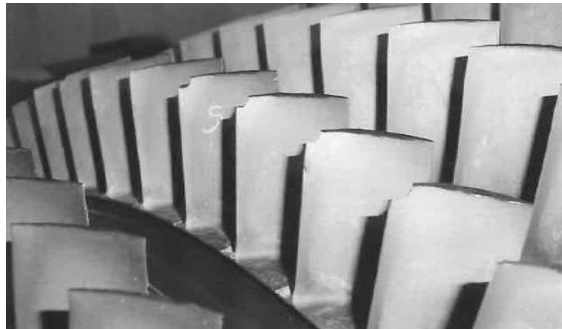
Figure 2.2

- 31X74281: HPC Rotor Assembly
 - Tip corner break-outs on some HPC stages (Figure 2.2)

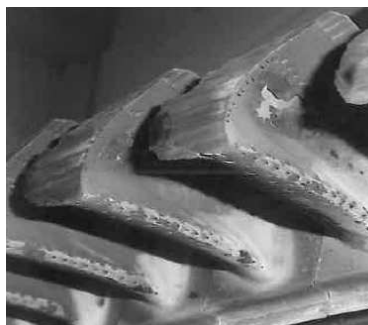
Figure 2.3

- 52X74281: HPT Rotor Assembly
 - All blades were found with multiple damages and heavy tip wear and have therefore been scrapped (Figure 2.3),
 - HPT Retainer broken,
 - Rear shaft was found with signs of overheating and broken-off material and have therefore been scrapped (Figure 2.4)

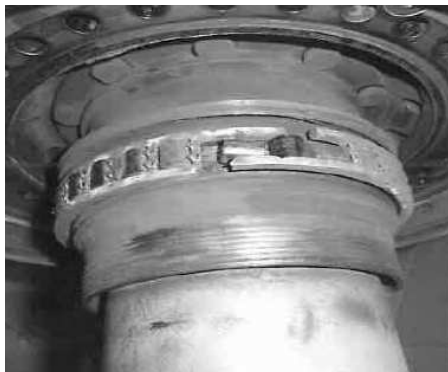
- 55X74281: LPT Shaft Assembly
 - LPT shaft was found with heavy wear, chafing and with high metal pick-ups on the painted surface,
 - Bearing #4 has been found with multiple damages (inner race destroyed, rollers worn, burnt, deformed and partially missing),
 - Bearing No. 4 Rotating Air/Oil Seal heavily worn

Figure 2.5 shows the layout of the assembly of the inner race, rollers and cage, and Figure 2.6 shows the appearance of a very damaged outer race.

- **Inner race:** Rollers path diameter wear with smeared material; Lubrication holes clogged due to shoulders diameter wear; Inner back up bearing diameter wear; FWD seal teeth wear,

- **Rollers:** Several spalling craters located on outer diameters (no singular spalling); Flat spots located on outer diameter and end wear; Rollers diameters within specifications except one place removed from cage rupture location (diameter decrease 0.2 mm); Rollers length values between 14 and 14.04 mm (specifications 14 ± 0.2 mm); Microstructure didn't show diameter overheating evidence; Hardness check within specifications; Microstructure OK,

- **Cage:** Rails and two spacers broken (no singular damage)

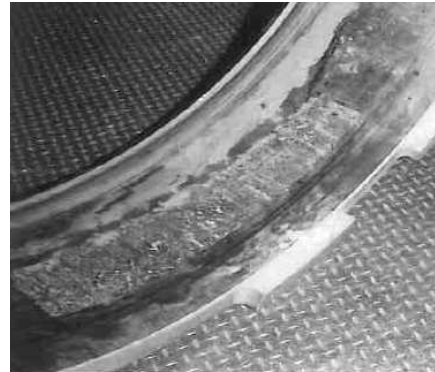
Figure 2.6

- **Outer race:** Spalling area (lg 78 mm) at race way location; Microstructure exhibited fatigue butterflies at spalling area location; Hardness check within specifications; Groove on inner diameter machined by inner back up bearing; No damage due to assembly operation

Based on the performed analysis it was concluded: bearing failure root cause identified as outer race spalling due to material fatigue.

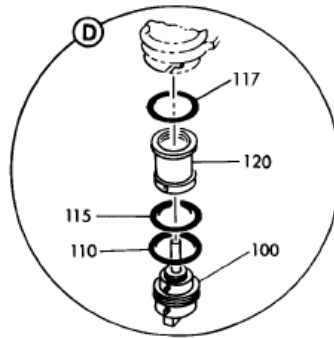
Figure 2.8

- The Lubrication Unit was running during the event flight (Shaft shear section not broken)
- Pump performances within CMM limits
- Dark oil deposit most likely occurred post bearing failure and during the low / no oil operation
- The analysis of the oil filter showed the presence of particles of various metals and non-metals: tungsten, chromium, nickel, vanadium, manganese, aluminum, molybdenum, iron, titanium, etc. Also, the traces of metal that match the composition of M50 steel (from which the outer race engine bearing No. 4 is made) were found.
- The exploded view of the CMD (detail D in the Figure 2.7) is shown in the Figure 2.8.

Two oil samples were taken for the analysis from the middle chip detector from forward sump. In one of them there were found very large amounts of impurity such as iron, chromium, molybdenum, nickel, vanadium, aluminum, titanium and silicon.

In the second sample there were found exceptionally large amounts of impurity such as iron, nickel and silicon. Viscosity of oil in alert and very high water contamination.
