AIRCRAFT ACCIDENT REPORT AND EXECUTIVE SUMMARY

Reference:	CA18/2/3/8567	
Aircraft Registration	ZS-JZF	Date of Accident	21 October 2008		Time of Accident	0609Z
Type of Aircraft	Piper PA32R-300		Type of Operation		Private	
Pilot-in-command Licence Type		Private	Age	55	Licence Valid	Yes
Pilot-in-command Flying Experience		Total Flying Hours	297.29		Hours on Type	176.29
Last point of departure		Rand Aerodrome (FAGM) Gauteng.				
Next point of intended landing		Ficksburg Aerodrome (FAFB) Free State Province.				
Location of the accident site with reference to easily defined geographical points (GPS readings if possible)						
Wesbank Raceway, approximately 2km north of Rand Aerodrome near Germiston (GPS Positions: S25° 13.957 E028° 07.960)						
Meteorological Information		Fine weather conditions; No clouds; Temperature; 18°C; Wind: 360°/10kt.				
Number of people on board	1 + 5	No. of people injured	0	No. of people killed	1+5	
Synopsis						
<p>On 21 October 2008, the pilot accompanied by 5 passengers took off from Runway 35 at Rand Aerodrome at approximately 0609Z for the intended flight to Ficksburg Aerodrome (FAFB). The aircraft was fuelled to full capacity of 94 US gallons the pre

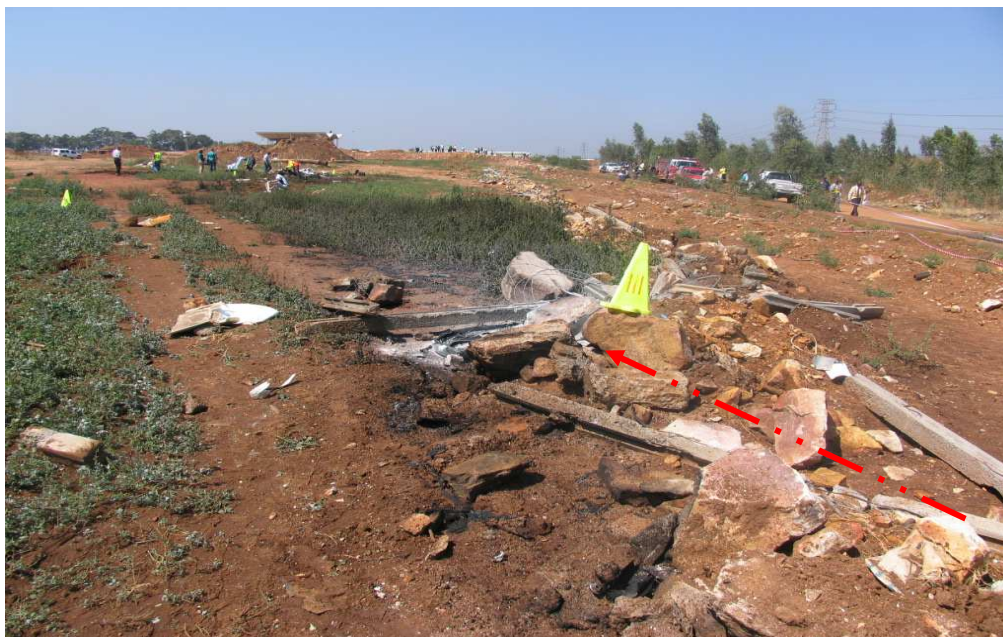
PHOTO1: VIEW OF RUBBLE WHICH WAS IMPACTED BY NOSE LANDING GEAR DURING AN EMERGENCY LANDING.

1.12.1 The aircraft's nose landing gear and left-hand wing impacted with a heap of rubble on a heading of approximately 170°M just prior to an open grass/sandy area at the Wesbank Raceway near Gosforth Park, approximately 1.9km (1.1nm) to the west of the threshold of Runway 17 at Rand Aerodrome. During the impact sequence, the nose wheel broke off and the aircraft subsequently cart-wheeled before coming to rest approximately 56 metres from the initial impact point.

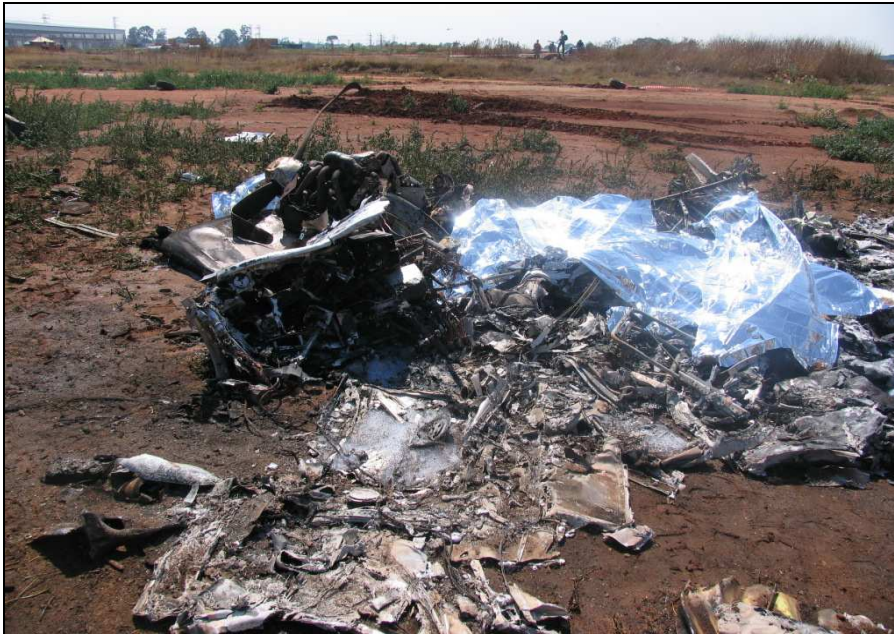
1.3.1 The aircraft was destroyed on impact and by the post-impact fire that erupted.

PHOTO2 : VIEW OF AIRCRAFT WRECKAGE DESTROYED BY THE POST-IMPACT FIRE

1.14.1 A post-impact fire erupted during the impact sequence and the aircraft was destroyed by the ensuing fire.

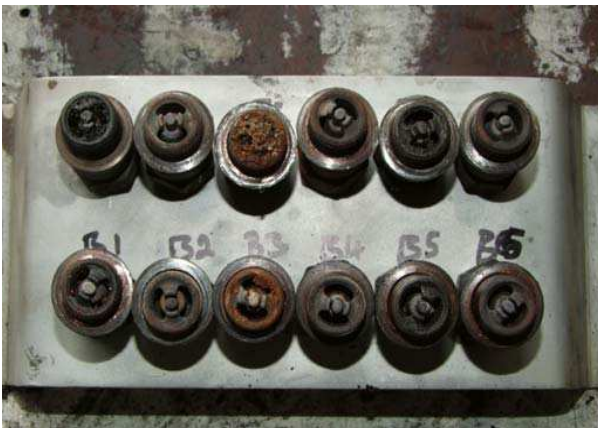
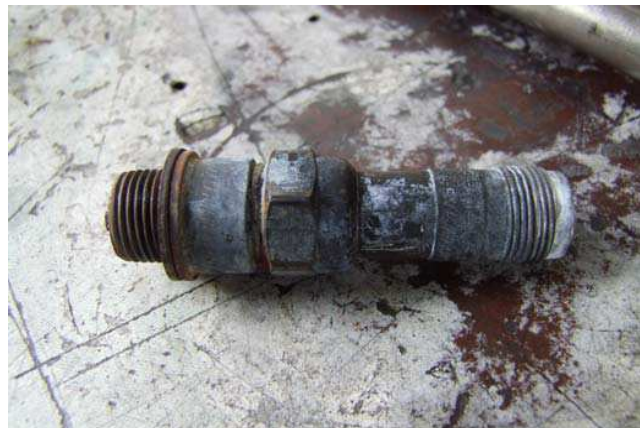
The spark plugs RHM 40E were all intact and appeared to have been in a proper working condition prior to the accident. Soot and FOD found on the plugs are post accident material. (See attached Photo)

PHOTO :THE SPARK PLUGS RHM 40E WERE ALL FOUND INTACT AND IN PROPER WORKING ORDER

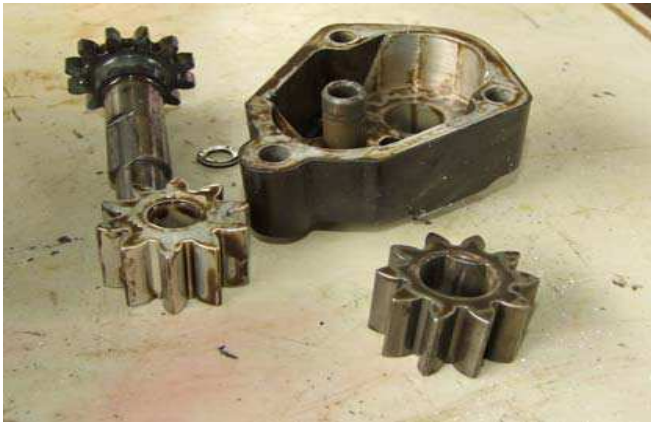
The oil pump was inspected and no internal damage found on gears , body and oil pump drive

PHOTO: The oil pump was inspected and no internal damage found on gears , body and oil pump drive gear. (see attached photo

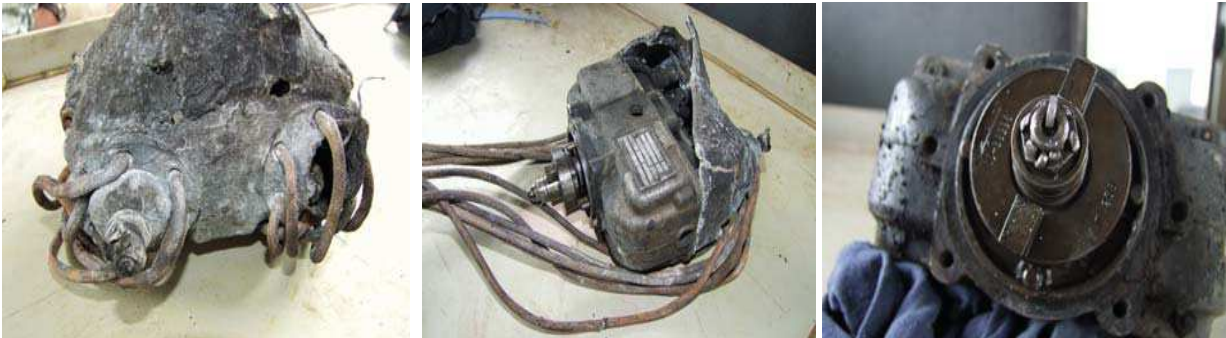
PHOTOS:The magneto was unable to be bench tested due to excessive fire damage, but no apparent defects due to failed parts was found.

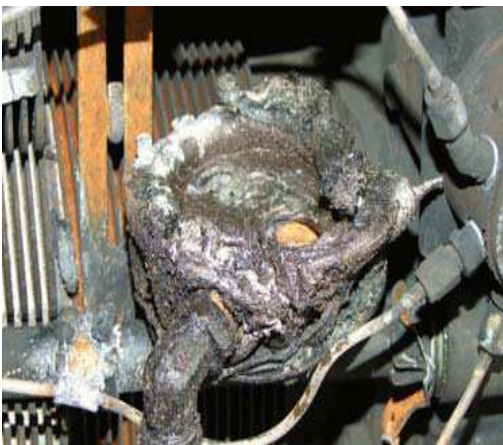
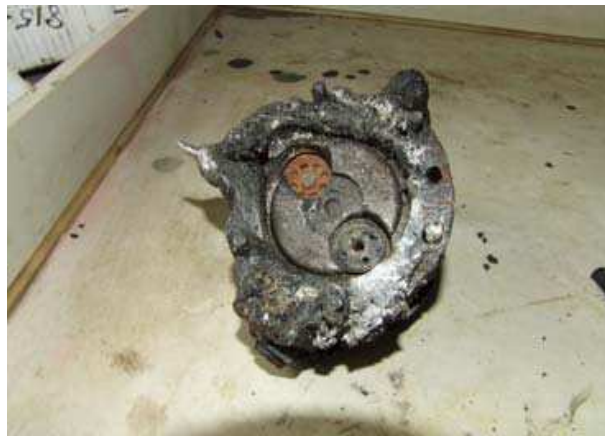
PHOTOS: The AC type fuel pump was excessively damaged due to fire, so no further test or inspections were carried out. (see attached photo)

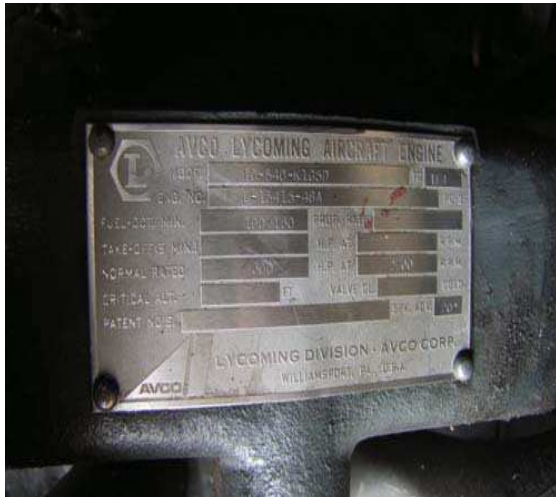
ENGINE DATA PLATE

The pistons part number LW 10207 (High Compression) were found fitted into this machine. Turbo charged engines are fitted with pistons part number LW 10545 (Low Compression) - see attached photos. It is my considered opinion that this engine has had an STC carried out to it making it a “ turbo - normalized ” engine and not a full “ Turbocharged ” engine. The data plate on the engine shows it as an IO-540 and not a TIO-540

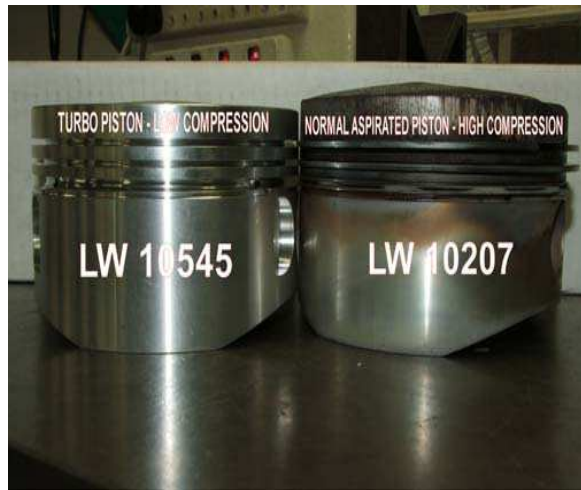
LEFT - SAMPLE - NORMAL PISTON

RIGHT- SAMPLE - HIGH COMPRESSION PISTON

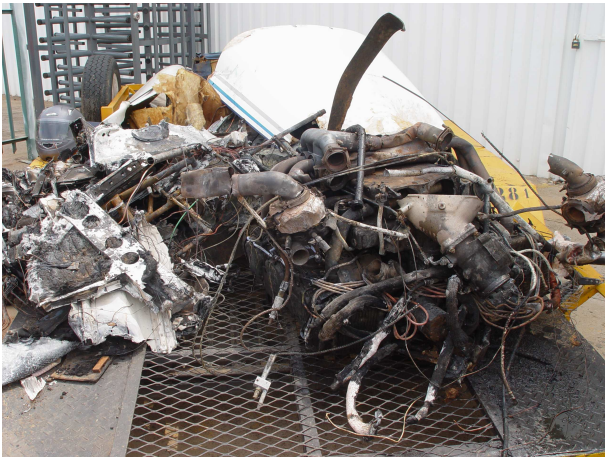
Photo 1: Condition of wreck (digital)

6.1. Visual, Stereo- and SE microscope Investigation. The visual inspection revealed severe impact and post-impact fire damages (Photo's 1, 2 and 3).

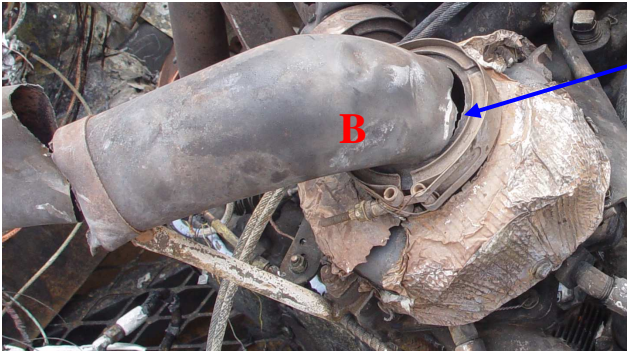
The left hand (pilots view) turbocharger marked B revealed impact marks resulting in a tear in the exhaust outlet duct (Photo's 2 and 3, blue arrows). No clear evidence of pre-impact damages to the exhaust inlet and air outlet ducts could be detected.

Photo 2: Left hand turbocharger B (digital)

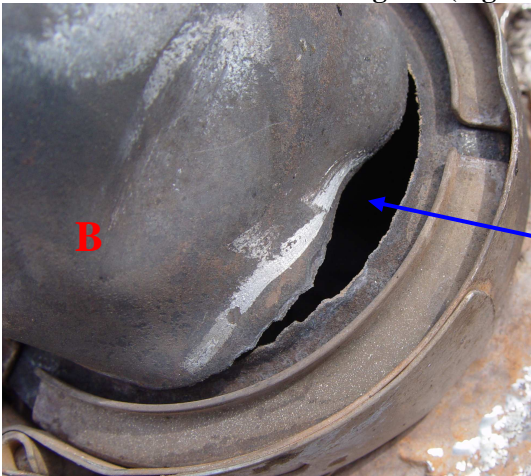
Photo 3: Turbocharger B, Exhaust outlet duct showing impact fracture (digital)

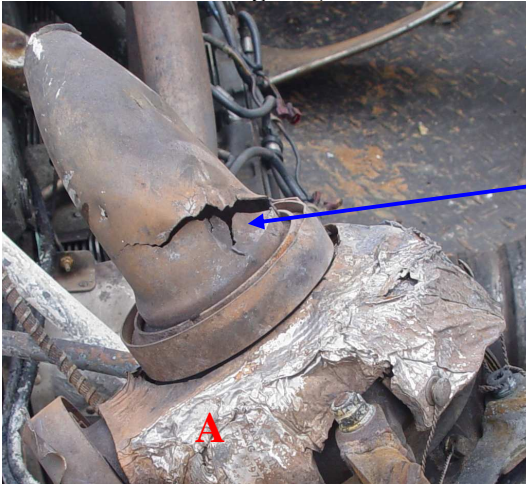
The right hand (pilots view) turbocharger marked A revealed a fracture in the exhaust outlet duct (Photo's 4 and 5, blue arrows). Decolourisation in the adjacent areas to the fracture (Photo 5, green arrow) indicates exposure over a period of time to the high temperature exhaust gases. Taking into account that the exhaust inlet duct was fractured on impact, it can be assumed that the exposure of the exhaust outlet duct to exhaust gasses was prior to final impact. Also compare to Turbocharger B (Photo 3). On tear down of Turbocharger A foreign matter was detected entrapped in the hot cycle turbine (Photo 6, green arrow). The foreign matter was most probably ingested after impact indicating that the engine was operating on impact. The cold cycle turbine (Photo 7) appeared to be in good condition. The bearing proved to be sticky but this can be attributed to post-impact ingested matter as well as lubrication break down during the post-impact fire. The inner area of the exhaust outlet duct (Photo 8, blue arrow) revealed severe wear due to high temperature exhaust gas exposure during operation.

Photo 4: Right hand turbocharger A showing fracture, blue arrow (digital)

- 7.1 The investigation revealed that the fracture in the **exhaust outlet duct** (Photo's 4 and 5) was induced over a period of time prior to impact.
- 7.2. The total effect of a ruptured **turbocharger exhaust outlet duct** on the overall performance of the engine, except resulting in higher noise levels, should be minimal.
- 7.3. Cockpit indications as per the **Manifold Pressure/Boost Indicator** would also be difficult to note by the crew as it display the average performance of both turbochargers during operation.
- 7.4. Pre-flight inspections may have revealed staining of the inner engine cowling areas by the escaping high temperature exhaust gasses.
- 7.5. Furthermore, exhaust gas fumes as well as higher noise levels may have been present in the cockpit areas during operation.

- 8.1. A post-impact fire complicates an investigation immensely but it is still recommended that the engine and all its components to be scrutinized for any defects that may have contributed to this accident.
- 8.2. Tests recreating the same scenario may be performed to determine the overall effect, if any. The relevant engine and turbocharger OEM's may also shed some light on this aspect.

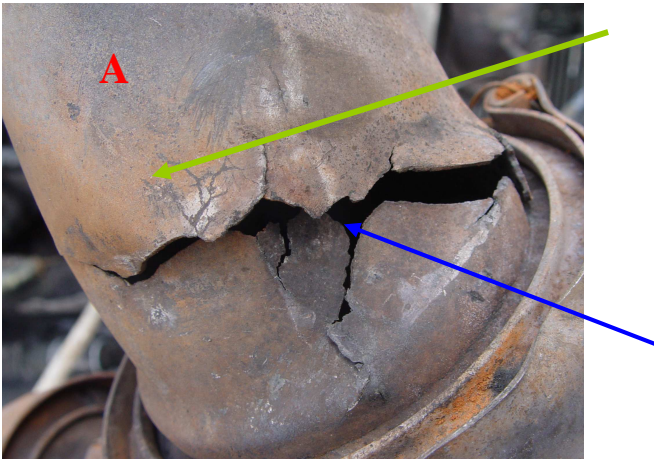
Photo 5: Turbocharger A, exhaust outlet duct showing pre-impact fracture (digital)

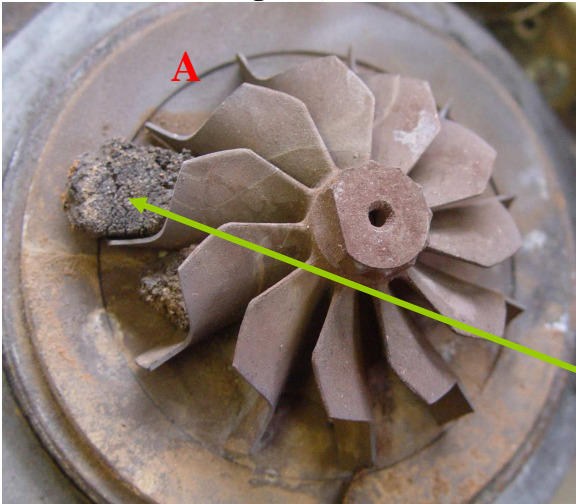
- On tear-down of the turbocharger, foreign matter was detected entrapped in the hot cycle turbine. The foreign matter was most probably ingested after impact, indicating that the engine was operating on impact. The cold cycle turbine appeared to be in good condition. The bearing proved to be sticky, but this can be attributed to post-impact ingested matter as well as lubrication break-down during the post-impact fire. The inner area of the exhaust outlet duct revealed severe wear due to high temperature exhaust gas exposure during operation.

Photo 6: Turbocharger A, exhaust turbine showing ingested foreign matter (digital)

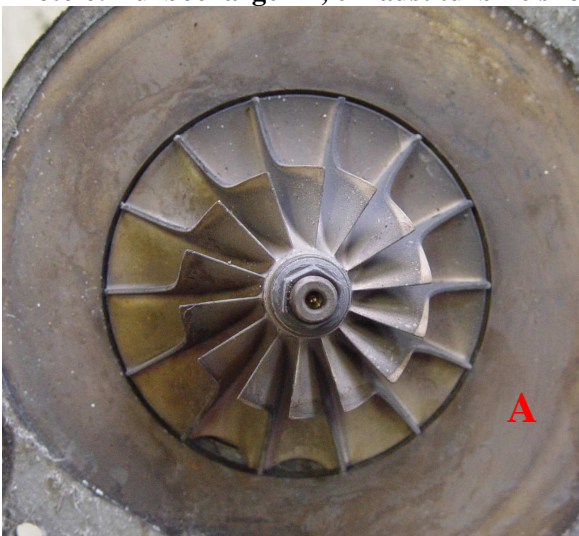
Photo 7: Turbocharger A, air turbine (digital)

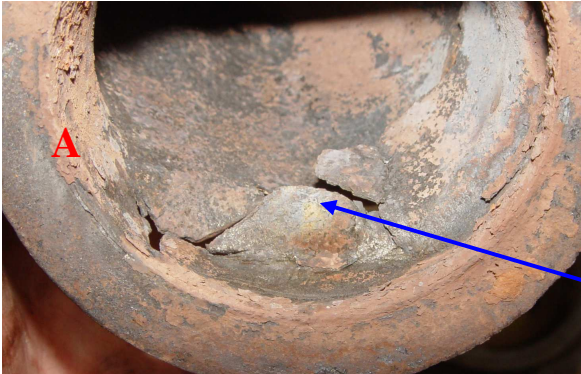
Photo 8: Turbocharger A, exhaust outlet duct, inner area showing fractures (digital)

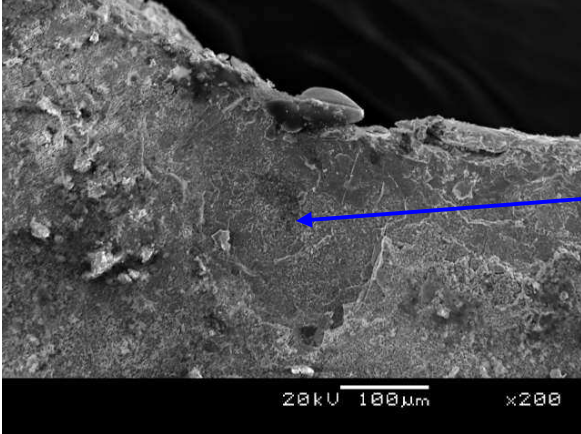
The SEM investigation revealed signs of flaking (Photo 9) adjacent to the original fracture. EDS results (attached) showed that these areas exposed by the flaking, as well as the majority of the investigated area adjacent to the original fracture, covered by exhaust residue with a high lead (Pb) content. This to prove that these flaked areas was exposed to leaking exhaust gasses over a period of time. Also compare the EDS results from the inner exhaust outlet duct areas (Photo 10) adjacent to the original fracture (attached). The fracture surface from the original fracture (Photo 11) shows some residue build-up as well as geometry comparable with a slow propagating fracture (Photo 12). Compare to a laboratory induced overload type fracture surface (Photo 13) from the same material.

Photo 9: Flaking in area adjacent to original fracture (x200, SEM)

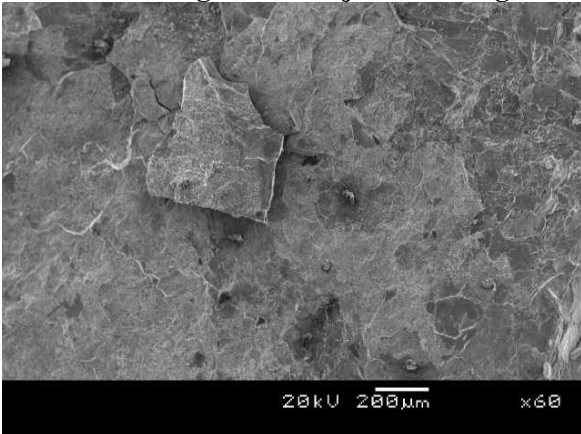
Photo 10: Exhaust residue build-up, inner area adjacent to original fracture (x60, SEM)

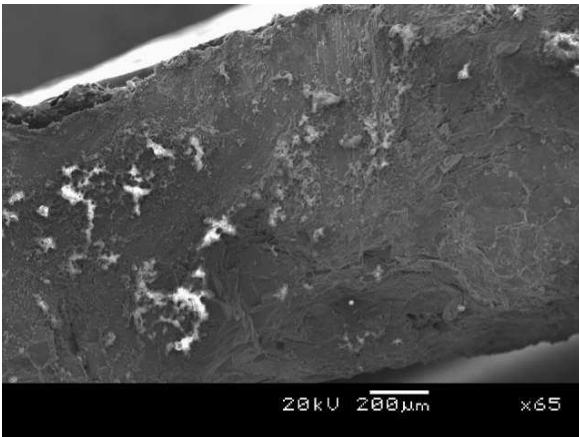
Photo 11: Fracture surface, original fracture (x65, SEM)

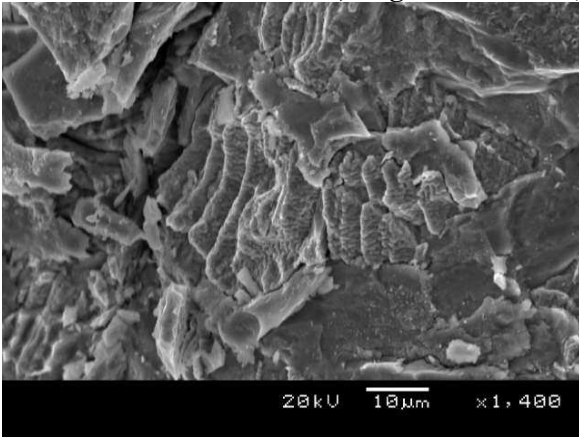
Photo 12: Fracture surface, original fracture (x1400, SEM)

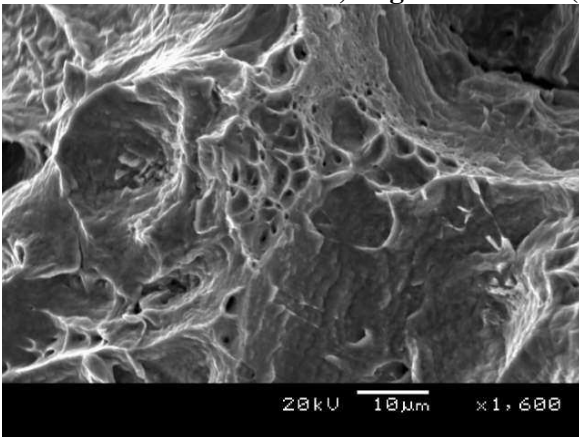
Photo 13: Fracture surface, laboratory induced overload fracture (x1600, SEM)
