AIRCRAFT ACCIDENT REPORT AND EXECUTIVE SUMMARY

Reference:	CA18/2/3/8566	
Aircraft Registration	ZS-RMJ	Date of Accident	21 October 2008	Time of Accident	1030Z	
Type of Aircraft	Robinson R22 Beta II (Helicopter)		Type of Operation	Training		
Pilot-in-command Licence Type		Commercial	Age	35	Licence Valid	Yes
Pilot-in-command Flying Experience		Total Flying Hours	1102.8		Hours on Type	358.9
Last point of departure		Grand Central Aerodrome (FAGC)				
Next point of intended landing		Grand Central Aerodrome (FAGC)				
Location of the accident site with reference to easily defined geographical points (GPS readings if possible)						
Open area next to Grand central Aerodrome, GPS Position: S25°59.380' E28°08.035' Elevation, 5325						
Meteorological Information		Visibility, Good, No Clouds, Temperature, 25° Wind, 3-9 knots.				
Number of people on board	1 + 1	No. of people injured	0	No. of people killed	0	
Synopsis						
<p>The instructor and a licensed student pilot embarked on a training flight with the intention to conduct autorotation and flaring exercises at Grand Central Aerodrome (FAGC) general flying area South of Allandale road. The helicopter was refuelled to full capacity prior

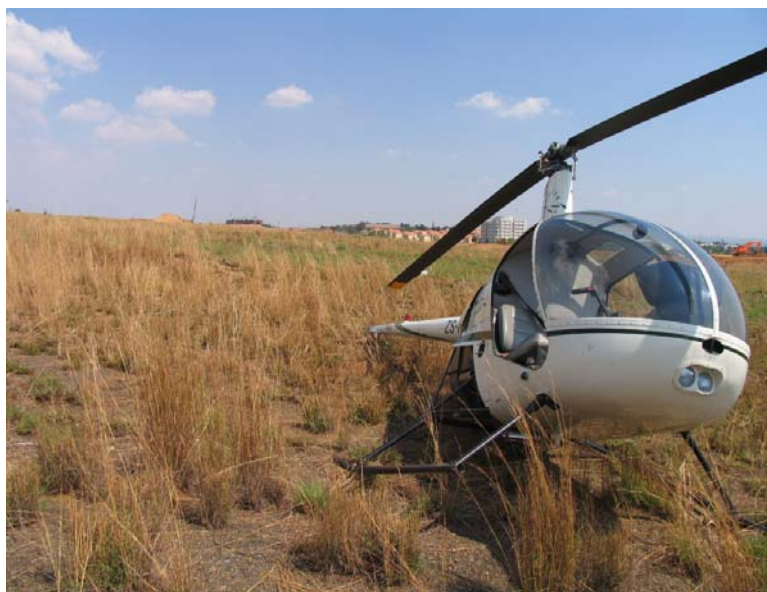
1.3.1 The helicopter was substantially damaged.

Photo 1: A view of the aircraft as it came to rest.

- 3.1.8 The helicopter's right hand skid collapsed and the tail section separated from the helicopter due to the impact.
- 3.1.9 The helicopter was refuelled to full capacity prior to the flight.

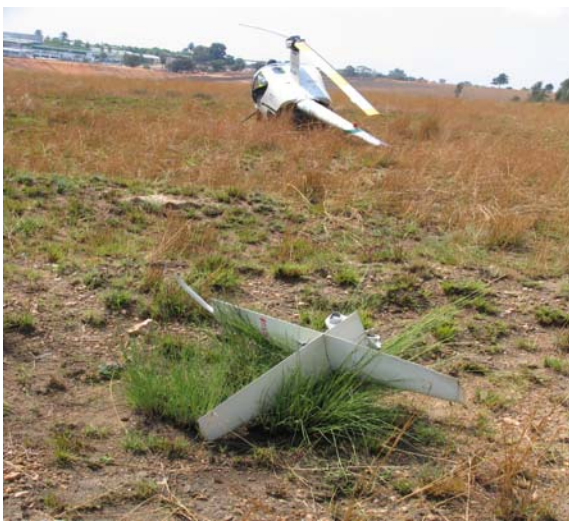
1.12.1 The helicopter impacted an ant hill with force whilst it was being operated at an altitude of 6 feet AGL damaging the tail rotor blades. The tail rotor gearbox and the empennage were detached from the tail boom. The skid, main rotor blades, and the tail boom sustained substantial damages. Photos below give the evidence of the wreckage at the accident side.

Figure 3: View of the empennage.

2.3 The tail boom, the skids and the main rotor blades were substantially damaged. The tail rotor gear box and the empennage separated from the tail boom.

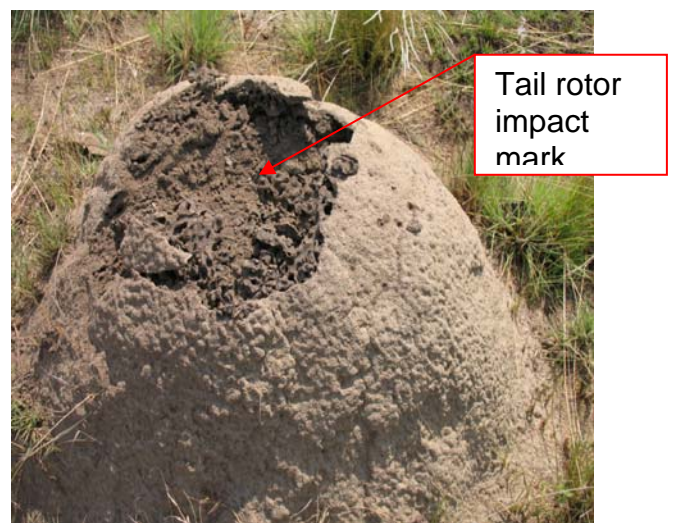
Figure 4: View of the ant hill.

2.2 The student pilot descended to 6 feet above the ground on a boundary outside Grand Central Aerodrome where he did a flare in autorotation exercise. Whilst busy with the exercise at 6 feet (low altitude), both of the pilots failed to look out for obstacles on the ground and impacted an ant hill with the tail rotor. The helicopter tail rotor and empennage separated from the tail boom. Because of this, the helicopter lost control due to tail rotor effectiveness and the helicopter yawed to the left and impacted the ground on it skids.

- 3.2.1 Tail rotor impacted an ant hill at low level flight.

- 3.3.1 Failure of the instructor and the student pilot to look out.
