AIRCRAFT ACCIDENT REPORT AND EXECUTIVE SUMMARY

| | | | | Reference: | CA18/2/3/8568 | |
| Aircraft Registration | ZS-NAB | Date of Accident | 23 October 2008 | | Time of Accident | 1647Z |
| Type of Aircraft | Beechcraft Baron 58 | | Type of Operation | Unknown | | |

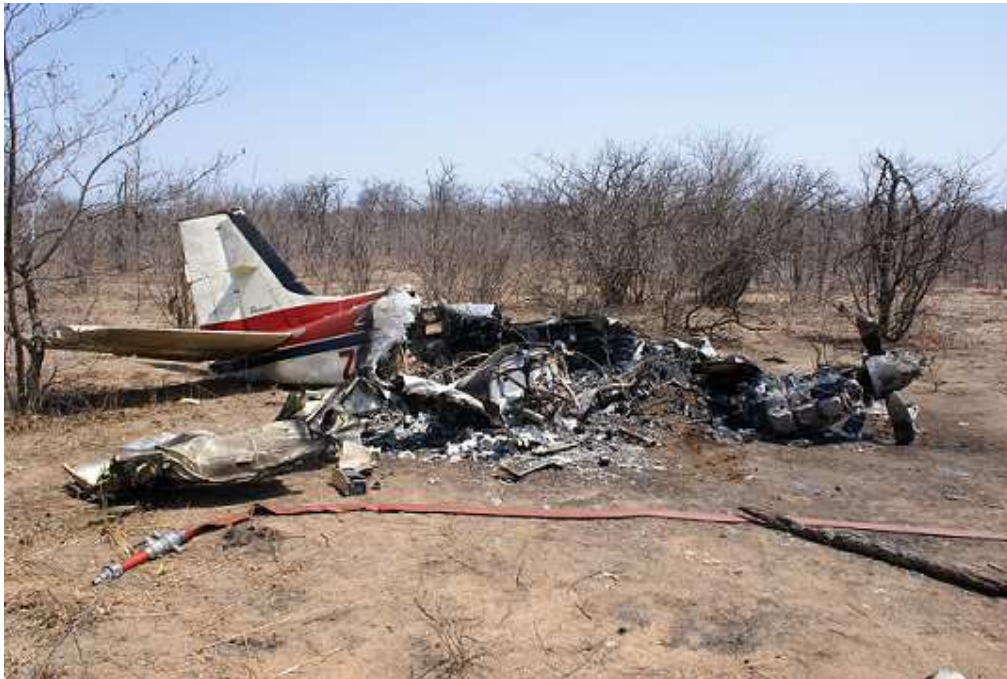
1.3.1 The aircraft was destroyed during the impact sequence and also by the post-impact fire that erupted.

Figure 3, showing the main wreckage.

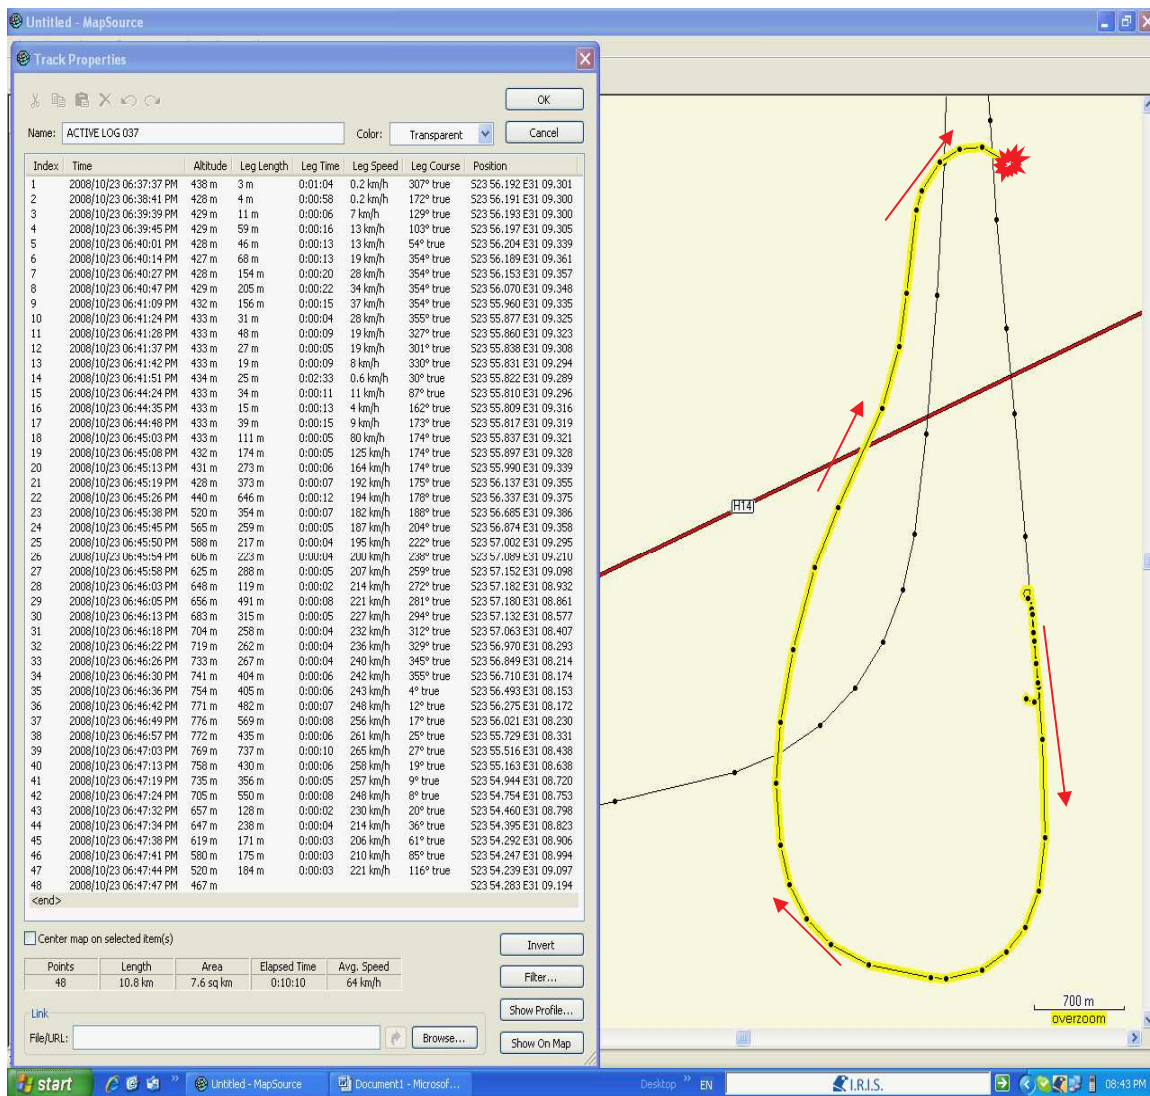
1.8.4 The track was plotted on a picture showing the pattern of the circuit. According to the track log, the pilot took off from RWY 19 in a southerly direction and then entered a climbing turn when it reached the altitude 606 metres. Thereafter the aircraft turned to the right through less than 90 degrees into the crosswind leg, reaching 656 metres before starting to turn downwind. After turning into the downwind, the aircraft started losing altitude from 776 metres, with a slight change in direction towards the runway centre line and tightening the turn even further onto the base leg. The aircraft made very tight base leg turn with an increase in the rate

of descent and thereafter impacted with terrain.

Figure 4, showing the track log of the right-hand circuit flow at FAPH.

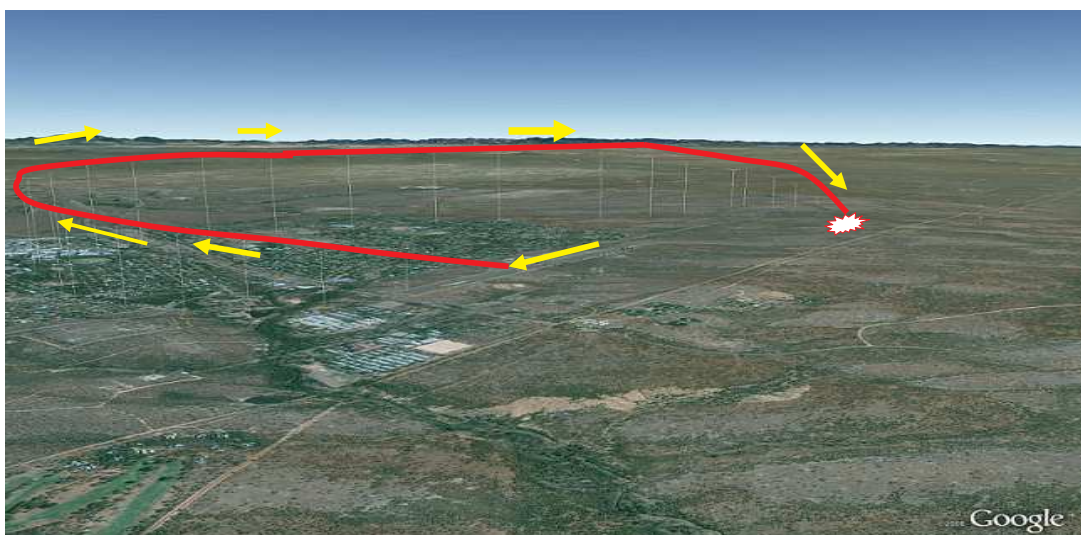
Figure 5, showing a different view and representation of the last track flown around the aerodrome.

The actual circuit flown by the pilot, indicating that the aircraft was flying in the downwind leg not parallel to the RWY, but cutting into the circuit towards the RWY centreline.

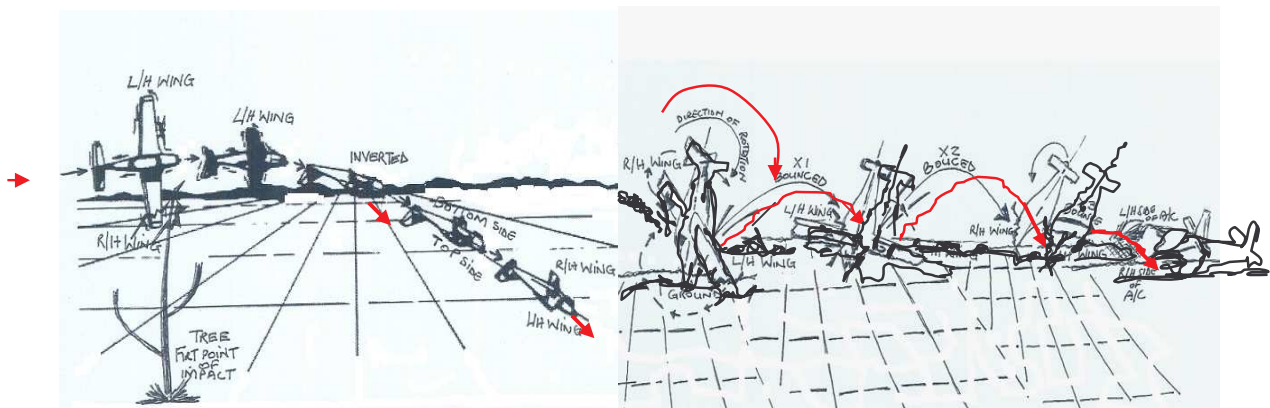
- (i) Prior to impact the aircraft entered into a banked turn towards the right, where the outer wing (left-hand) was raised higher than the inner wing (right-hand). The right-hand wing collided with a tree, which resulted in a portion (wingtip - approximately 1 metre long) separating from the wing. The aircraft impacted with the ground in a nose-down attitude with high velocity. The detached piece of wing structure remained entangled in the tree, which was approximately 4 metres above the ground.

Figure 7 Impact sequence of the aircraft.

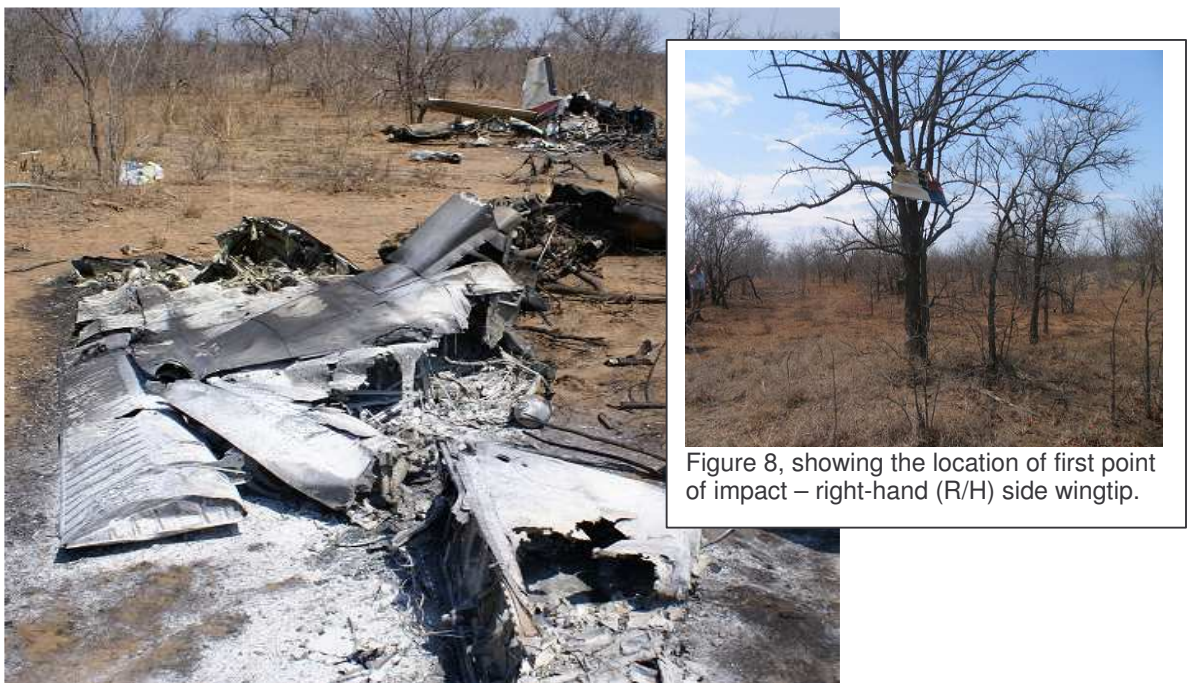
Figure 8, showing the location of first point of impact – right-hand (R/H) side wingtip.

Figure 9, showing the wreckage, destroyed by the impact and post-impact fire

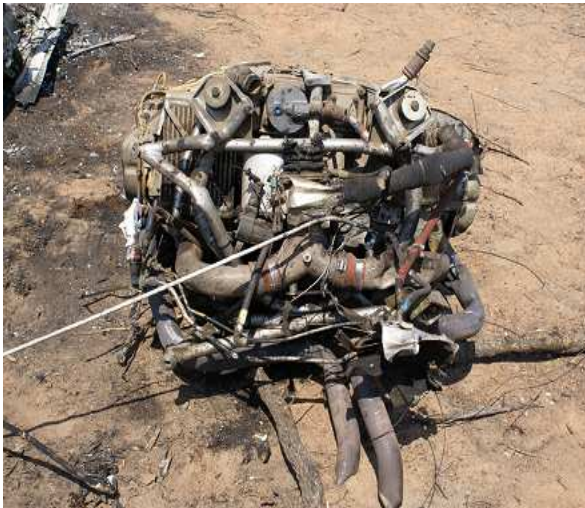
L/H Engine S/N 298711-R

- II. The two engines separated from the aircraft on impact. The left-hand engine was found approximately 40 metres from the main wreckage and in close proximity to the right-hand wing. The location of the right-hand engine was next to the main wreckage. Both engines sustained major impact and fire damage.

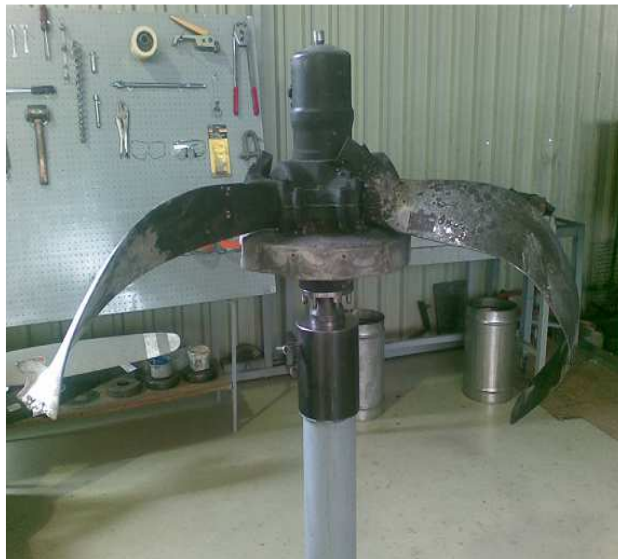
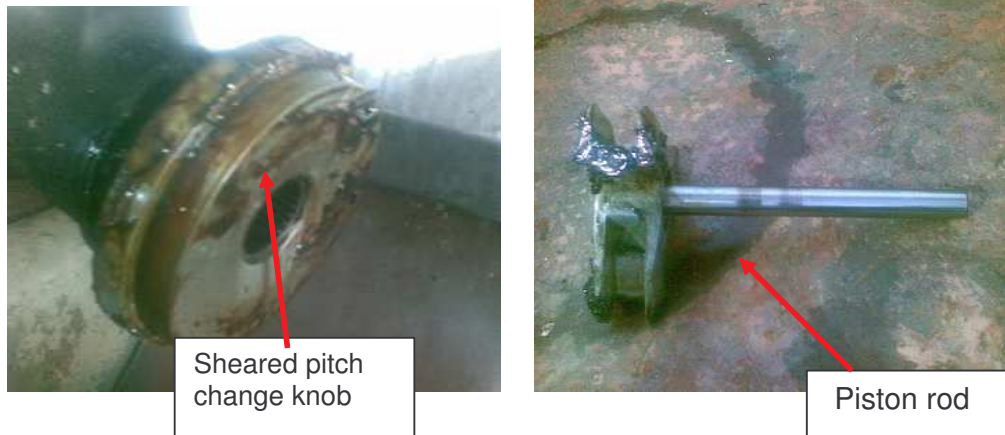
Right-hand propeller: S/N ED 2452

- (i) The Propeller S/N ED 2452 (Blades S/N E 66154; E66108; E66092) **fitted on the right-hand engine** of the aircraft showed that two of the propeller blades were bent backwards towards the engine, and were stationary at the moment of impact with the ground. The start latches were engaged, suggesting that the engine had stopped “shut down” normally.

- (ii) The examination of the right-hand propeller also indicated that as the affected engine slowed down, the propeller governor allowed oil

pressure into the propeller cylinder, thus pushing the piston to fine pitch position. This would have also caused the start latch sleeve to migrate past the spring loaded latches. As the prop speed decreased to below 800 r.p.m, the latch spring overcame the centrifugal force acting on the latches and allowed them to move to engage the latch sleeve.

- (iii) The internal damage caused to the propeller hub unit was minimal, but two of the blades pitch change knobs were found to be sheared off.

In conclusion, it appears that the right-hand propeller (S/N ED 2452) was stationary at the time of impact, as evidenced by the nature of the damage caused to the propeller whilst the left-hand propeller (S/N ED 2453) was at maximum power at the moment of impact.

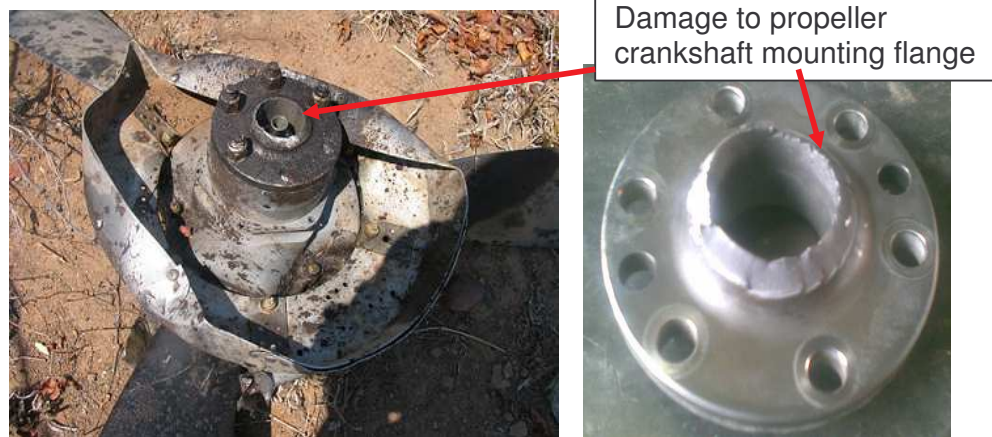
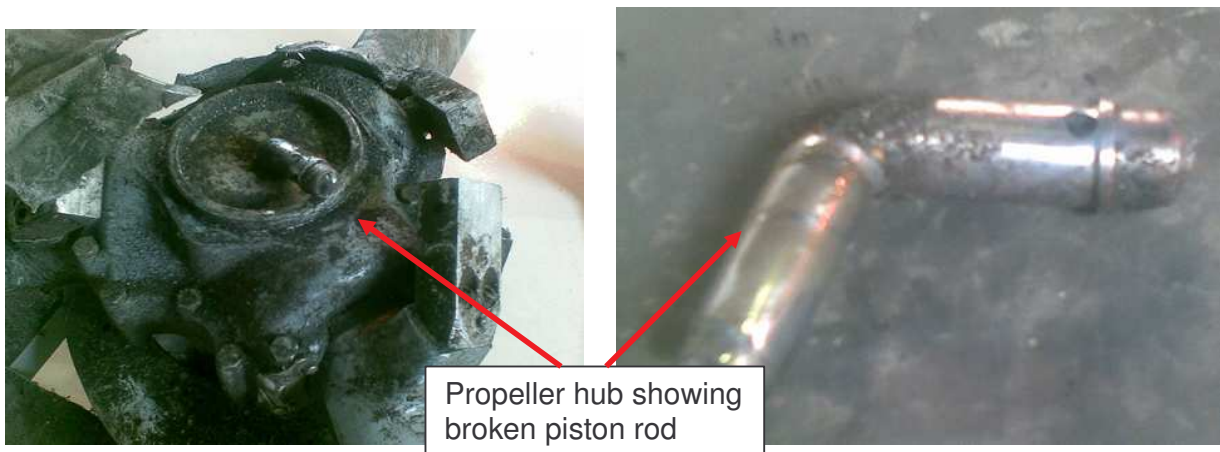
L/H Propeller: S/N ED 2453

- (i) The Propeller S/N ED 2453 (Blades S/N E 59373; E59871; E59578) that was **fitted to the left-hand engine** indicated a high level of energy output at the moment of impact. The propeller crankshaft's mounting flange had broken off and was still attached to the propeller. The cylinder and piston were missing. The piston rod had broken off just forward of the pitch change rod shoulder and bent almost ninety degrees and approximately 1.50 inches aft of the oil hole. The rear hub half was cracked on the leading edge side of a blade port, indicating that the particular blade had impacted with the ground at a high r.p.m and power setting. All three blades had transverse scratch marks consistent with that of a rotating propeller.

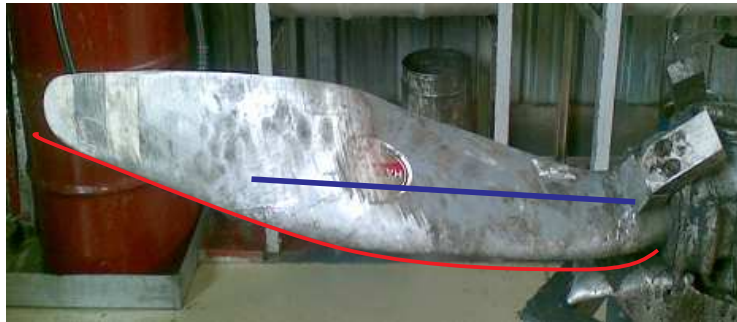
1.16.2 Propeller blade S/N E 59871 was damaged and slightly curved at the 6 inch station in the plane of rotation. The pre-load shelves of the three blades ports on the rear hub were also damaged. This implied that the blades had impacted with the ground at a high r.p.m and/or power setting.

L/H propeller blade; Note scratches and slight curve in the plane of rotation, at the 6 inch station.

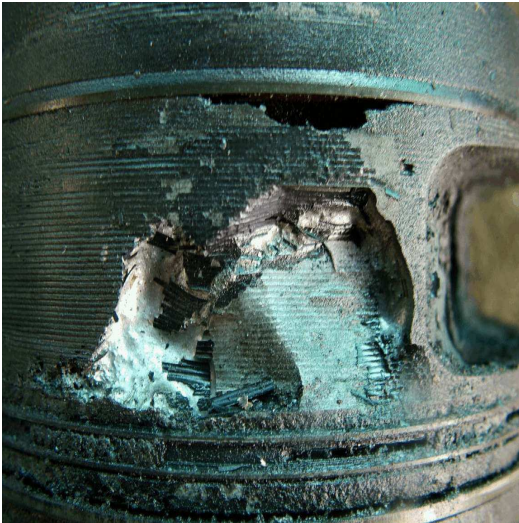
- (ii) Prior to the disassembly of the engine, some mechanical problems were identified. The six cylinders were removed from the crankcase and all cylinders were intact, but damaged by the fire. During the disassembly of the pistons from the cylinders, the only difficulty experienced was with the removal of the #6 piston. It appeared as if the piston seized in the bore of the cylinder. The most appropriate method used to remove the #6 piston was by removing the big-end bearing cap and separating it from the crankshaft. The #5 piston showed melting of the piston skirt, but without any scoring, which normally accompanies seizure in operation.
- (iii) Both engine fuel systems were reduced to ashes in the post-impact fire. It was also not possible to determine if any of the components in the engine fuel system had become defective or were not functioning correctly.

Photo showing damage caused to #5 piston.

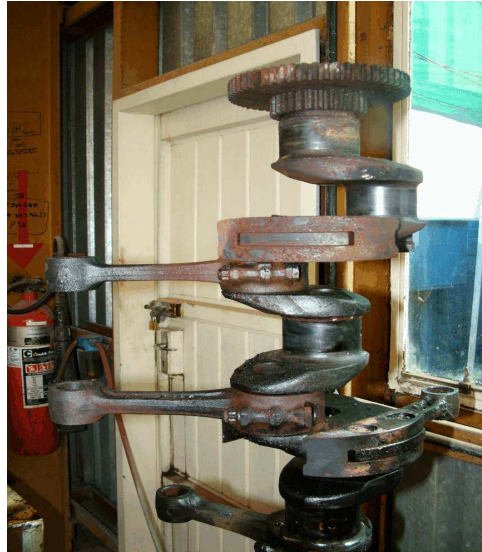
Photo showing the crankshaft as examined.

- (iv) The crankshaft and connecting rods were also examined and the damage caused to the crankshaft was determined to be the result of the fire. The crankshaft main bearing journals showed no signs of scoring or abnormal wear. There was oxidation of the surface of the #7 main bearing journal and minor scoring. The internal surface of both crankcase halves displayed evidence of oil.

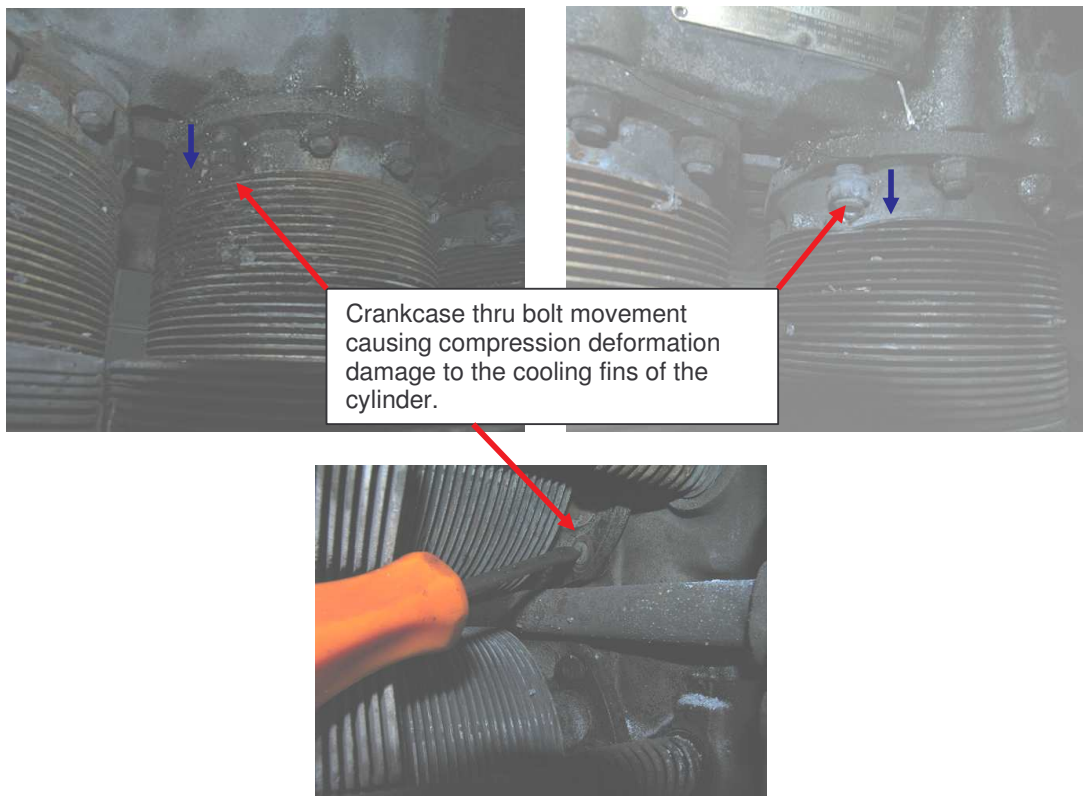
- (vi) During the on-site investigation and later in the engine teardown examination, it was established that some of the engine crankcase thru bolts nuts had failed. The result was that the thru bolts had pulled to the opposite side of the crankcase.

- (vii) The situation was brought to the attention of the engine manufacturer, with the objective of obtaining some clarity as to the cause of the thru bolts nut failures. The engine manufacturer was of the opinion that the nuts may have failed as a result of the heat of the fire. However, in an Airworthiness Bulletin (AWB 85-011) cases of engine thru-bolts and cylinder tie down nuts failures, following installation on engines, are quoted.

- (viii) These failures typically happened after an overhaul, but could also occur in new engines received from the manufacturer. According to the AWB, in-flight failure of such items of hardware may well result in engine failure and a serious accident. In most cases, such a failure can be attributed to improper heat treatment during manufacture or following local re-plating processes.

Fig 9 Pulled crankcase thru bolt.

- 2.11 Indications were that on the right-hand engine some of the engine crankcase thru-bolts nuts had failed, with the result that the thru-bolts, on the one side of the crankcase where the nuts had failed, had pulled to the opposite side of the crankcase. The opinion of the engine manufacturer is that the thru-bolt nuts may have failed as a result of the heat exposure from the post-impact fire. However, it is a known fact that engine thru-bolts and cylinder tie down nuts had previously failed following installation on an engine and prompted the issuance of an AWB. These failures typically happened after an engine overhaul, but had also occurred on newly manufactured engines. According to the AWB, in-flight failure of such items of hardware may well result in engine failure and a serious accident. Failure of the nuts may therefore not have been the reason for the pilot to shut down the engine and feather the propeller.

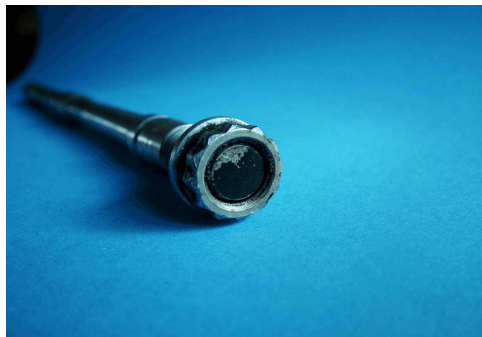
- (v) All eight crankcase thru bolts were still intact. During the disassembly it was found that several of the thru bolt nuts were not properly fastened or torqued and others were cracked open.

Photo showing positioning of nut on crankcase thru bolt during disassembly

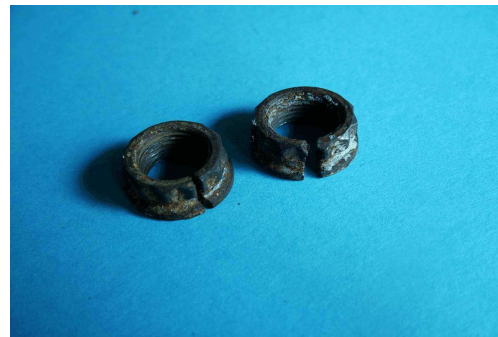
Photo showing cracked Crankcase thru bolt nuts.
