## AIRCRAFT ACCIDENT REPORT AND EXECUTIVE SUMMARY

Ref No.	CA18/2/3/8571	
<b>Aircraft Registration</b>	ZU-RAH	<b>Date of Accident</b>	27 October 2008		<b>Time of Accident</b>	1610Z
<b>Type of Aircraft</b>	Alouette II SNIAS SE3130	<b>Type of Operation</b>		Training		
<b>Pilot-in-command Licence Type</b>	Student (Helicopter)	<b>Age</b>	42		<b>Licence Valid</b>	Yes
<b>Pilot-in-command Flying Experience</b>	Total Flying Hours	25.0		Hours on Type	25.0	
<b>Last point of departure</b>	Brits Aerodrome (FABS)					
<b>Next point of intended landing</b>	Brits Aerodrome (FABS)					
<b>Location of the accident site with reference to easily defined geographical points (GPS readings if possible)</b>						
Helicopter landing area next to runway 20 at FABS						
<b>Meteorological Information</b>	Surface wind 270° at 10 kts, temperature 28 °C, CAVOK					
<b>Number of people on board</b>	1 + 0	<b>No. of people injured</b>	1 + 0		<b>No. of people killed</b>	0
<b>Synopsis</b>	<p>According to the instructor, the student pilot was busy with the third solo circuit training flight for the day when the accident occurred. The pilot approached the concrete block landing area next to runway 20 at Brits Aerodro

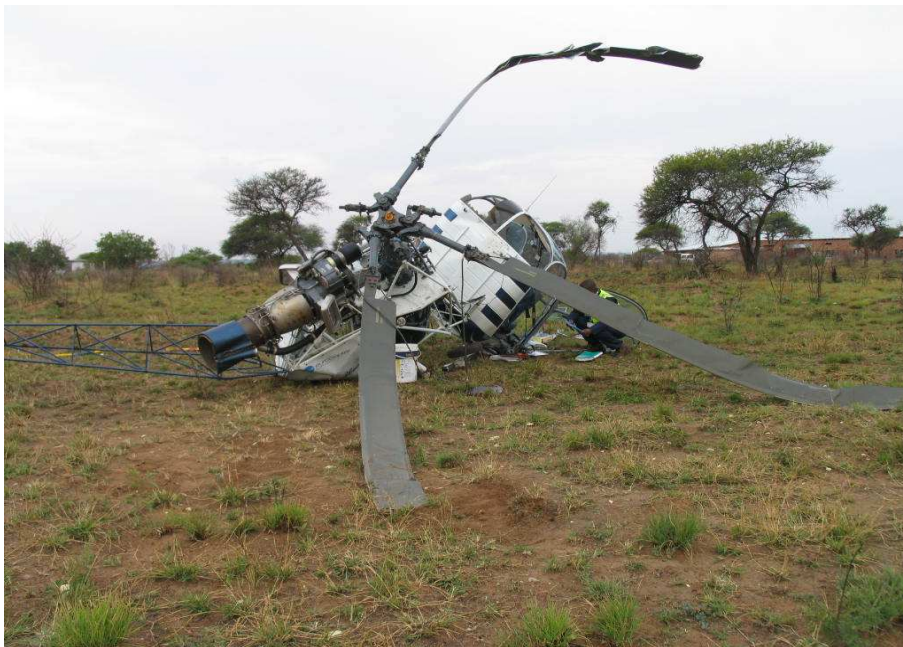
**Figure 1: The helicopter wreckage**

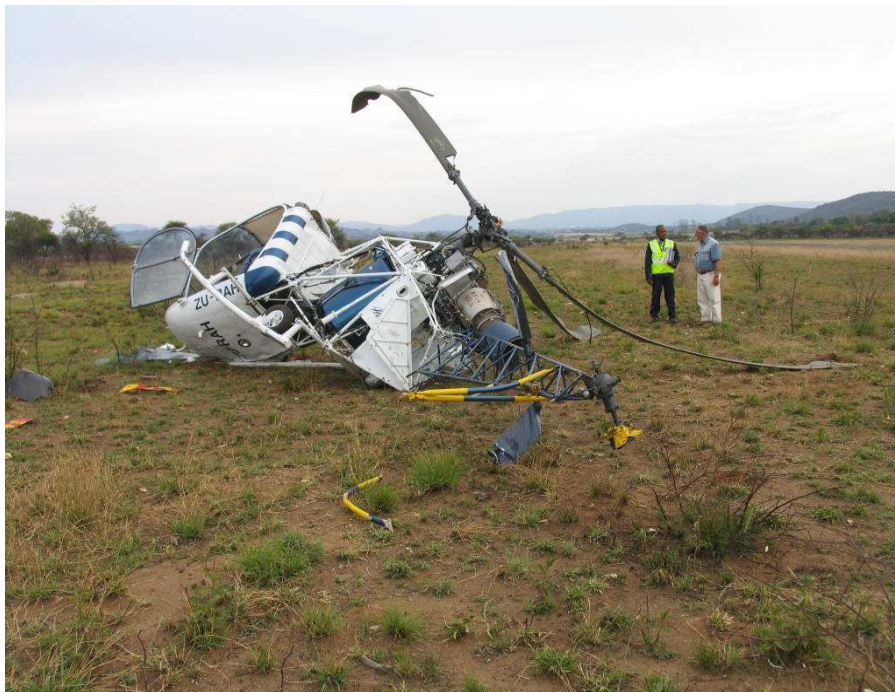
**Figure 2: The helicopter wreckage**

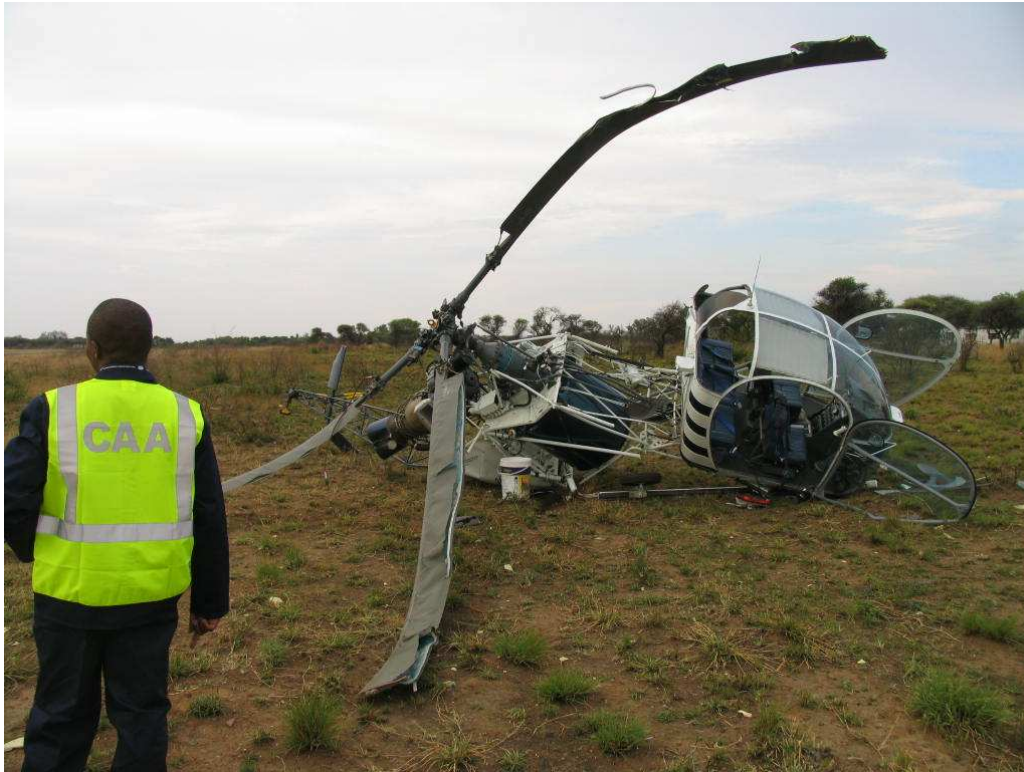
1.3.1 The helicopter fuselage, main rotor blades, tail rotor, landing skids and airframe were extensively damaged during the impact.

**Figure 3:** Damage sustained to main rotors and fuselage structure

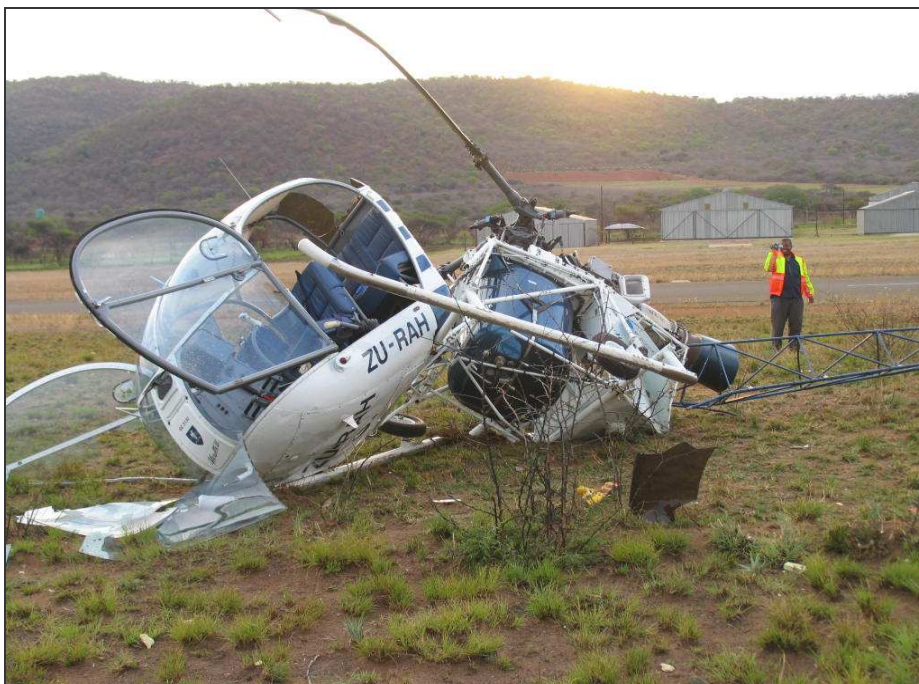
**Figure 4:** View of the wreckage with the runway and hangars in the background

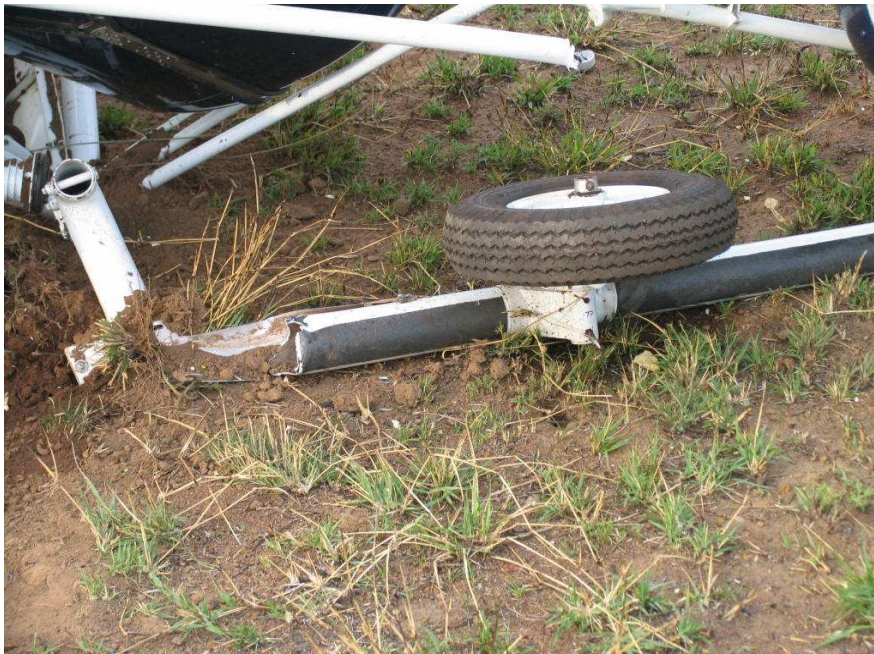
1.12.1 The helicopter started spinning excessively to the left at the concrete block parking bay near the windsock. The student pilot attempted to correct the situation with the cyclic control, causing the helicopter to move forward and then downwards to eventually land hard on the right hand skid, causing the main rotor blades to impact the tail rotor boom. The helicopter then rolled over onto the right-hand side.

**Figure 5:** The helicopter skid damaged on impact
