## AIRCRAFT ACCIDENT REPORT AND EXECUTIVE SUMMARY

Reference:	CA/18/2/3/8591	
<b>Aircraft Registration</b>	ZS-RRG	<b>Date of Accident</b>	04 December 2008		<b>Time of Accident</b>	1530Z
<b>Type of Aircraft</b>	Robinson R22 Beta II		<b>Type of Operation</b>	Private		
<b>Pilot-in-command Licence Type</b>	Private		<b>Age</b>	34	<b>Licence Valid</b>	Yes
<b>Pilot-in-command Flying Experience</b>	Total Flying Hours	101.4		<b>Hours on Type</b>	23.6	
<b>Last point of departure</b>	Tempe aerodrome, Free State Province (FATP)					
<b>Next point of intended landing</b>	Tempe aerodrome, Free State Province (FATP)					
<b>Location of the accident site with reference to easily defined geographical points (GPS readings if possible)</b>						
In an open area on a farm, 20 nm north of Bloemfontein, elevation 4 693 ft (GPS co-ordinates: S 29°22.783' E 026°12.558')						
<b>Meteorological Information</b>	Visibility good, scattered clouds, temperature 31 °C, wind 10 knots.

**Name of Owner/Operator** : Westline Aviation CC  
**Manufacturer** : Robinson Helicopter Company  
**Model** : R22 Beta II  
**Nationality** : South African  
**Registration Marks** : ZS-RRG  
**Place** : In an open area on a far

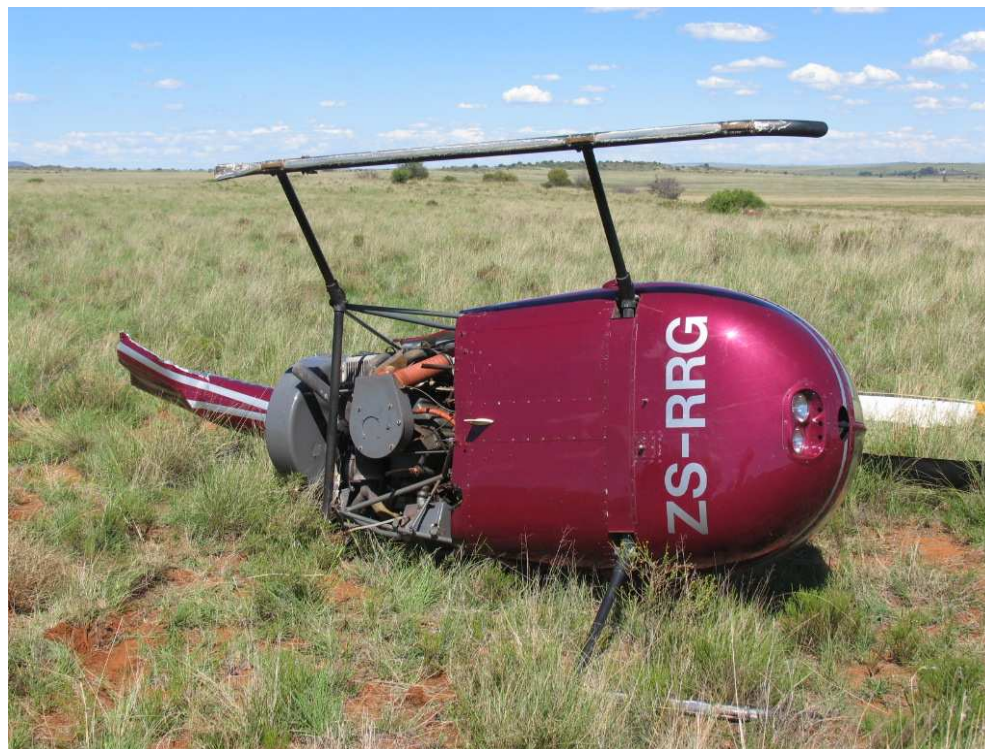
- 1.3.1 The helicopter was extensively damaged.

Figure 1: View of the wreckage after impact.

- 1.12.1 The helicopter impacted the ground with the left-hand skid first causing it to break off. The main rotor blades impacted the tail boom causing the tail rotor section to separate from the tail boom. The main rotor head and the main rotor gearbox were also damaged during the accident sequence.
