AIRCRAFT ACCIDENT REPORT AND EXECUTIVE SUMMARY

Ref No.	CA18/2/3/8596	
Aircraft Registration	ZS-RNU	Date of Accident	17 December 2008		Time of Accident	1600Z	
Type of Aircraft	Robinson R22 Helicopter		Type of Operation		Private		
Pilot-in-command Licence Type		Private (Helicopter)	Age	38	Licence Valid	Yes	
Pilot-in-command Flying Experience		Total Flying Hours	63.3		Hours on Type	63.3	
Last point of departure		Junctionspruit farm, Free State					
Next point of intended landing		Killarney farm, Free State					
Location of the accident site with reference to easily defined geographical points (GPS readings if possible)							
Killarney farm, 20 nm south of Winburg (GPS position: S28°44' 34.42" E027°00' 34.00")							
Meteorological Information		Surface wind: Calm; Temperature: 30°C; Visibility: CAVOK					
Number of people on board	1 + 1	No. of people injured	0		No. of people killed	0	
Synopsis							
<p>The pilot, accompanied by a passenger, took off from Junctionspruit farm on a local private flight. He had 10 US gallons of fuel on board and intended returning to the farm.</p> <p>After flying for about 50 minutes, he experienced a slight loss of altitude whilst flying at around 5 00

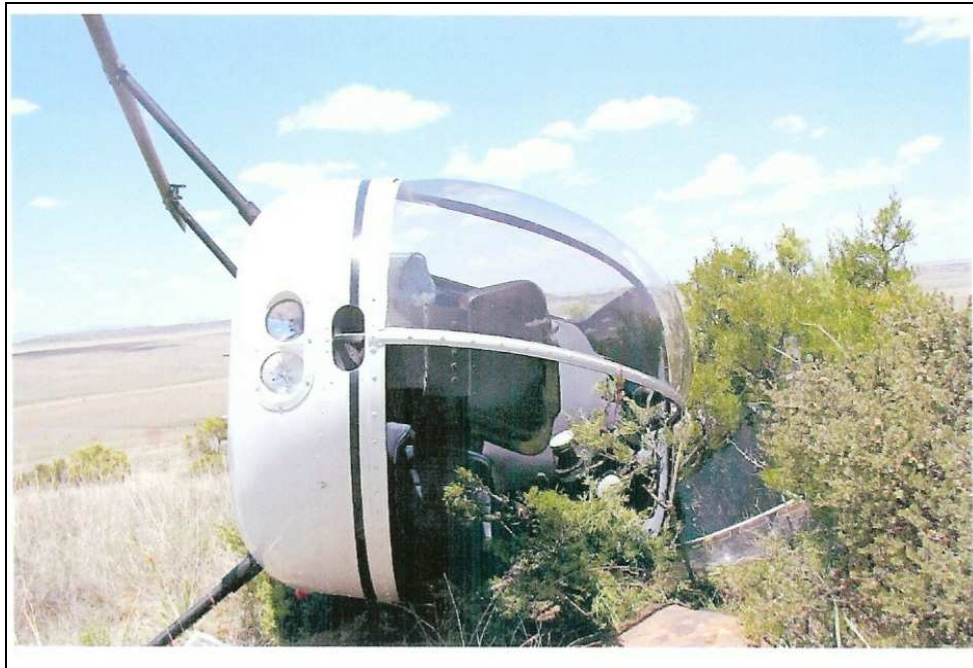
- 1.1.3 On touchdown, however, the right skid landed on a rock, causing the aircraft to bounce and roll over onto its left side. The pilot immediately shut down the engine and he and the passenger exited without any injuries.

Figure 1. The helicopter after rolling over onto its left side.

1.12.1 The pilot was flying from the east to the south-west over the farm when he experienced visual and aural warnings of low RPM. During the landing that followed, the right skid touched down onto a rock, causing the helicopter to bounce back into the air and roll over onto its left side. The main rotor blades, hub and tail rotor blades were substantially damaged, and the left skid failed on impact.

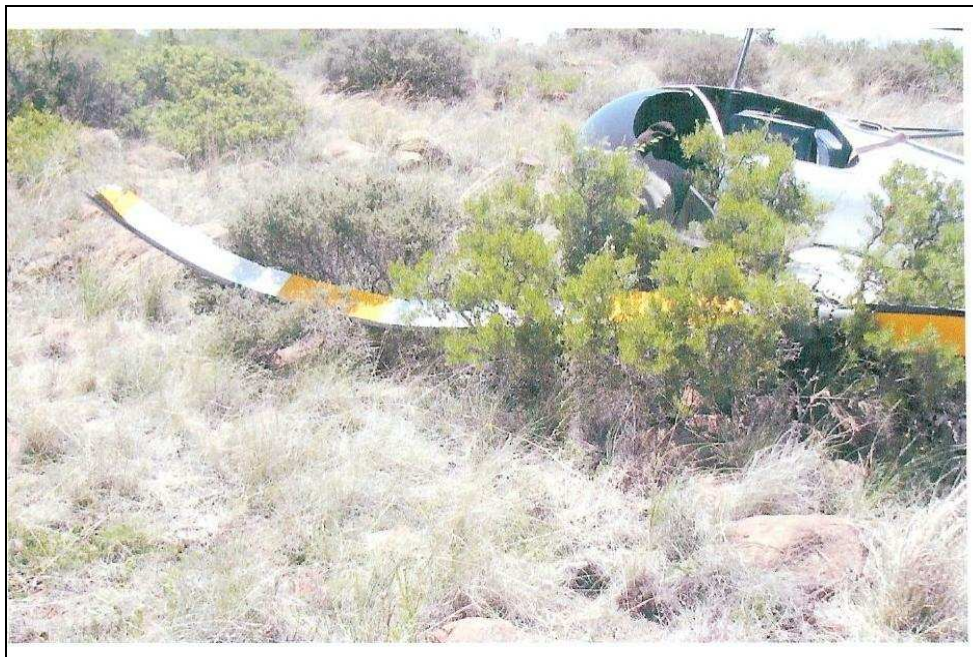
Figure 2. Damage to the main rotor.

1.3.1 The main rotor blades, hub, tail rotor blades and fuselage were substantially damaged, and the right skid was fractured
