Statens haverikommission
Swedish Accident Investigation Board

Finalreport RL 2011:14

**Aircraft accident to helicopter SE-JKF
at Stockholm/Arlanda airport,
Uppsala county, Sweden on 9 January 2009**

Case L-01/09
2011-10-21

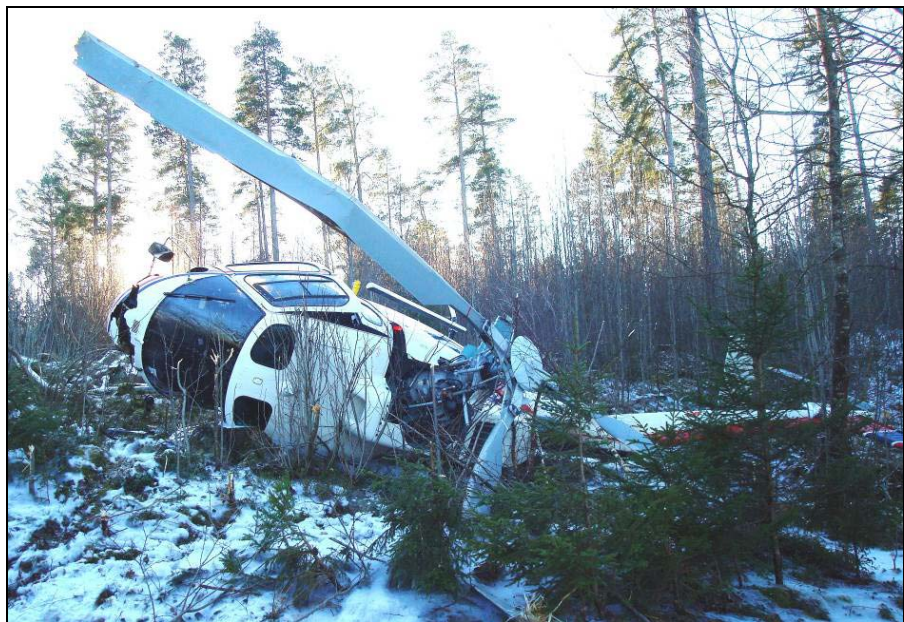
On impact with the ground the right landing gear broke. The helicopter finally rolled over to the left, whereupon the rotor blades slashed the adjacent trees and ground. The main rotor blades bent and the transmission partly detached from its mountings. The helicopter structure and tail boom suffered substantial damage. The tail rotor blades were not damaged.

Figure 3. The helicopter wreckage as seen from the dirt road (from the north).

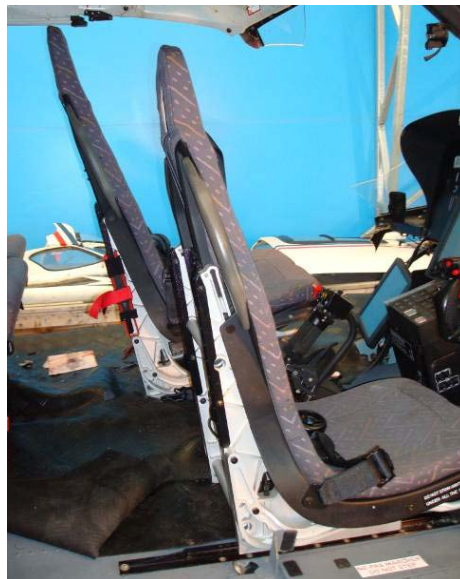
After the accident the pilot's cabin was relatively intact. The helicopter was equipped with energy-absorbing pilot's seats, of Sicma Aero Seat 159-Series type, fitted with four-point seat belts. Damage to the right hand pilot's seat (the one used by the pilot) showed that the vertical forces on impact were so great that the seat's stressed components broke, whereupon the seat was deformed and compressed during energy absorption. See the illustrations below.

Figure 4. Compressed pilot's seat (right)

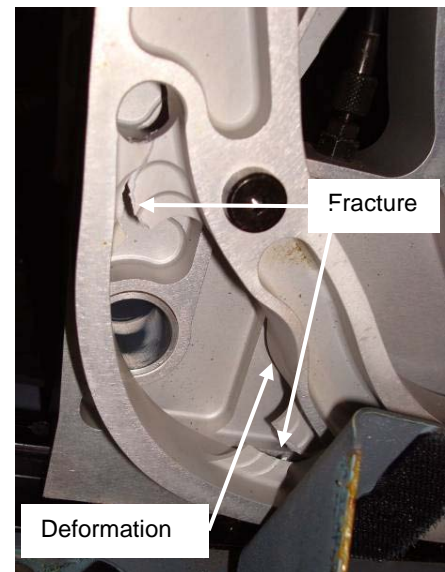
Figure 5. Fractures and deformation

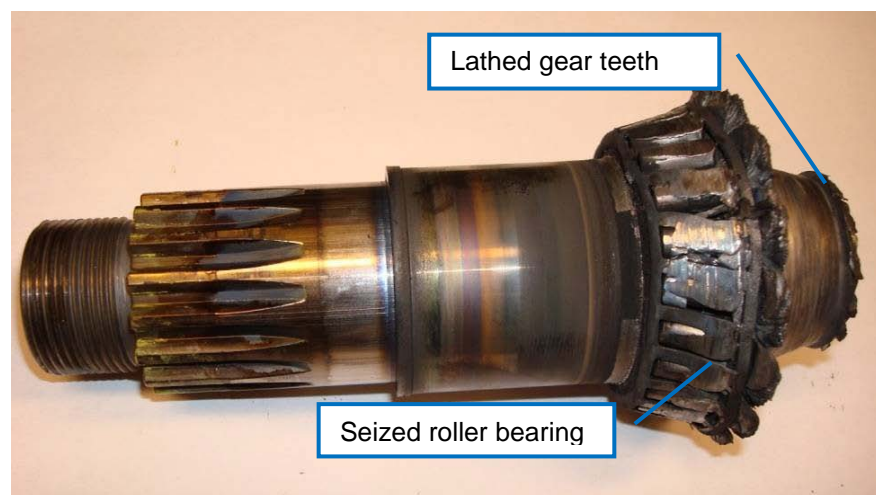
The tail rotor gearbox and tail rotor were detached from the helicopter and inspected by an authorised helicopter workshop. On dismantling the gearbox it was found that there was virtually no oil in it, but there was a large amount of metal chips. The gear teeth on the input drive shaft gear (the smaller) were completely “lathed off” and the adjacent roller bearing had seized. The gear teeth on the output drive gear (the larger) were severely damaged. (See picture below.)

Figure 6. Input drive shaft

The technical examination showed that the tail rotor gearbox had been operating during the entire flight almost without any oil. Just before landing, the gearbox broke due to overheating and the tail rotor successively ceased to rotate. The pilot thereupon was affected by a TRDF, which according to Sec. 1. 18.1 is regarded as the most serious tail rotor failure from a flight safety viewpoint.

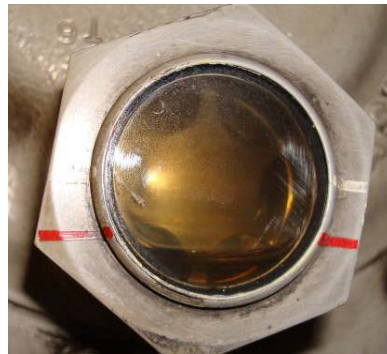
The illustrations below show the sight glass with the helicopter standing on a flat surface after the room temperature oil in the gearbox, due to gravity, has drained out through the hole for the chip warning sensor. The oil that can still be seen in the sight glass is residual oil that is stuck, due to capillary action, on the inside of the sight glass.

Figure 12. Seen at an angle from the front.

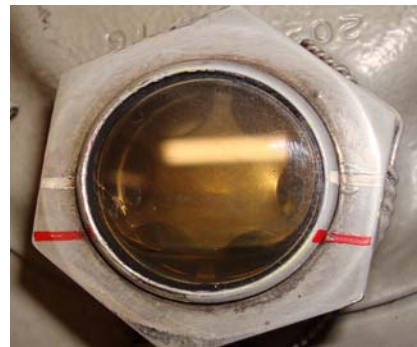
Figure 13. Seen directly from the front.
