AIRCRAFT ACCIDENT REPORT AND EXECUTIVE SUMMARY

Reference:	CA18/2/3/8605	
Aircraft Registration	A2-AHF	Date of Accident	17 January 2009	Time of Accident	1300Z	
Type of Aircraft	Beech Baron 58 (Aeroplane)		Type of Operation	Private		
Pilot-in-command Licence Type		Commercial	Age	35	Licence Valid	Yes
Pilot-in-command Flying Experience		Total Flying Hours	1 670.7		Hours on Type	65.5
Last point of departure		Private aerodrome north of Thabazimbi, Limpopo Province				
Next point of intended landing		Wonderboom Aerodrome (FAWB), Gauteng Province				
Location of the accident site with reference to easily defined geographical points (GPS readings if possible)						
South-west of Thabazimbi (GPS co-ordinates: S 24°20.361' E 027°05.335')						
Meteorological Information		Visibility good, clouds nil, temperature 28°C, wind nil				
Number of people on board	1 + 5	No. of people injured	0	No. of people killed	0	
Synopsis						
<p>On 17 January 2009, the SACAA was informed of an accident that occurred in Thabazimbi. It was found that the aircraft was registered in Botswana Civil Aviation Authority. The SACAA commenced with the onsite investigation. The Botswana Civil Aviation Authority was invite

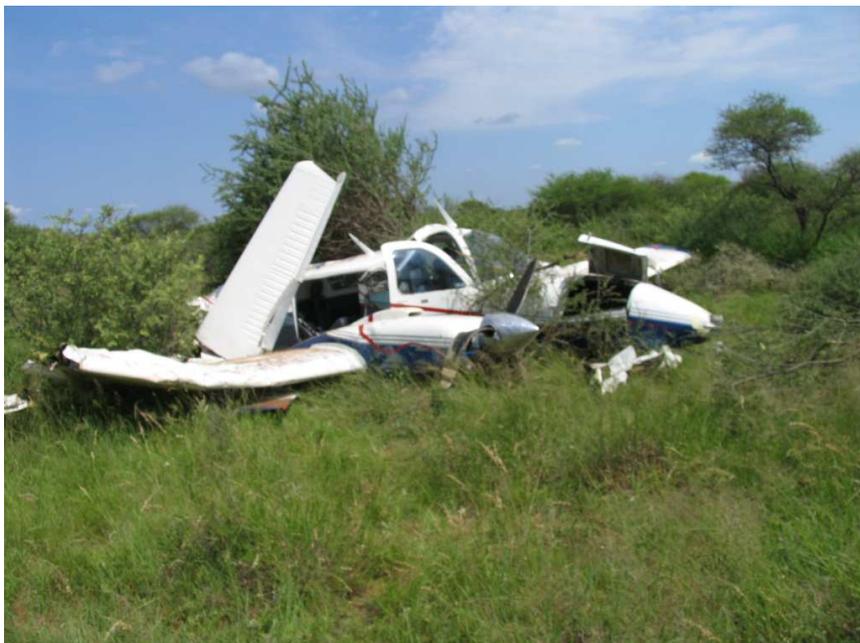
1.3.1 The aircraft was destroyed.

Figure 1: The aircraft wreckage in a bush

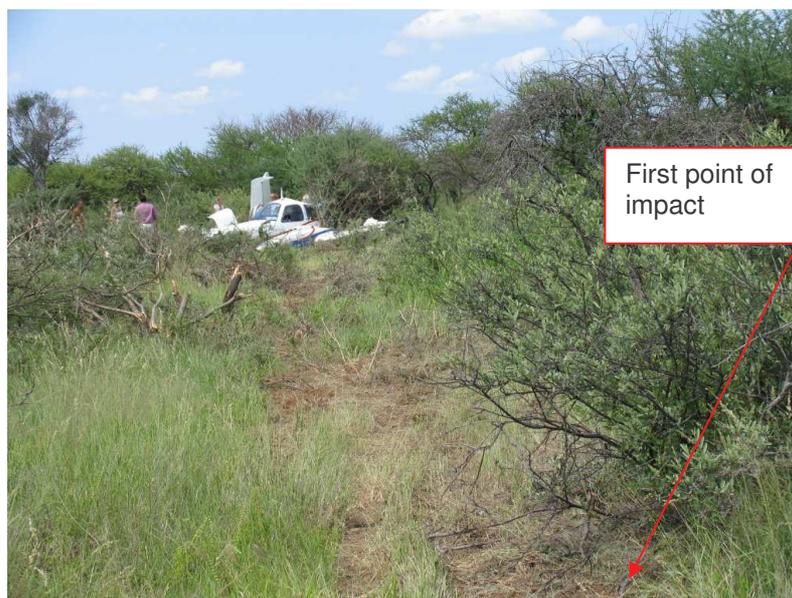
1.12.1 The aircraft collided with the trees after impact. Pre-impact flight controls integrity was established at the site.

1.12.2 The engine number 1 propeller showed signs of the engine operating at full power settings at the time of impact, namely major rearward bending and significant impact damage on all three blades. The engine number 2 propeller was found in a feathered position at the accident site. The aircraft impacted the ground with the undercarriage retracted.

1.12.3 There was evidence of damage on the flight controls. Tree impact marks were evident on both wings and the aircraft belly. The fuselage aft of the pilot's seat remained relatively intact. The tail section of the fuselage was destroyed. The instrument panel was intact and offered useful information about the pre-impact indications.

Figure 2: The first point of impact and final position of the main wreckage

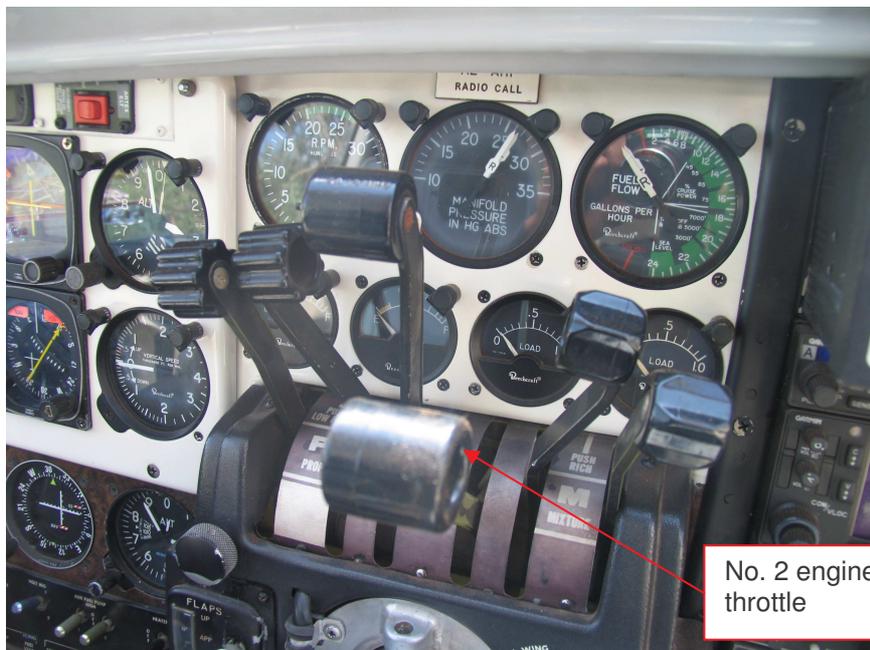
1.16.2 Figure 3 below shows engine number two throttle in the OFF position, indicating that number two engine was not running prior the accident.

Figure 3: The number 2 engine throttle pulled backward/in the off position at the accident site

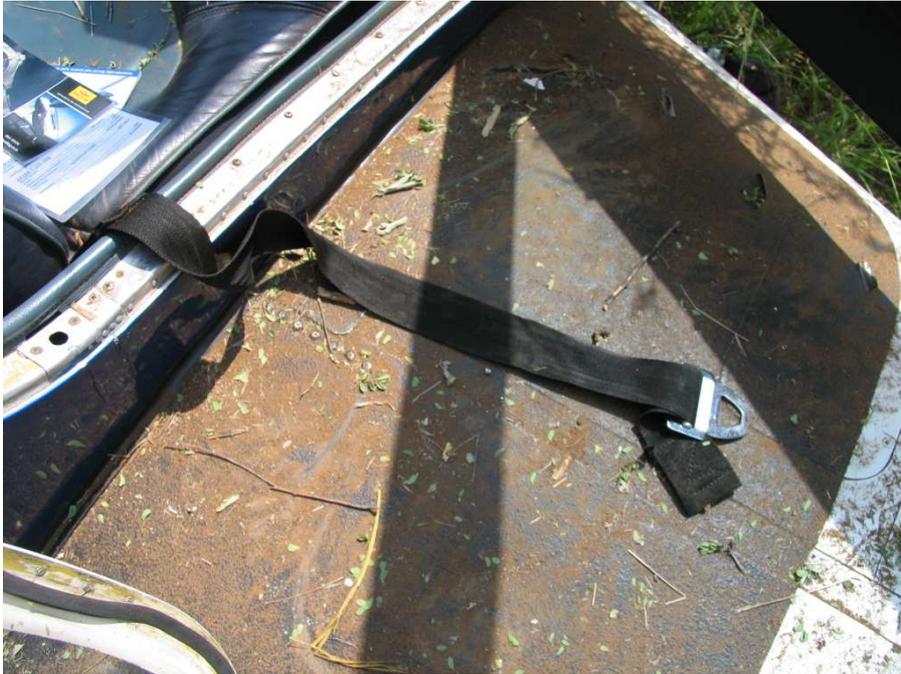
1.16.2.1 1.16.3 During the inspection of the co-pilot seatbelt (safety harness) (Figure

4) no anomalies or defects could be found with respect to its functionality.

Figure 4: View of the co-pilot safety belt
