AIRCRAFT ACCIDENT REPORT AND EXECUTIVE SUMMARY

Reference:	CA18/3/2/8610	
Aircraft Registration	ZS-CPC	Date of Accident	22 January 2009		Time of Accident	1500Z
Type of Aircraft	Extra 300 L		Type of Operation		Private Flight	
Pilot-in-command Licence Type		Airline Pilot	Age	46	License Valid	Yes
Pilot-in-command Flying Experience		Total Flying Hours	25 000.00		Hours on Type	254.3
Last point of departure		Kitty Hawk Aerodrome (Boschkop)Gauteng Province				
Next point of intended landing		Kitty Hawk Aerodrome (Boschkop)Gauteng Province				
Location of the accident site with reference to easily defined geographical points (GPS readings if possible)						
Gravel road next to Kitty Hawk GPS co-ordinates: S25°52.190E028°26.380 Elevation 4586' AMSL						
Meteorological Information		Temperature:23°C Visibility: 10 km, Surface wind 360°/5 kt.				
Number of people on board	1 + 1	No. of people injured	0	No. of people killed	0	
Synopsis						
<p>The pilot accompanied by a passenger was engaged on a private flight from Kitty Hawk aerodrome to the general flying area (GFA). The pilot stated that after a flight of approximately 10 minutes, he decided to return to Kitty Hawk. During the downwind leg

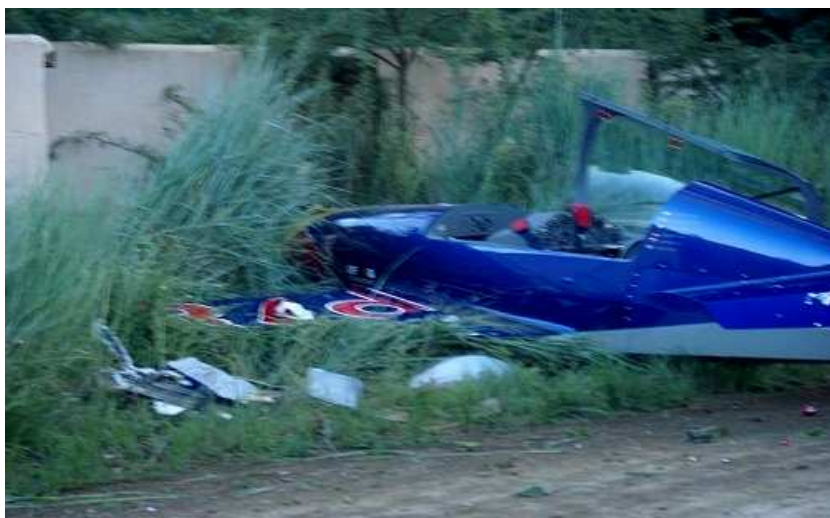
1.3 The aircraft was substantially damaged during the impact sequence.

FIGURE 1, SHOWS THE WRECKAGE IN VEGETATION AGAINST THE WALL

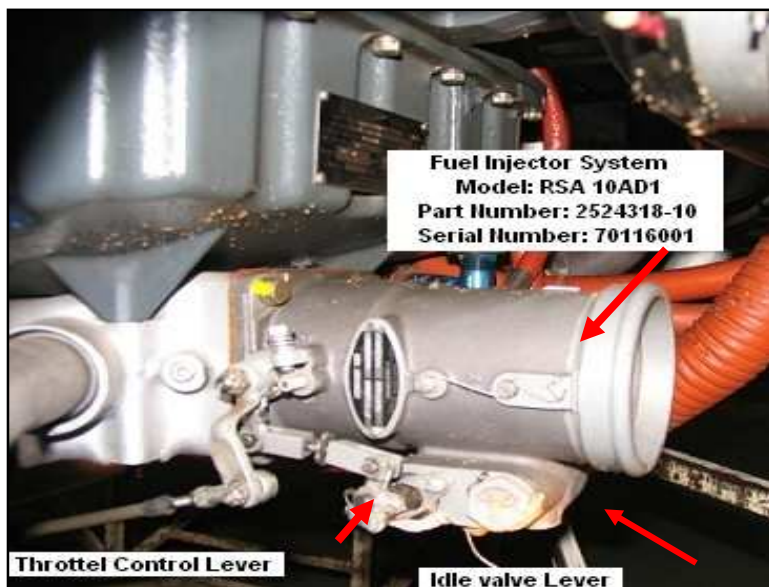
1.6.7 Engine Accessory Component Defect: During the engine examination, it was established that the engine was malfunctioning due to the Precision Air motive RS & RSA Fuel Metering System/Fuel Injector, Model: RSA – 10AD1, Part Number 2524318-10, serial number 70116001 spring steel rolled locking pin on the fuel injector had subsequently failed (fractured) during operation and prevented further throttle lever input of the fuel injection system.

FIGURE 2: SHOWS THE FUEL INJECTOR INSTALLED TO THE ENGINE

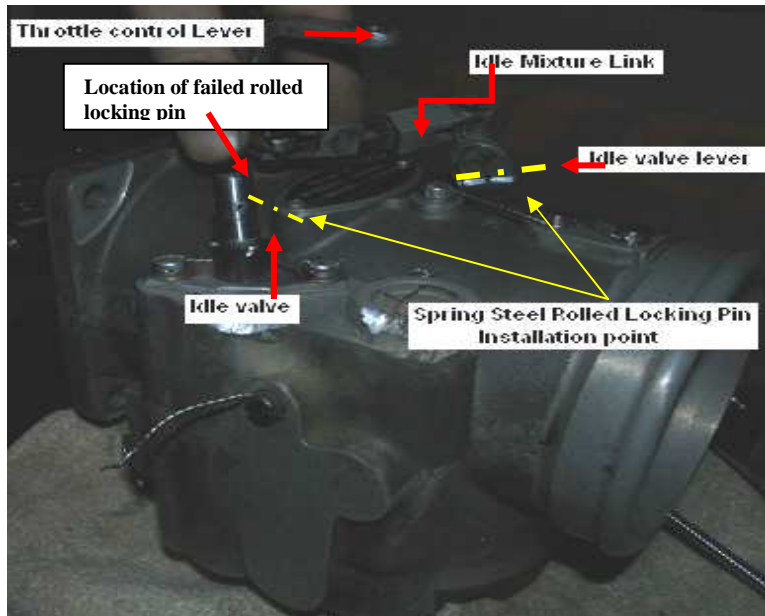
1.6.8 Component – Part Failure: During the Fuel Metering System/Fuel Injector System investigation, it was established that the spring steel rolled locking pin had failed/fractured during normal throttle operation.

Figure 3: shows location of spring steel rolled locking pin installation point on fuel injector

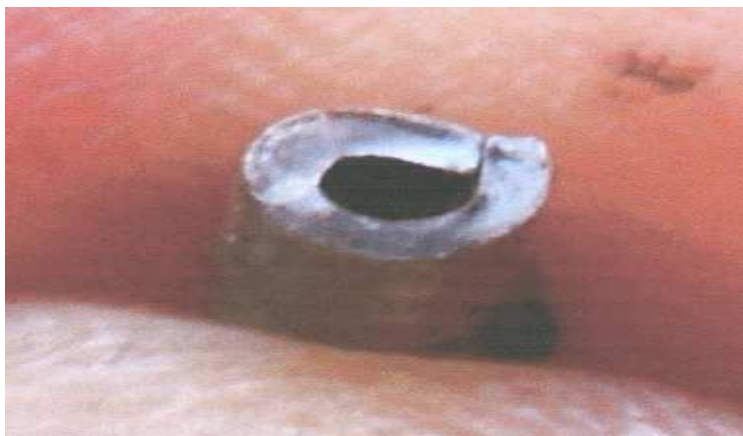
FIGURE 4: SHOWS THE SPRING STEEL ROLLED LOCKING PIN FAILURE

- (ii) The spring rolled pin (figure 4above) indicated that the spring rolled locking pin started to fracture for some time and eventually fractured when the pilot reduced the throttle setting prior to the accident.

1.16.3 Evidence showed that the spring steel roller pin fractured at the idle control lever attachment. The fractured pieces of spring steel roller pin was then removed from the idle control lever installation and visually inspected. According to the type of failure, the spring steel roller pin started to fracture during operation some time ago and finally fractured when the pilot reduced the setting on the throttle lever. The evidence found indicated the following:

- (i) The spring steel roller pin was installed before to the clamping securing screw was tightened.
- (ii) The tightening of the clamp screw caused that the idle control lever hole to exert pressure on the roller pin which eventually resulted in it being deformed.
- (iii) Due to the stress pressure exerted on the roller pin it developed hair thin cracks and after some time it eventually failed.

- 2.6 Pieces of spring steel roller pin were removed from the idle control lever and control shaft for examination. It was established that the spring steel roller pin was installed before the clamping screw was tightened. The investigator is of the opinion that the clamping was done to facilitate proper positioning of the roller pin in the hole of the control shaft. The tightening of the clamp screw caused the idle control lever hole to exert pressure on the roller pin which eventually resulted in it being deformed. Due to the noticeable stress pressure exerted on the roller pin it eventually developed hair thin cracks and started to fracture.

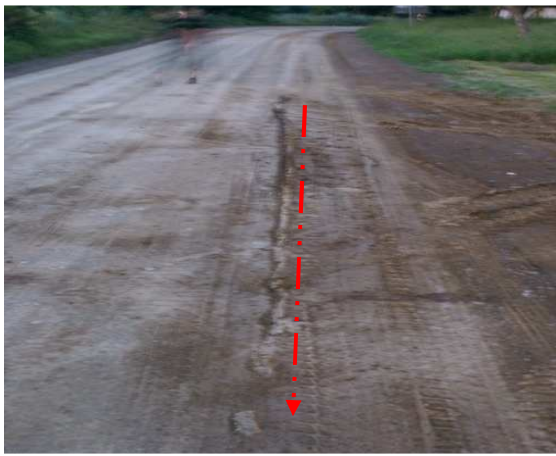
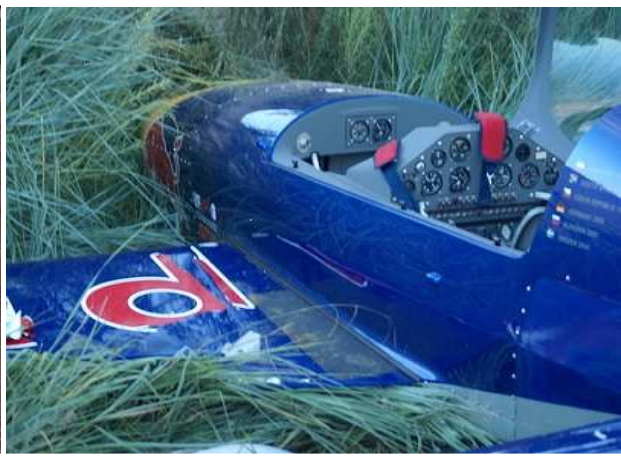
1.12.2 The aircraft landed heavily onto the gravel road during the forced landing causing the left main landing gear to separate from the aircraft during the impact sequence. The aircraft then skidded on the gravel road causing a ground scrape mark of approximately 30 metres on the gravel road. The aircraft subsequently veered the left and both wings impacted vegetation at the left side of the road. The aircraft eventually came to a rest approximately 100 to 150 metres down the road from where it touched down. The aircraft came to rest with its nose against a brick wall, facing 90 degrees with the road.

Figure 6 & 7, shows the ground scrape marks and wreckage facing at an angle of 90 degrees against the brick wall.

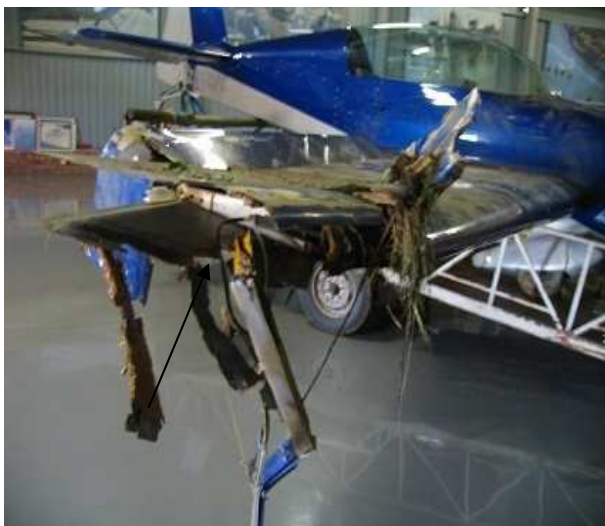
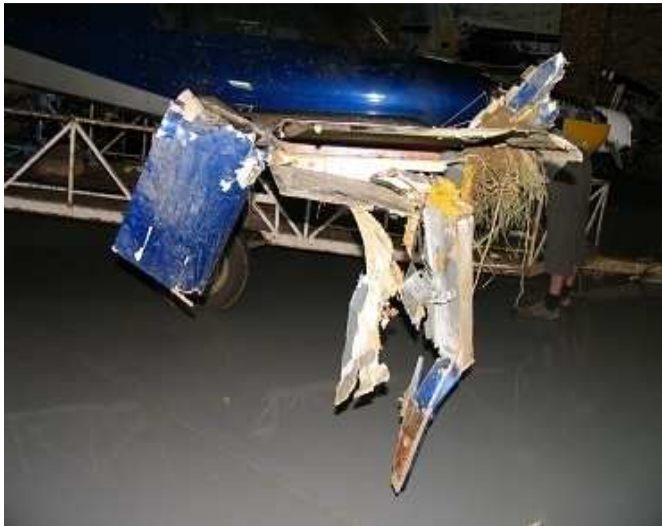
1.12.3 The aircraft sustained substantial ground impact damage in the accident. The notable damage caused to the undercarriage, wings and propeller.

Figure 8 & 9, shows extent of damage caused to the wings.

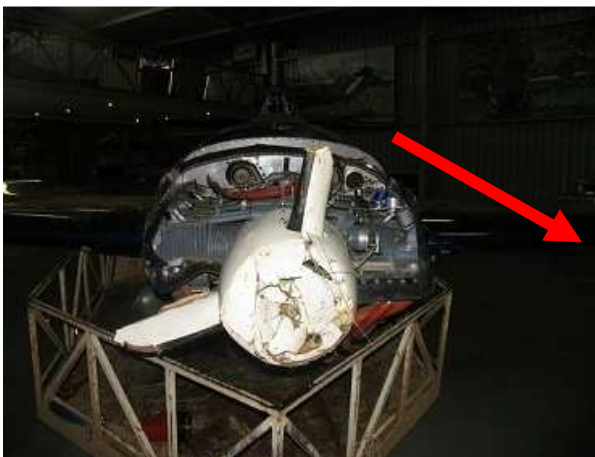
Figure 10, shows extend of damage caused to Propeller
