AIRCRAFT ACCIDENT REPORT AND EXECUTIVE SUMMARY

Reference:	CA18/2/3/8611	
Aircraft Registration	ZU-EHY	Date of Accident	07 February 2009		Time of Accident	0850Z	
Type of Aircraft	Cheetah Sport	NTCA Aeroplane	Type of Operation	Private			
Pilot-in-command Licence Type	Private Pilot		Age	51	Licence Valid	Yes	
Pilot-in-command Flying Experience	Total Flying Hours		1057.4		Hours on Type	57.2	
Last point of departure	Cirrus Private Aerodrome near Vereeniging, Gauteng.						
Next point of intended landing	Kololo Lodge 2 Private Aerodrome, Waterberg area near Vaalwater, Limpopo.						
Location of the accident site with reference to easily defined geographical points (GPS readings if possible)							
On grass runway at Kololo Lodge 2, Waterberg area near Vaalwater, Limpopo Province.							
Meteorological Information	Surface Wind: Easterly/Light ; Temperature 26°C; Visibility: CAVOK						
Number of people on board	1 + 1	No. of people injured	0	No. of people killed	0

Name of Owner/Operator : Waterston K.A.
Manufacturer : Rainbow Aircraft (Pty) Ltd.
Model : Cheetah
Nationality : South African
Registration Marks : ZU-EHY
Place : Kololo Lodge Aerodrome
Date : 07 February 2009
Time : 0850Z

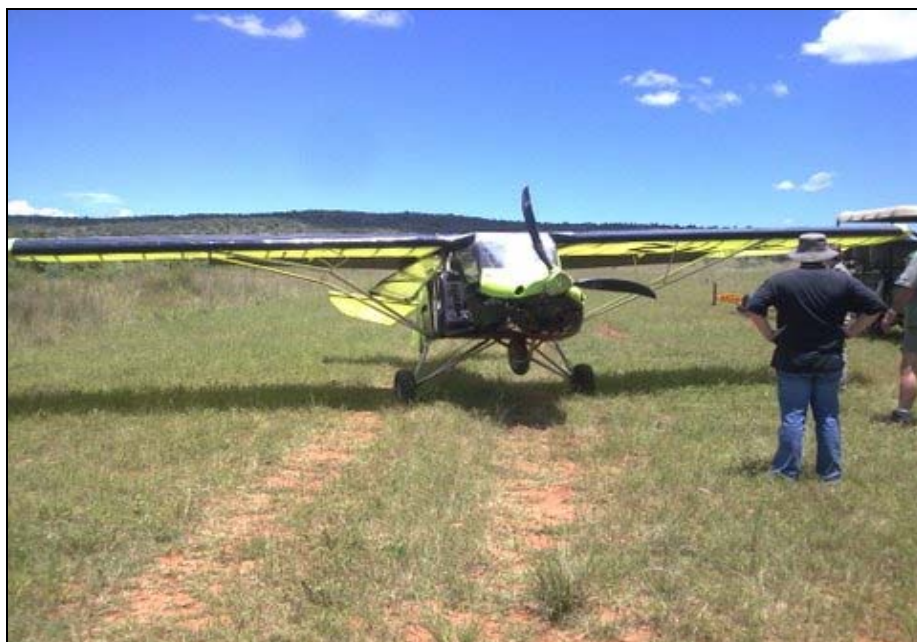
1.3.1 The aircraft sustained damage to the nose gear, right-hand wing struts, cockpit area and propeller blades during the impact sequence.

PHOTO 1: SHOWING AFTER THE AIRCRAFT WAS POSITIONED BACK ONTO ITS WHEELS.

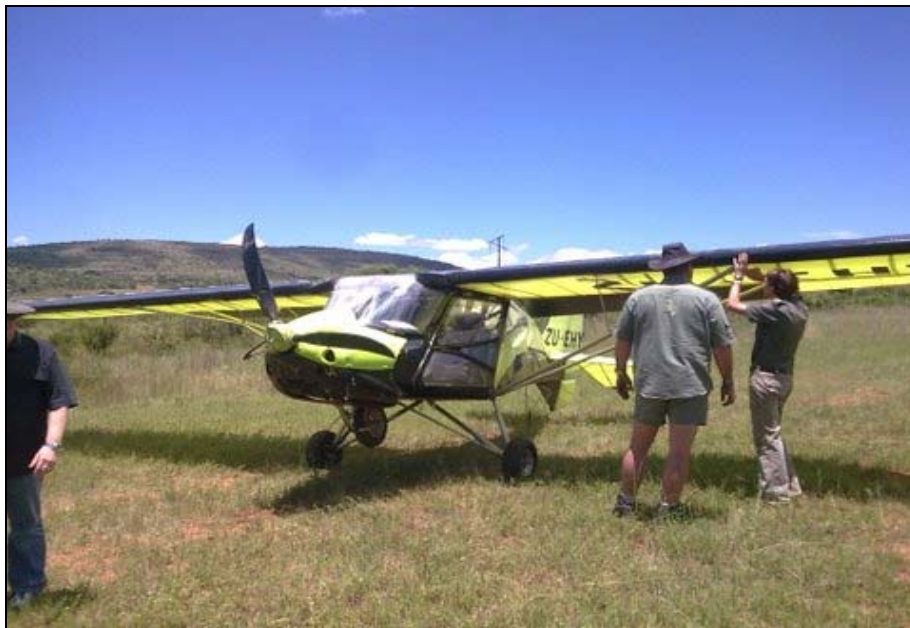
1.12.1 Upon landing on the grass Runway 03 with a down slope, the aircraft bounced twice. The nose wheel broke off after the second bounce and the aircraft nosed over.

PHOTO 2: SHOWS AIRCRAFT POSITIONED BACK ONTO ITS MAIN WHEELS, PROPELLER BLADES BENT, RIGHT WING STRUT BENT & NOSE WHEEL DAMAGED.

- 3 The pilot made an error of judgement during landing on the down slope of the runway by allowing the aircraft to land first on the nose landing gear. The aircraft then bounced twice during landing, resulting in the separation of the nose wheel and the aircraft then nosed over.
