AIRCRAFT ACCIDENT REPORT AND EXECUTIVE SUMMARY

Reference:	CA18/2/3/8645	
Aircraft Registration	ZS-RDB	Date of Accident	03 May 2009		Time of Accident	0830Z
Type of Aircraft	Robinson R22 Beta II		Type of Operation	Private		
Pilot-in-command Licence Type	Commercial		Age	38	Licence Valid	Yes
Pilot-in-command Flying Experience	Total Flying Hours	8084.2		Hours on Type	388	
Last point of departure	Kwandwe game reserve in the Eastern Cape area.					
Next point of intended landing	Kariega game reserve near Kenton-on Sea in the Eastern Cape area.					
Location of the accident site with reference to easily defined geographical points (GPS readings if possible)						
Kariega game reserve GPS Position: S33°34.113' E02 6°34.985' Elevation 1005 AMSL.						
Meteorological Information	Surface Wind, 10 Knots: Temperature, 18°C: Visibility, 10km: Scattered Clouds.					
Number of people on board	1 + 0	No. of people injured	0	No. of people killed	1	
Synopsis:

AIRCRAFT ACCIDENT REPORT

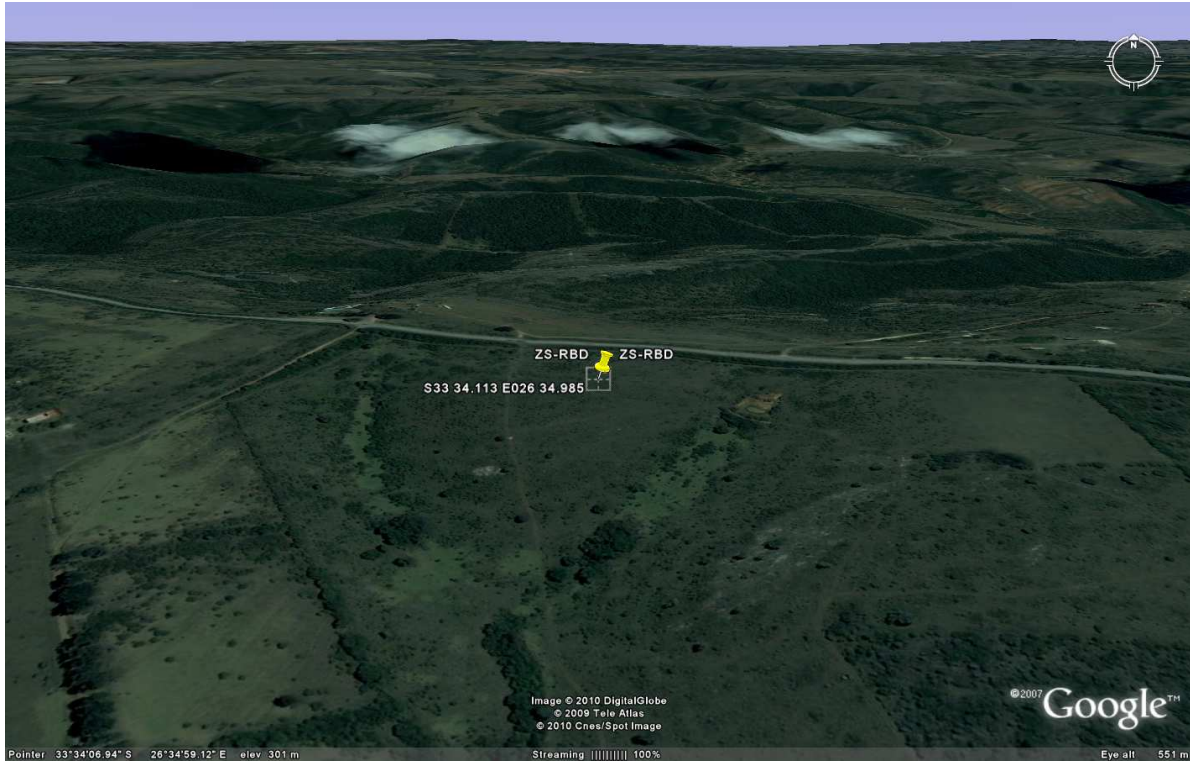
Figure 1: Terrain of the accident site.

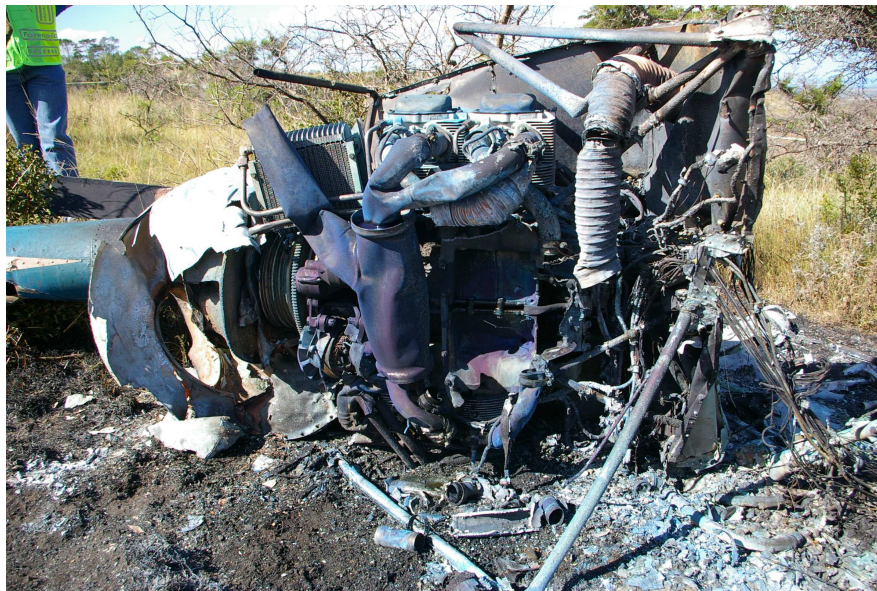
- 1.3.1 The helicopter was destroyed during the impact sequence and by post-impact fire.

Figure 2: A view of the main wreckage.

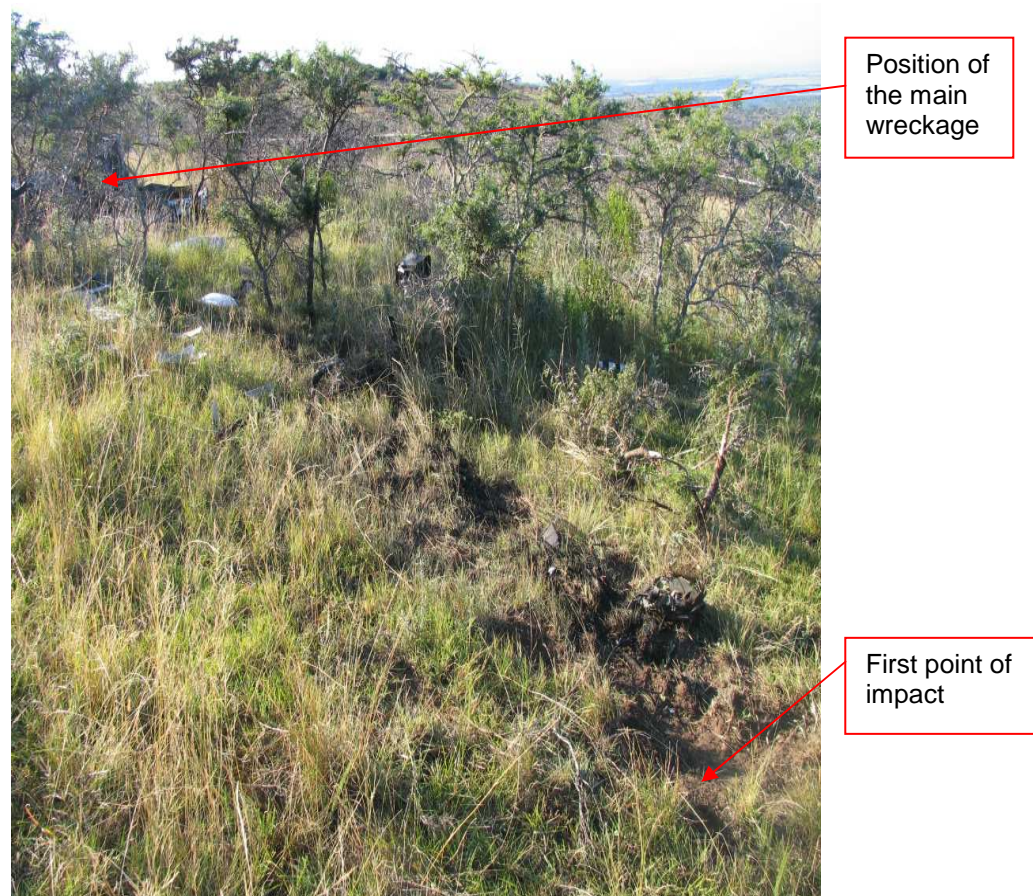
1.12.1 The accident occurred in a bush at Kariega game reserve. Components and structural pieces of the helicopter were scattered over an area of more than 16 metres in diameter, which was oriented on a southerly heading from the initial point of impact. The initial ground contact by the helicopter was shown by a ground scar caused by both skids. A few metres down the wreckage path from the initial point of impact were components from the skids. Other components from the cockpit/cabin area were situated on the right-hand side of the helicopter e.g. Perspex pieces from the shattered windscreen, the instrument panel and a headset.

1.12.2 The tail boom, including the tail rotor assembly, was still attached to the helicopter. The main wreckage was located at the last point of impact. The fuel tank ruptured and the helicopter caught fire. The fire also spread to the vegetation and to all other areas with fuel residue. The fuel tank was completely destroyed by the ground impact and post-impact fire.

Figure 3: First point of impact and final position of the main wreckage.

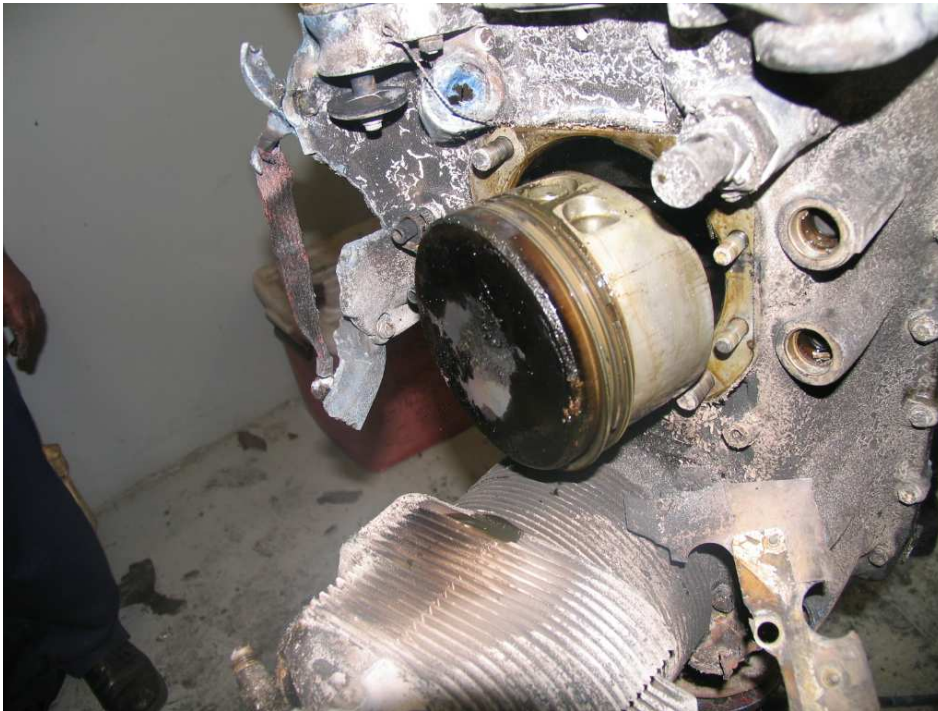
- i. The oil sump was missing from the engine or destroyed during the accident sequence.
- ii. All the piston cylinders were found to be heat-damaged and seized.

Figure 4: Heat damage caused to cylinders and pistons.

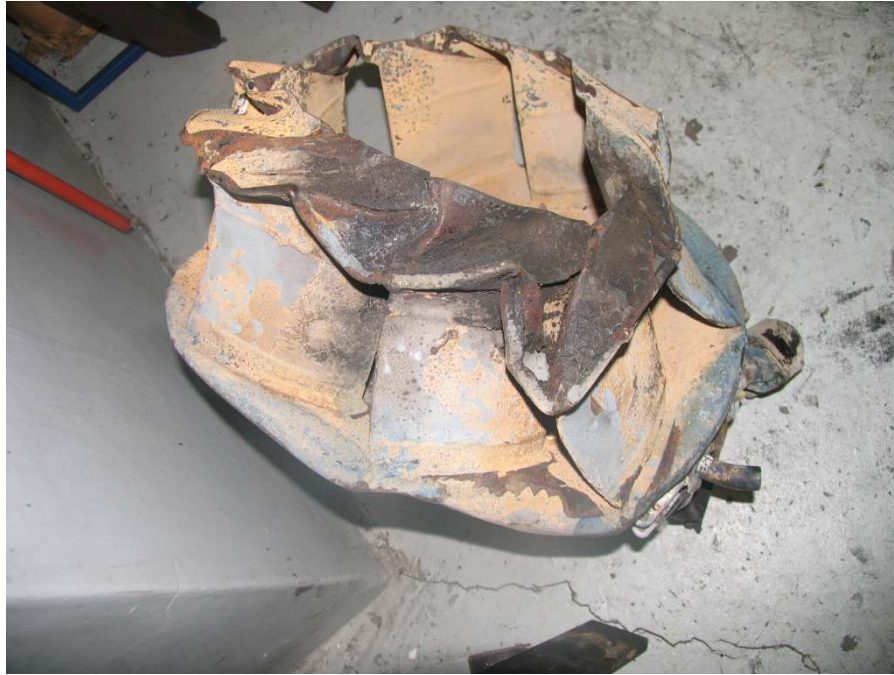
- vi. The investigation showed that the engine was running at a very high power setting. See the picture of a deformed cooling fan below.

Figure 5: View of a deformed cooling fan.
