AIRCRAFT ACCIDENT REPORT AND EXECUTIVE SUMMARY

Reference:	CA18/2/3/8653	
Aircraft Registration	ZS-RRO	Date of Accident	18 May 2009		Time of Accident	0600Z
Type of Aircraft	Robinson R22 Beta II		Type of Operation	Private		
Pilot-in-command Licence Type		Commercial Pilot(H)	Age	49	Licence Valid	Yes
Pilot-in-command Flying Experience		Total Flying Hours	2 818.2		Hours on Type	1 921.5
Last Point of Departure		Grootfontein Farm, Vaalwater, Limpopo Province				
Next Point of Intended Landing		Grootfontein Farm, Vaalwater, Limpopo Province				
Location of the Accident Site with Reference to Easily Defined Geographical Points (GPS readings if possible)						
Grootfontein Farm, Vaalwater; Limpopo Province (GPS co-ordinates: S24°03'781" E028° 16'840")						
Meteorological Information		Surface wind 200° at 5 kts, CAVOK, temperature 12°C , dew point 2°C				
Number of People on Board	1 + 1	No. of People Injured	0	No. of People Killed	0	
Synopsis						
<p>On 18 May 2009, the pilot flew from Polokwane to Thabazimbi and landed at Grootfontein Farm in Vaalwater to help with the darting of a buffalo. He then removed the helicopter doors and his personal baggage. After the pilot picked up the veteri

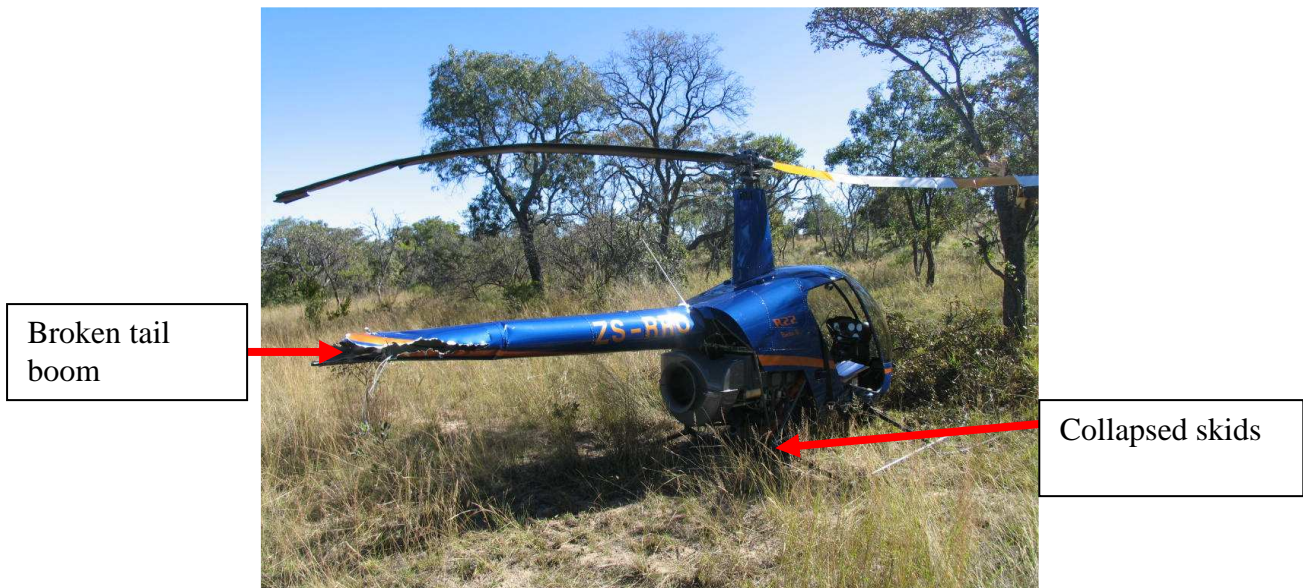
1.3.1 The helicopter sustained substantial damage to the tail boom and collapsed skids.

Figure 1: Damage to the tail boom and skids

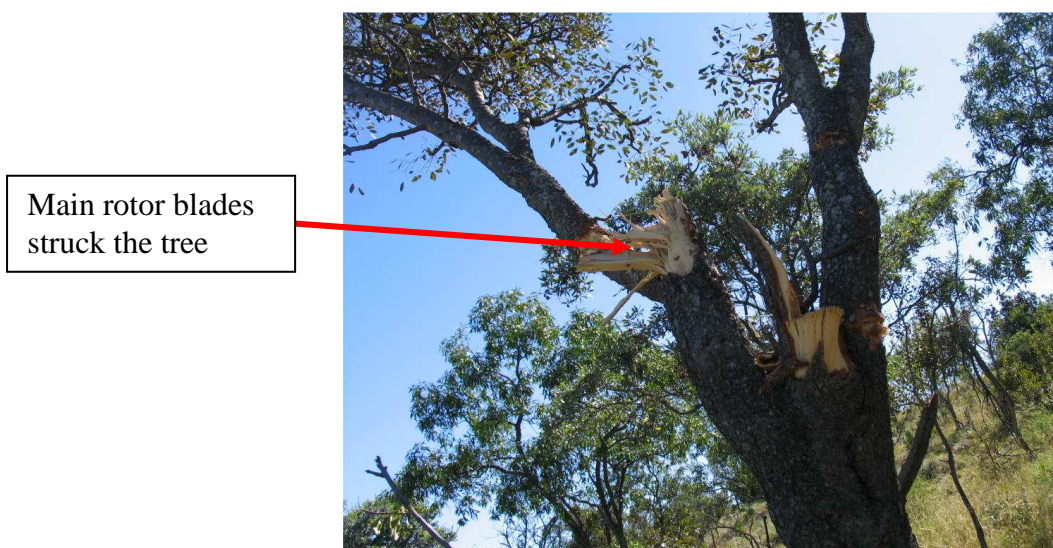
1.4.1 The helicopter main rotor blades struck a tree during impact.

Figure 2: Damage where the main rotor struck a tree

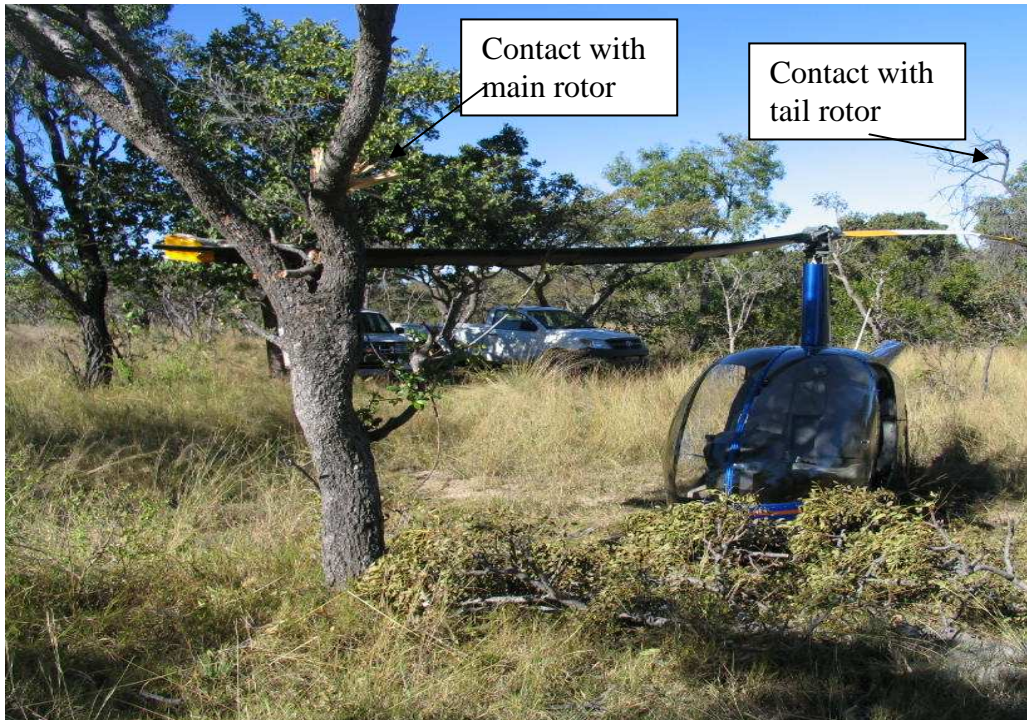
1.12.1 After the pilot experienced a power loss, the pilot initiated a forced landing; the helicopter was flying in a northerly direction. While the helicopter was descending, the tail rotor impacted a tree that was approximately 6 m high and the tail rotor was cut off from the helicopter. The main rotor then impacted a tree that was in front of the helicopter. The tail rotor assembly was found 10 m from the helicopter, and was still intact. The tail rotor, tail boom and main rotor were substantially damaged.

Figure 3: Damage to the aircraft
