AIRCRAFT ACCIDENT REPORT AND EXECUTIVE SUMMARY

Reference:	CA18/2/3/8657	
Aircraft Registration	ZS-RHC	Date of Accident	22 May 2009	Time of Accident	0833Z	
Type of Aircraft	Robinson R22 Beta		Type of Operation	Training		
Pilot-in-command Licence Type		Student	Age	42	Licence Valid	Yes
Pilot-in-command Flying Experience		Total Flying Hours	30,7		Hours on Type	5,7
Last point of departure		Grand Central Aerodrome (FAGC)				
Next point of intended landing		Grand Central Aerodrome (FAGC)				
Location of the accident site with reference to easily defined geographical points (GPS readings if possible)						
On grass next to taxiway "V" at FAGC						
Meteorological Information		Wind: 240/7kts, Temperature: 20C, Clouds: CAVOK				
Number of people on board	1 + 0	No. of people injured	1	No. of people killed	0	
Synopsis						
<p>The student pilot took off on an initial solo flight from Grand Central Aerodrome (FAGC). During the liftoff, he failed to compensate for weight and gravity shift and as a result the helicopter entered a dynamic rollover. Since it was very close to the ground, he was unable to recover from the situation.</p> <p>The student pilot suffered a broken collar bone and rib.</p

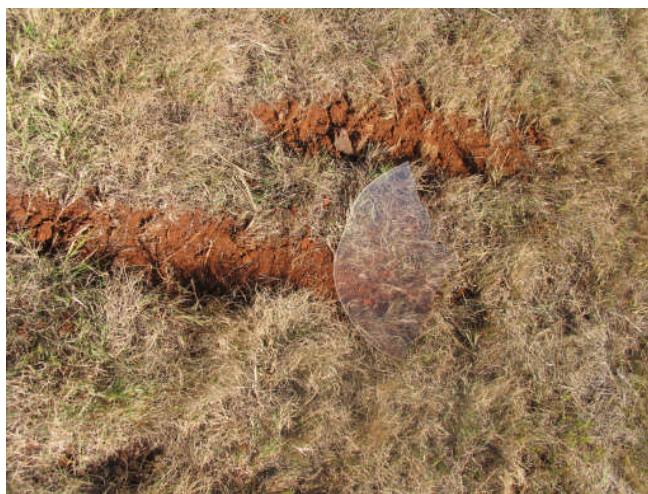
1.12.1 The main rotor struck the ground before the helicopter rolled over onto its right side.

Figure 2. The gouges made in the ground by the main rotor.

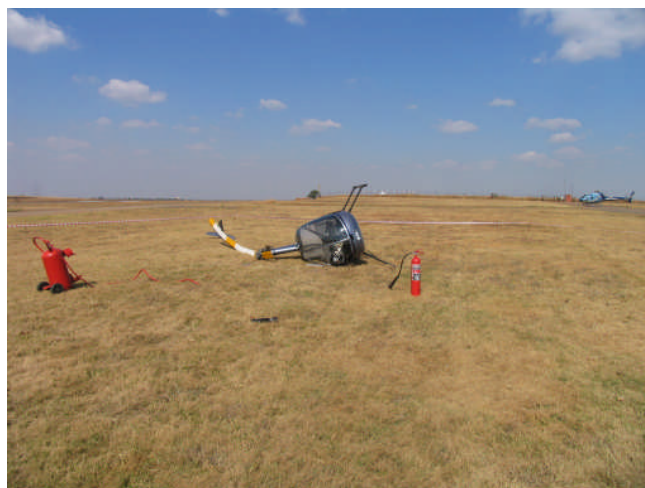
Figure 3. Front view of the damaged aircraft.

- 2.3 The helicopter sustained substantial damage to the main rotor blades and skids, and the windscreen was shattered. The aircraft was properly maintained and, according to available documentation, did not exhibit any defect or malfunction that could have contributed to or caused the accident.
