AIRCRAFT ACCIDENT REPORT AND EXECUTIVE SUMMARY

| | | | | Reference: | CA18/2/3/8664 | |
| Aircraft Registration | ZS-NIG | Date of Accident | 12/06/2009 | | Time of Accident | 0730Z |
| Type of Aircraft | American Champion | | Type of Operation | Private | | |

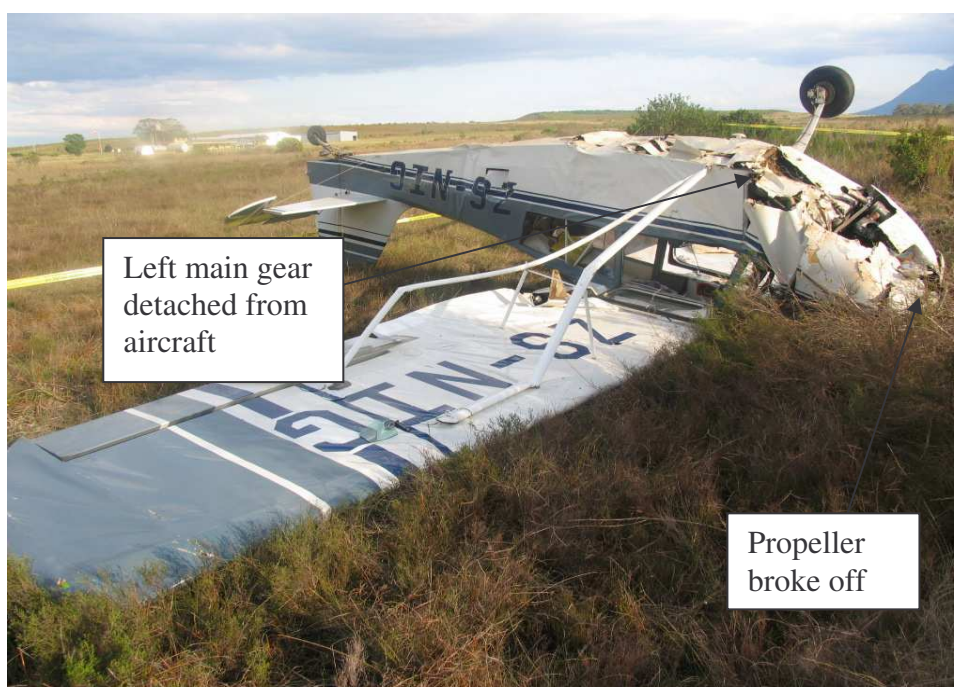
1.3.1 The aircraft sustained major damage during the accident sequence.

Figure 1: Damage to the aircraft

1.12.1 The pilot took off in a southerly direction and suddenly encountered dense fog. He then turned left into a northerly direction to return to land the aircraft on the runway. The aircraft approached in a left-hand wing low attitude and subsequently the left-hand main gear touched the ground and collapsed. The wings then levelled off, but the aircraft was still in a nose-down attitude. There was a ditch directly in front of the aircraft, and the nose gear impacted the ditch. The propeller struck and dug into the ground. The aircraft bounced and impacted the ground with its nose, before it nosed over, coming to rest in an inverted attitude on the grass area parallel to the runway.

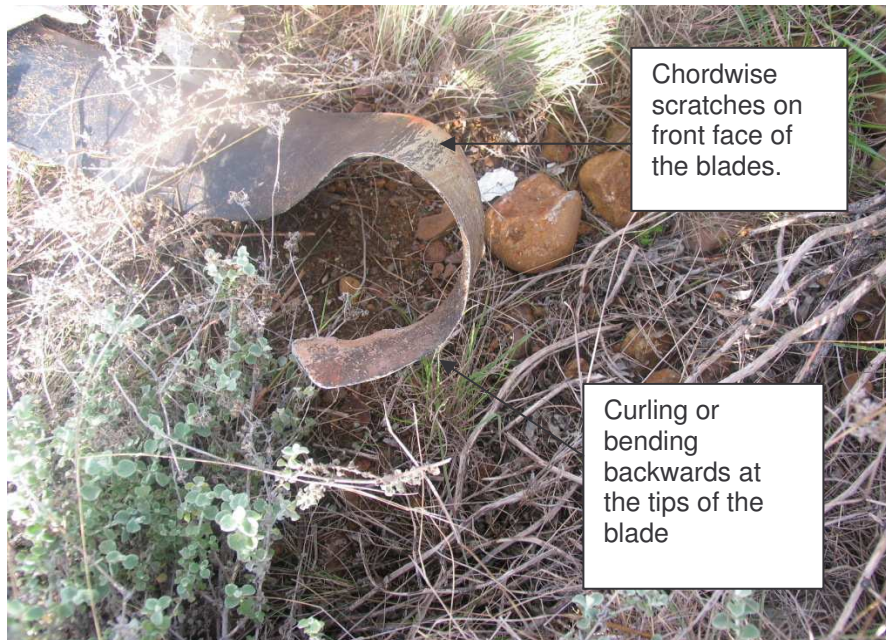
1.12.2 The propeller was recovered 4 m from the main wreckage. The damages to the propeller indicate that the propeller was rotating at the time of the accident.

Figure 2: Damage to the propeller
