**REPORT ON ACCIDENT TO  
HIMALAYAN HELI SERVICES PVT. LTD.  
LAMA HELICOPTER VT-WEX NEAR  
SHRI AMARNATHJI HELIPAD ON 09.07.2009**

1. Helicopter
  - a. Type and Model : SA315B Lama Helicopter
  - b. Nationality : Indian
  - c. Registration : VT-WEX
2. Owner/Operator : Himalayan Heli Services Pvt. Ltd., 104, 7 LSC Madangir, New Delhi-62
3. Date of Accident : 09.07.2009
4. Time of Accident : 07:30 IST.
5. Last Point of Departure : Baltal Helipad
6. Point of Intended Landing : Sh. Amarnathji Helipad
7. Geographical Location of Accident : At a distance of 500 m from Sh. Amarnathji Helipad  
**Coordinates:**  
Latitude : N 34° 12'55"  
Longitude : E 75° 30'40"  
Height : 11,700 ft.
8. Type of Operation : Non-scheduled Operation
9. Phase of Operation : During approach for landing

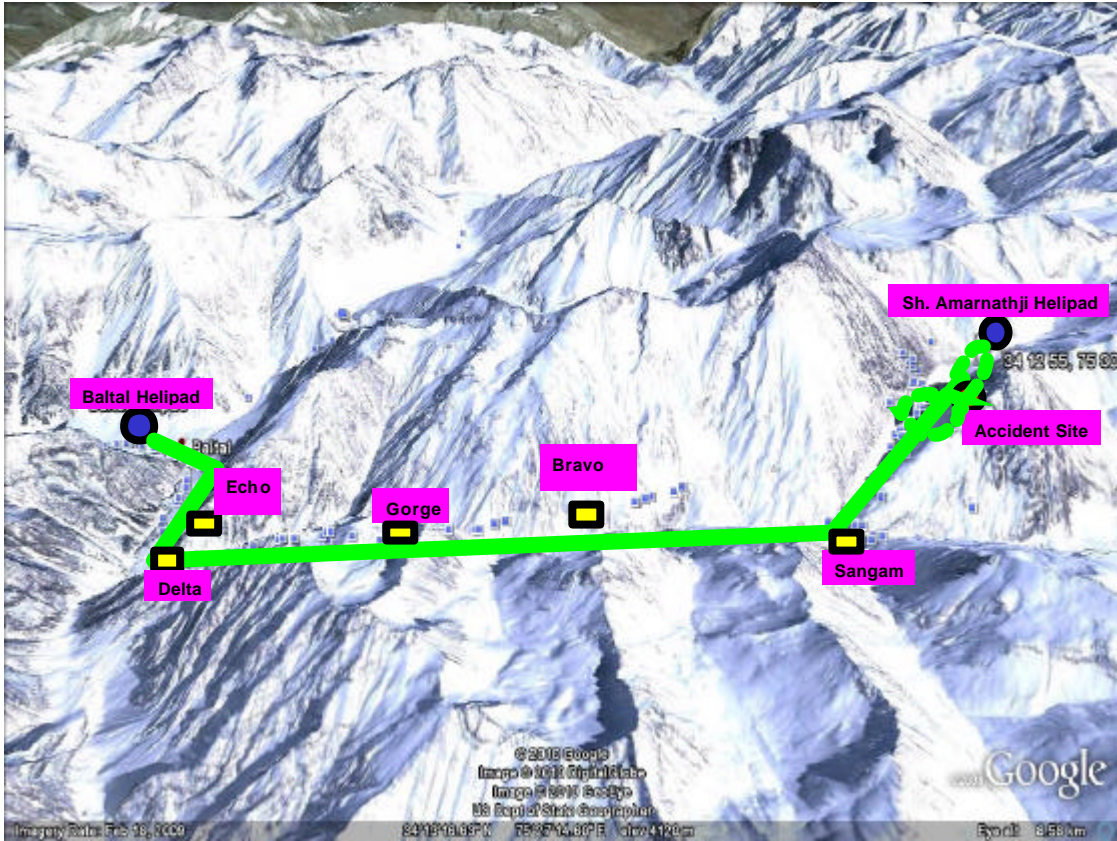
*Topographic chart indicating Take off helipad, the flight path, reporting points, landing helipad & the accident site*

- Reporting points
- The flight path,  
The dotted is the flight path after aborted landing.

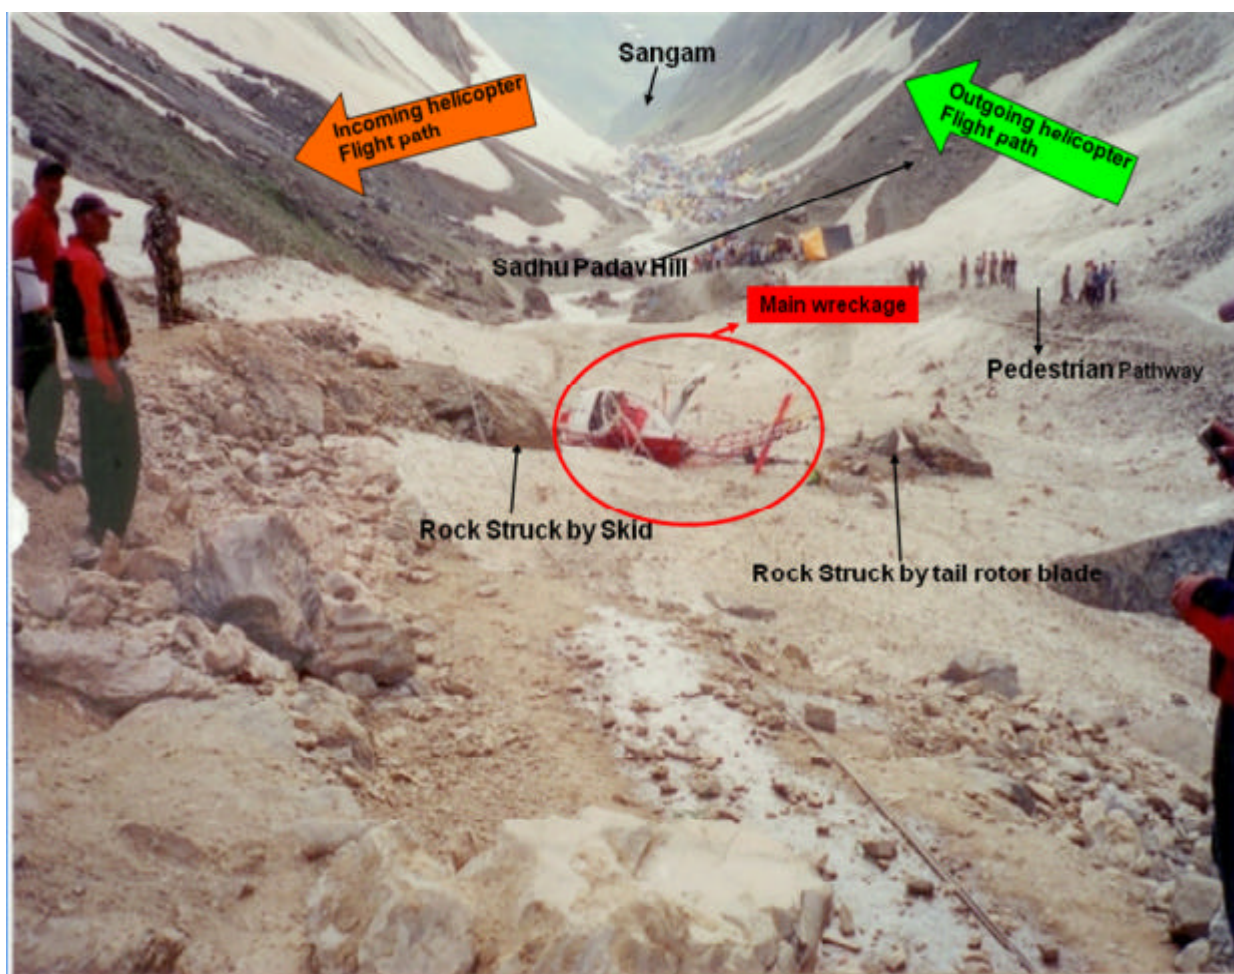
At around 500mts downstream of the Sh. Amarnathji helipad, helicopter carried out continuous right turn across the width of the valley. In the process it passed over a hill (Sadhu Parao) of height **11800 ft.** on the left side (out going route) of the valley and then while entering the valley again, its skid hit a female pilgrim standing on the pedestrian pathway flanking the valley and leading to the cave, at the back of her head (Lower occipital region). Thereafter it entered the valley in nose up attitude. In the process, the tail rotor and aft portion of tail boom of the helicopter hit the ridge/ stone as evident from the chipping of the rock. Due to the

impact the tail rotor separated along with the hub assembly. Due to loss of tail rotor the directional control was lost and helicopter went into spin. In the process the left skid of the helicopter hit one of the rocks and toppled over to the right side. This is indicated by impact marks on the rock and damage noticed on the skid and fuselage bottom portion. There was not much spread of the wreckage.

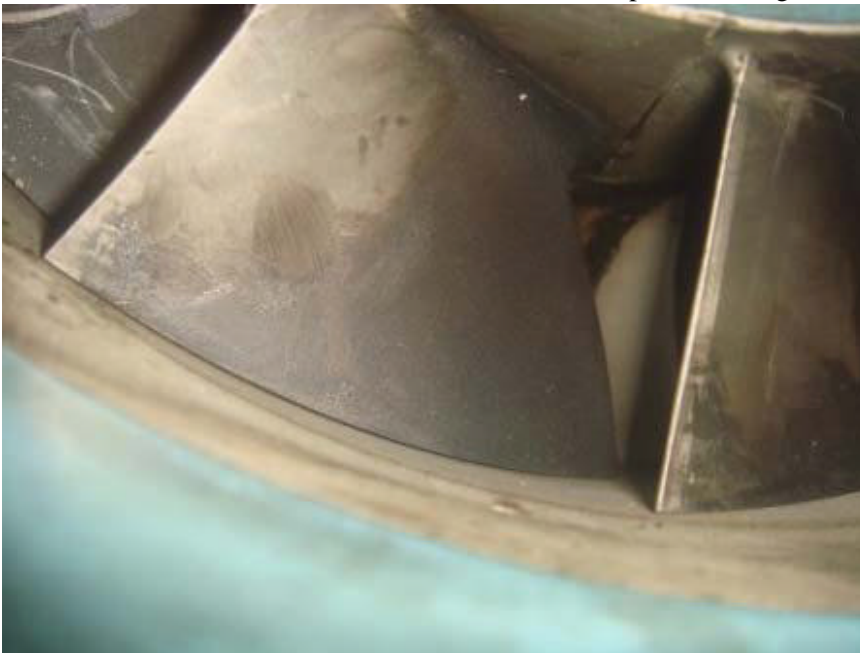
### **AXIAL COMPRESSOR & INLET PATH**

- Found dirty, black with oil presence due to impact, tiny particles of dislodged epoxy from inlet port found in entry area
- No Foreign Object Damage or significant damages
- No sign of erosion on blades' leading edge
- Blades' profile smooth
- Presence of oil with dirt (black) in the compressor casing.

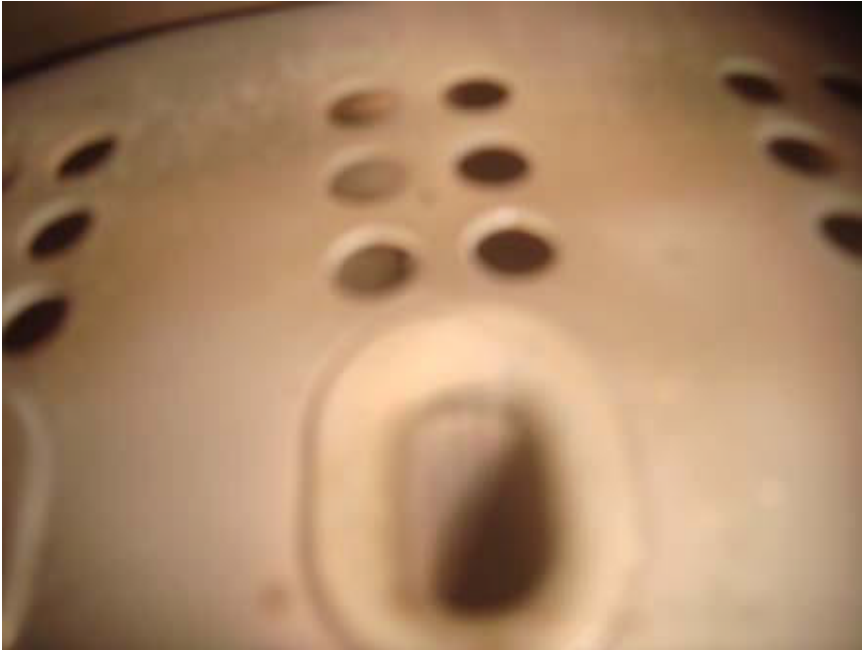
### **COMBUSTION CHAMBER**

- No overheat evidence noticed
- No Cracks, hot spots, bulging noticed
- General condition of combustion chamber satisfactory
- Sand and dust (possibly collected by its post impact position on floor) noticed in the turbine casing

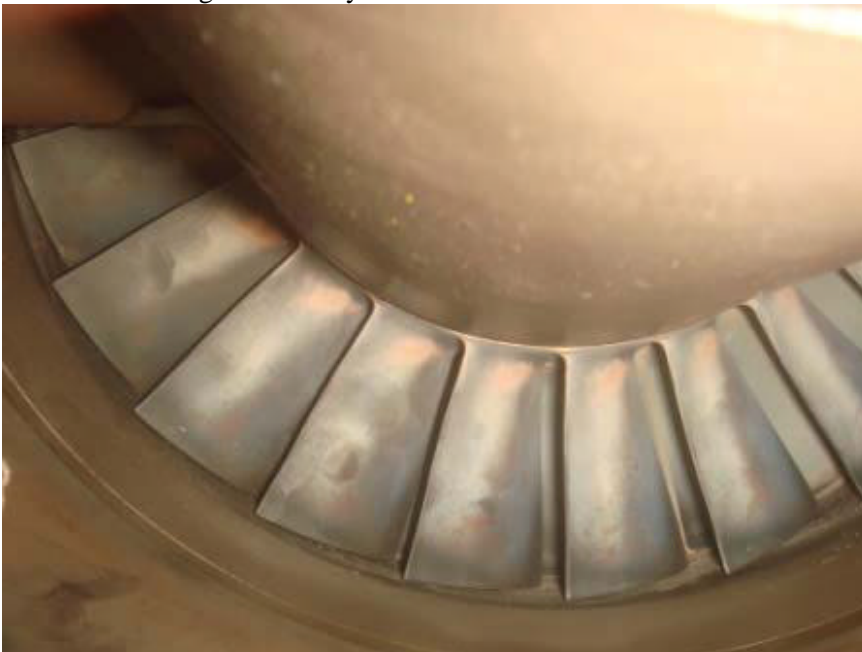
**1<sup>ST</sup>, 2<sup>ND</sup> & 3<sup>RD</sup> STAGE TURBINE**

No damage or anomaly noticed.

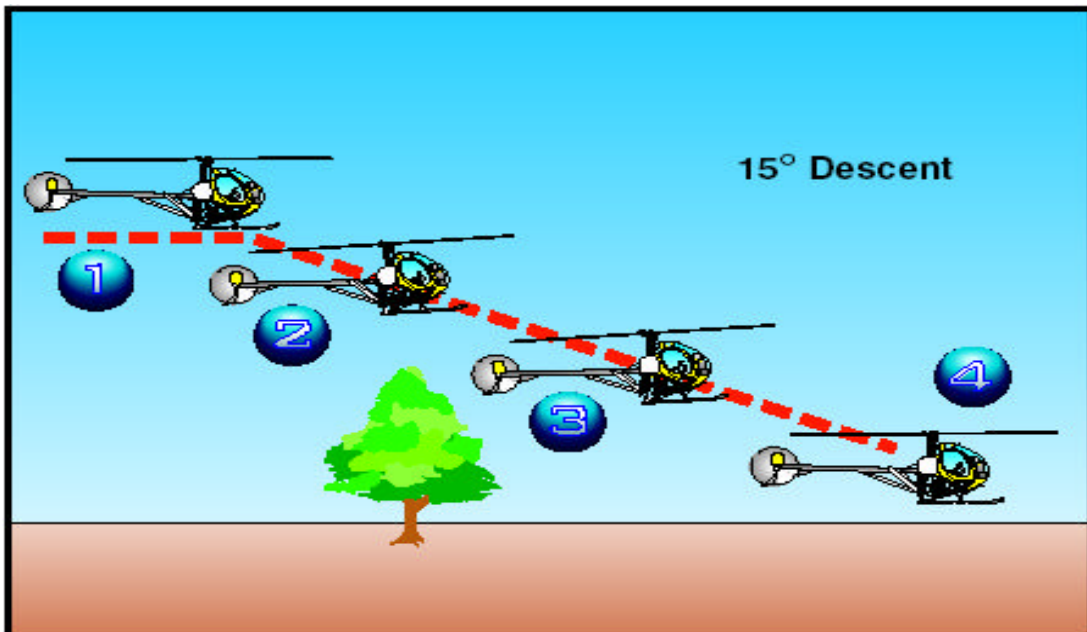
*Loss of effective translational lift occurs higher in a steep approach (Position 3 of the fig), requiring an increase in the collective to prevent the settling, and more forward cyclic to achieve the proper rate of closure. Terminating the approach at hovering altitude above the intended landing point with zero ground*

*speed (Position 4). If power has been properly applied during the final portion of the approach, very little additional power is required in the hover.*
