# AIRCRAFT ACCIDENT REPORT AND EXECUTIVE SUMMARY

Reference:	CA/18/2/3/8675	
<b>Aircraft Registration</b>	ZS-MPB	<b>Date of Accident</b>	18/07/2009		<b>Time of Accident</b>	1330Z
<b>Type of Aircraft</b>	Beech 36		<b>Type of Operation</b>	Private		
<b>Pilot-in-command Licence Type</b>		Private	<b>Age</b>	42	<b>Licence Valid</b>	Yes
<b>Pilot-in-command Flying Experience</b>		Total Flying Hours	1898,22		Hours on Type	177,2
<b>Last point of departure</b>		Stellenbosch aerodrome (FASH) in the Western Cape Province				
<b>Next point of intended landing</b>		Upington International Airport (FAUP) in the Northern Cape Province				
<b>Location of the accident site with reference to easily defined geographical points (GPS readings if possible)</b>						
Gravel road approximately 25 km west of Kenhardt in the Northern Cape						
<b>Meteorological Information</b>		Temperature 22°C. CAVOK.				
<b>Number of people on board</b>	1+0	<b>No. of people injured</b>	0	<b>No. of people killed</b>	0

**Name of Owner/Operator** : JF Holdings (PTY) LTD  
**Manufacturer** : Beech Aircraft Corporation  
**Model** : B 36 TC  
**Nationality** : South African  
**Registration Marks** : ZS-MPB  
**Place** : Appro

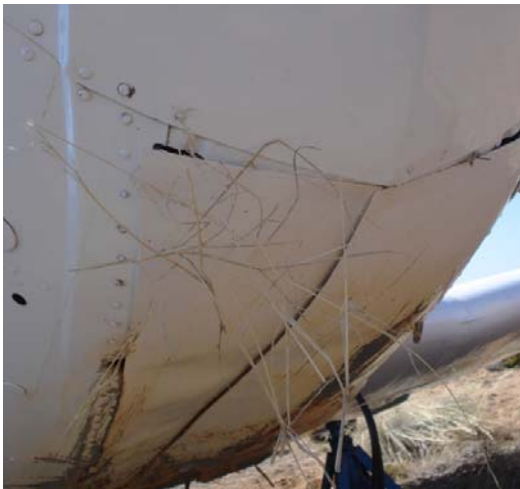
Picture 1. Showing the landing gear doors closed

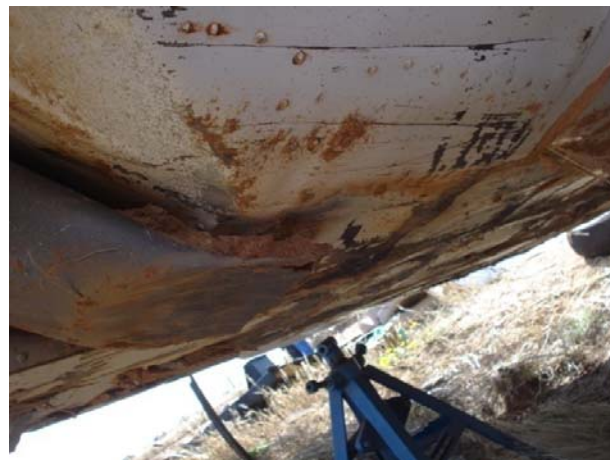
Picture 2. Showing the lower part of the aircraft.

1.3.1 The aircraft suffered damage to the engine, underside and propeller.

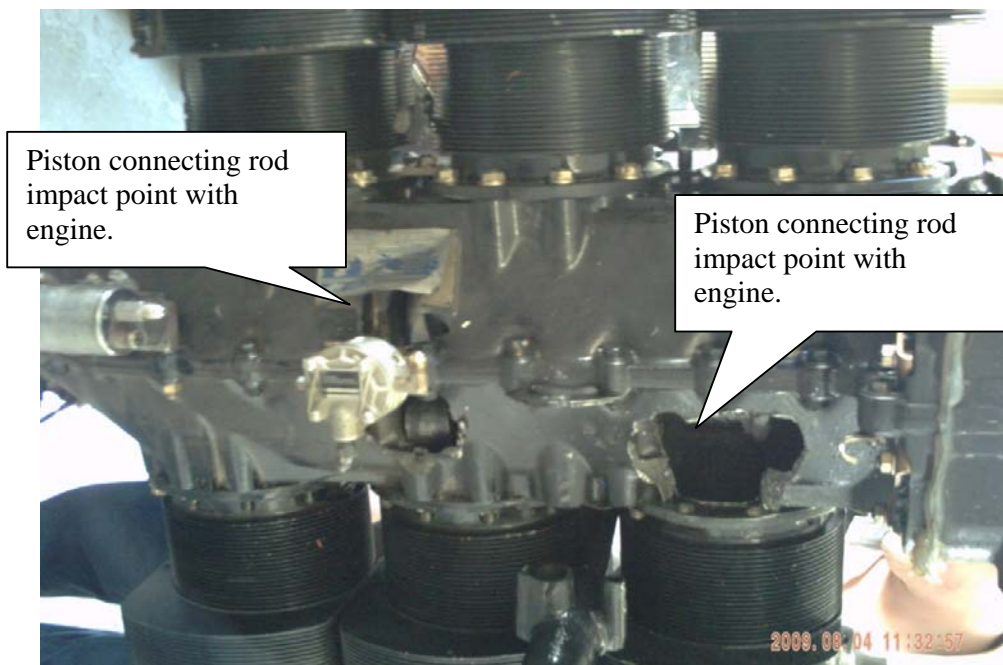
Picture 3 showing uncontained engine failure.

3.1.5 The dislodged seal caused the engine oil to leak out of the engine. The absence of adequate lubrication resulted in the engine suffering an uncontained engine failure in flight.

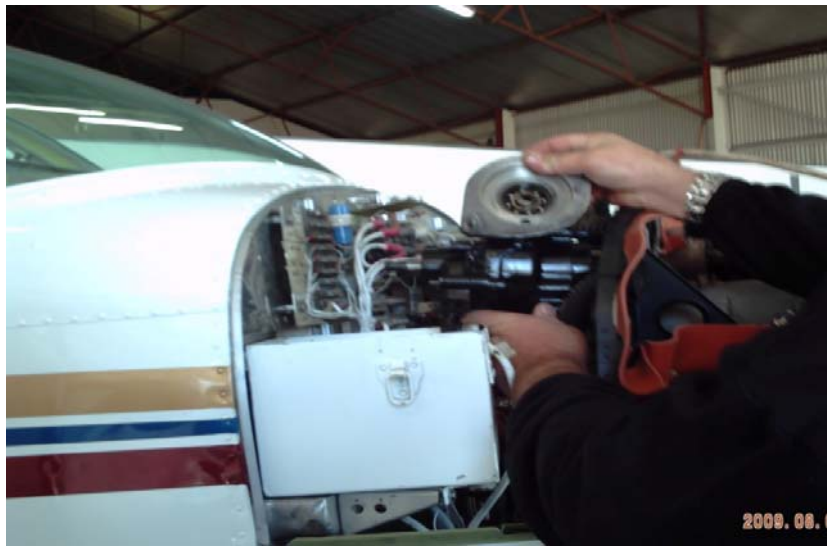
Replacing the starter clutch assembly required the technician installing the starter clutch assembly to obtain the assistance of a more experienced technician to assist in the installation of the unit, as he was of the opinion that it would not fit. The more experienced technician, after moving electrical wiring out of the way, managed to slip the starter clutch assembly over the studs without moving the engine.

Picture 4 showing some of the challenges of installation.

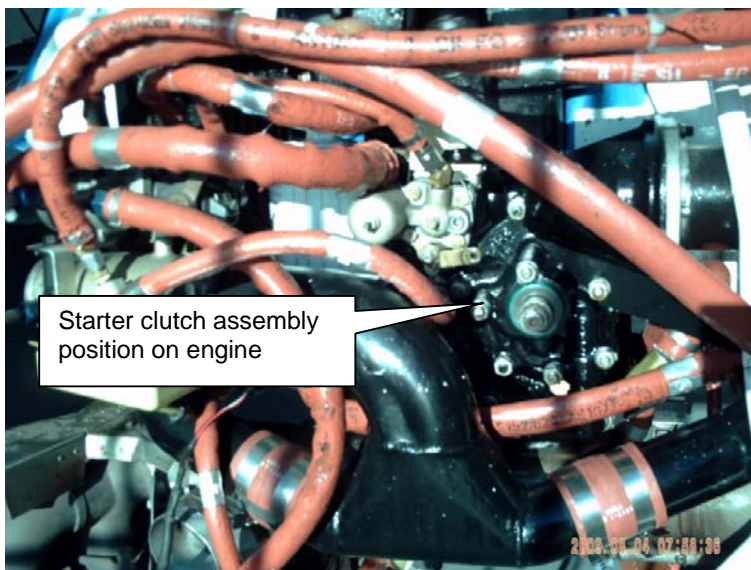
The starter clutch assembly is located on the engine between the firewall of the aircraft and the engine of the aircraft.

Picture 5 showing the position of the starter clutch assembly on the engine.

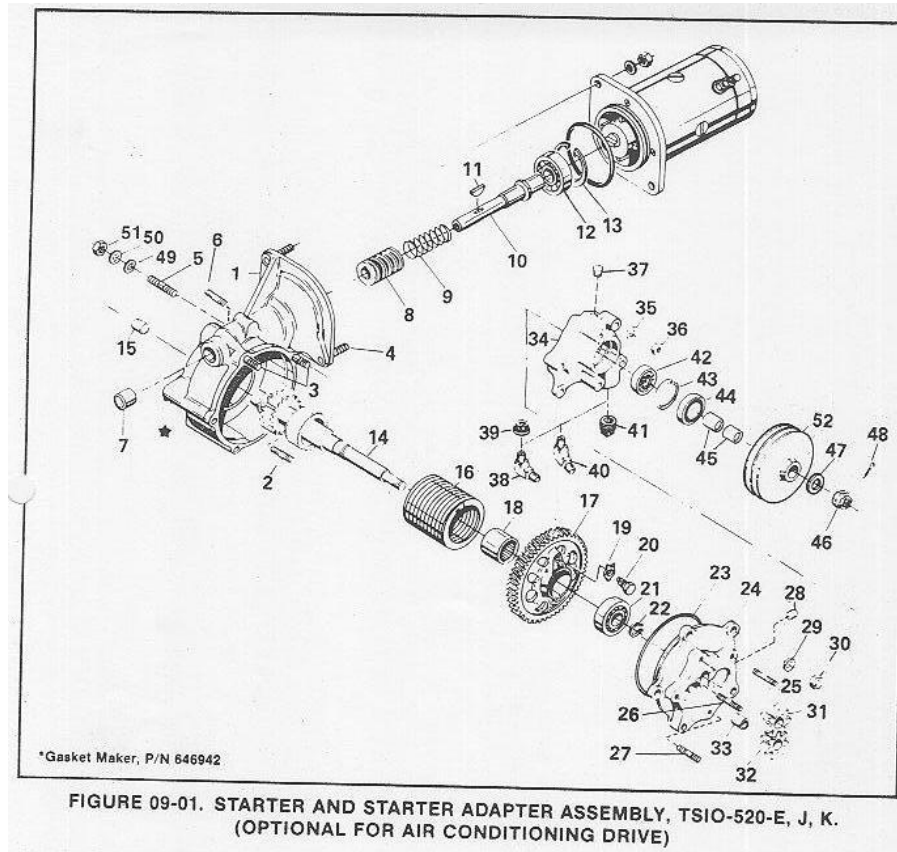
The parts removed were the starter and starter adaptor assembly, which included the optional air-conditioning drive.

The part supplied was the starter and starter adaptor assembly, which did not include the optional drive system as illustrated in Figure 1 Part 52, and associated components.

Figure 1 Showing Starter clutch assembly with optional air-conditioning drive.

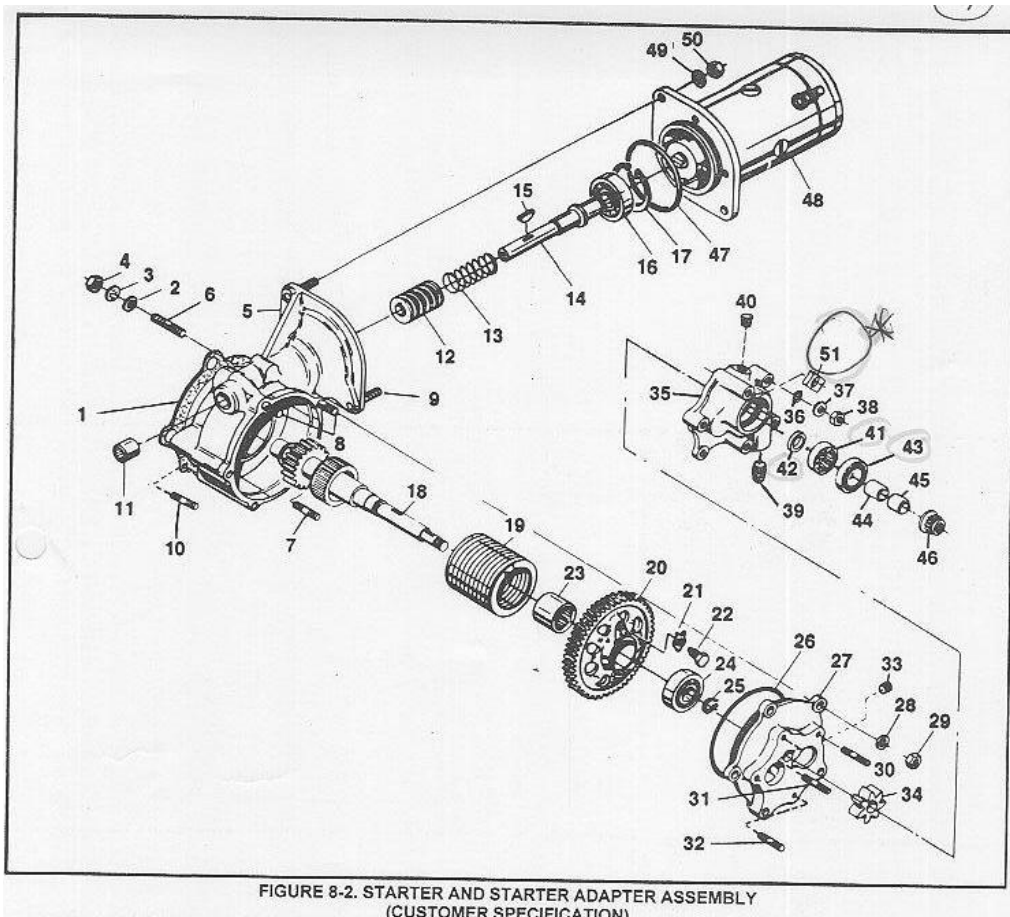
The absence of the optional air-conditioning drive requires that the starter clutch assembly be assembled as per Figure 3. A clip seal retainer (Figure 3 Part 51) needs to be installed.

The purpose of the clip seal retainer is to secure the oil seal (Figure 3 Part 43) to the body assembly scavenge pump (Figure 3 Part 35).

Figure 3 showing starter clutch assembly without optional air-conditioning drive.

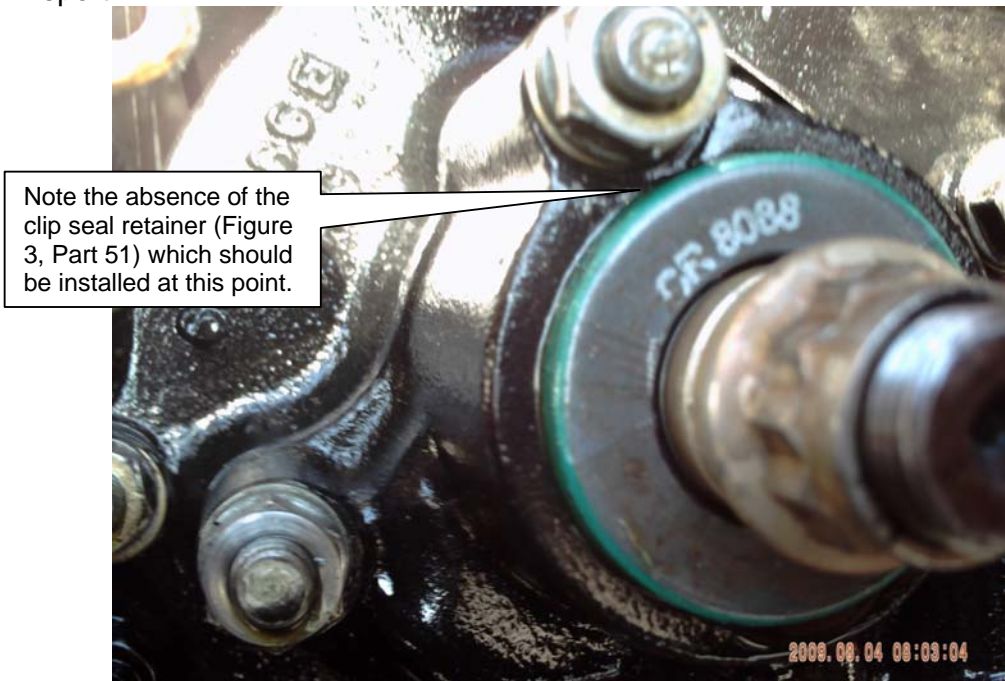
Picture 6 showing the dislodged oil seal on the starter clutch assembly.

- 2.7 The starter clutch assembly was supplied to the AMO without the clip seal retainer.
- 2.8 The clip seal retainer was omitted during installation of the starter clutch assembly. This resulted in the seal becoming dislodged during flight. The dislodged seal caused the engine oil to leak out of the engine. The absence of adequate lubrication resulted in the engine suffering an uncontained engine failure in flight.

3.1.4 The clip seal retainer had been omitted, resulting in the seal becoming dislodged during flight.

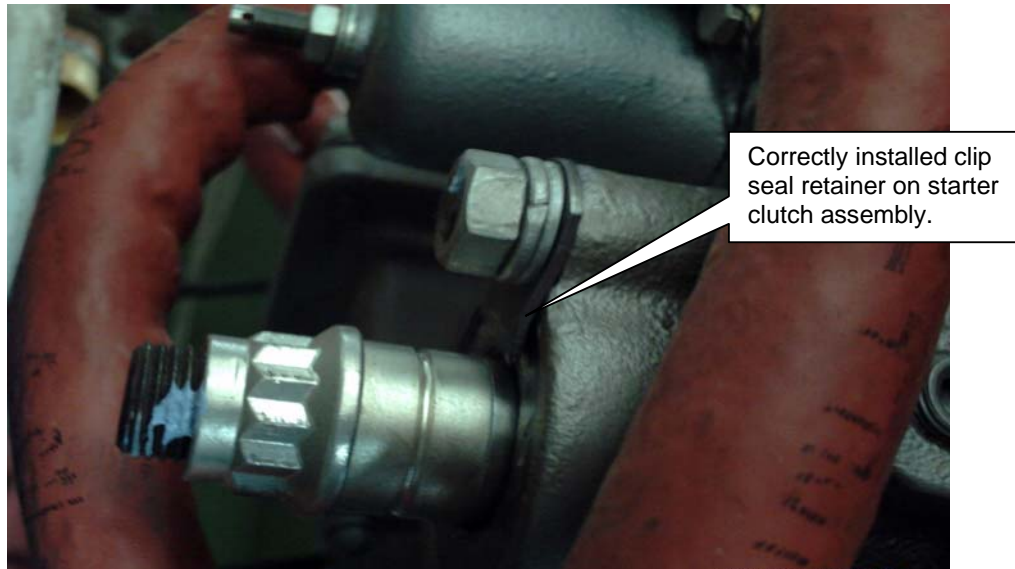
Picture 7 shows an example of the clip seal retainer on the starter clutch.
