## AIRCRAFT ACCIDENT REPORT AND EXECUTIVE SUMMARY

Reference:	CA18/2/3/8690	
<b>Aircraft Registration</b>	<b>ZS-OEG</b>	<b>Date of Accident</b>	2 September 2009	<b>Time of Accident</b>	1120Z	
<b>Type of Aircraft</b>	Mooney M20R		<b>Type of Operation</b>	Private		
<b>Pilot-in-command Licence Type</b>		Private	<b>Age</b>	42	<b>Licence Valid</b>	Yes
<b>Pilot-in-command Flying Experience</b>		Total Flying Hours	3 070.55		Hours on Type	1 203.8
<b>Last point of departure</b>		Kuruman Aerodrome (FAKU)				
<b>Next point of intended landing</b>		Port Alfred Aerodrome (FAPA)				
<b>Location of the accident site with reference to easily defined geographical points (GPS readings if possible)</b>						
Koffiefontein farm, 45 nautical miles from Kimberley, Northern Cape province. GPS position S 29°24.54" E 024°35.56"						
<b>Meteorological Information</b>		Surface wind: 270°/15-20 kts; Temperature: 30°C; Visibility: CAVOK				
<b>Number of people on board</b>	1 + 0	<b>No. of people injured</b>	0	<b>No. of people killed</b>	0

**Name of Owner/Operator** : Dr R F Odendaal Incorporated  
**Manufacturer** : Mooney  
**Model** : M20R  
**Nationality** : South African  
**Registration Marks** : ZS-OEG

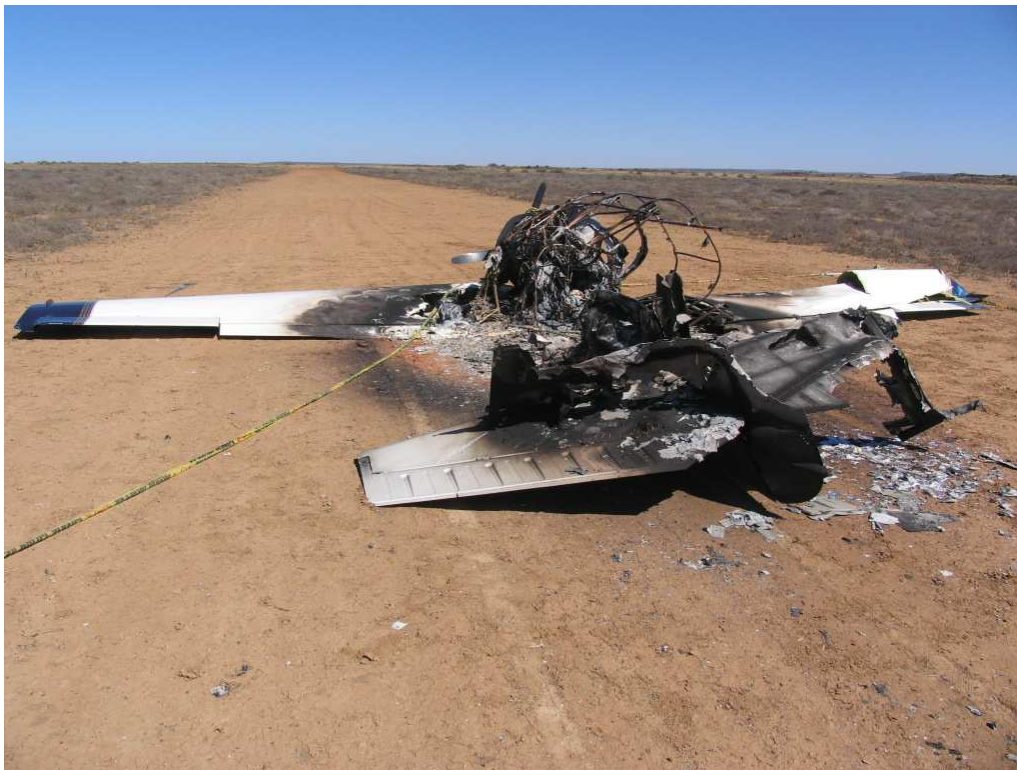
1.3.1 The aircraft was destroyed by fire after landing.

**Figure 1.** The burnt-out aircraft.

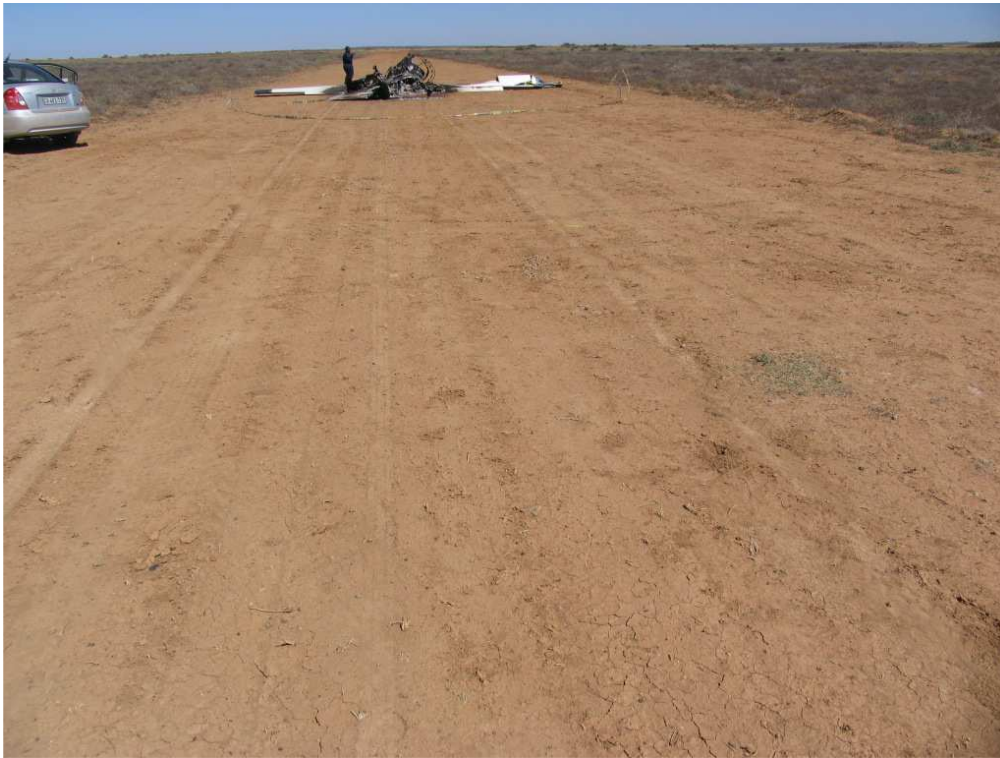
1.11.1 A normal landing was carried out and the aircraft came to a stop 300 m from touchdown. There was no damage to the aircraft at that point, but the smoke increased and turned dark.

Figure 2. Rear view of the wreckage and air strip.

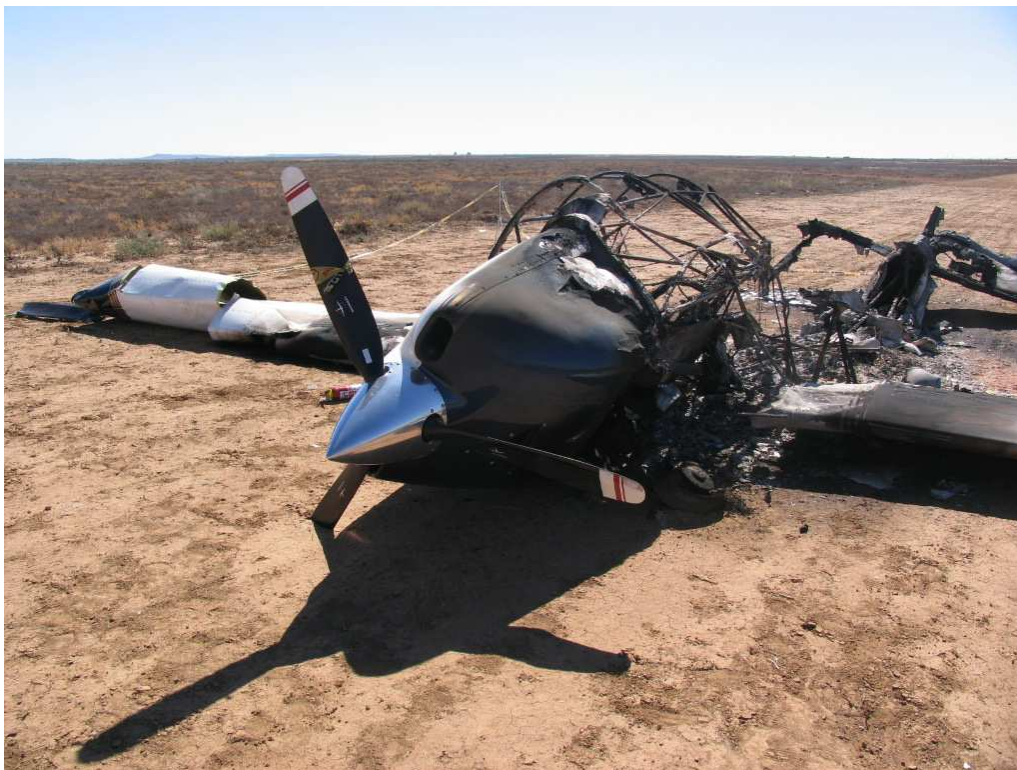
Figure 3. Front view of the wreckage.

1.11.3 The fuselage burned from the front to the back, and the wings dropped after structural failure, followed by the engine and propeller. The fire was contained on the cabin side by the firewall.
