FINAL INCIDENT REPORT

HCLJ510-000696	Incident		
Aircraft:	Bombardier CL-600-2D24 (CRJ 900)	Registration:	OY-KFF
Engines:	2 General Electric CF34-8C5	Flight:	Scheduled flight, IFR
Crew:	4 – no injuries	Passengers:	55 – no injuries
Location:	Copenhagen Airport Kastrup (EKCH) RWY 04R	Date and time:	09.10.2009 at 21.03 UTC

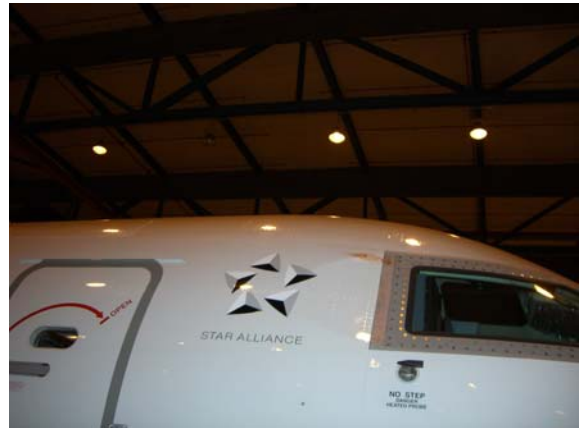
The picture on the right shows traces of blood from a bird on the right side window.

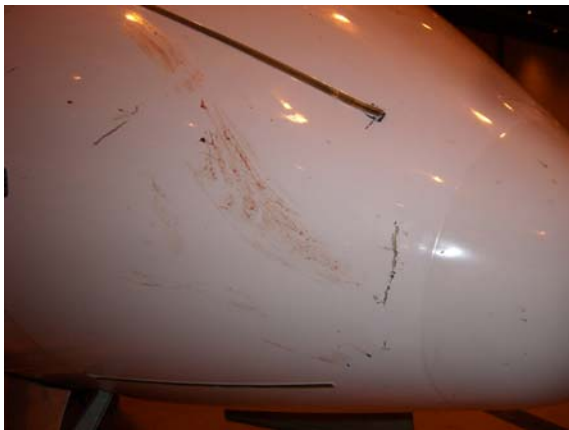
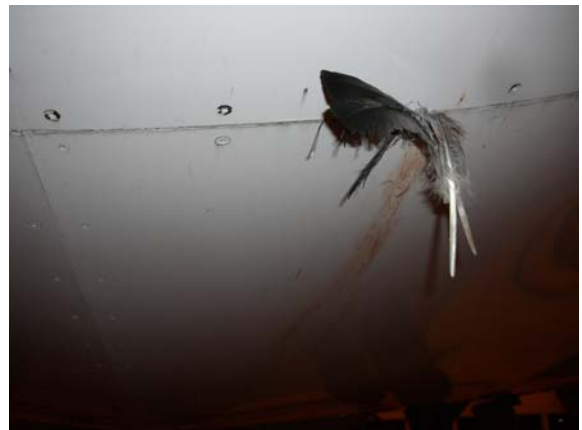
The radome, weather radar, left/right cockpit side windows, the right front edge of the wing, the right blade root/fuselage screen, the right motor pylon/screen were all damaged.

The two pictures below show traces of blood and feathers on the front of the right-hand side of the aircraft.

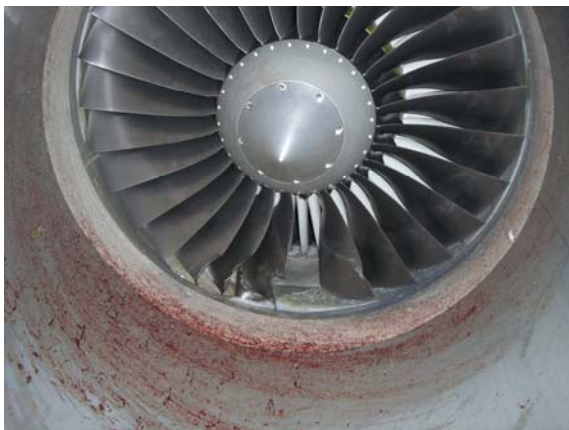
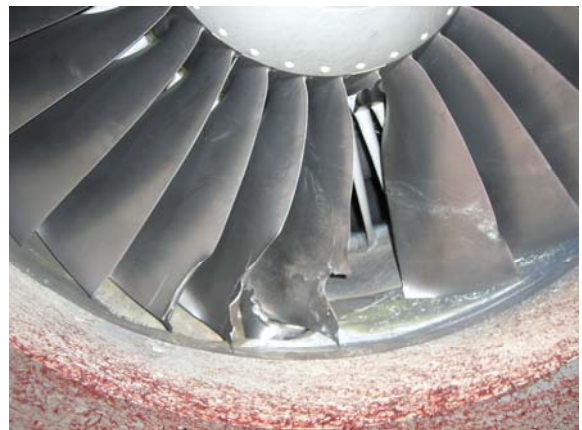
The right engine incurred extensive damage, as can be seen from the pictures below.

The aircraft's right engine was damaged significantly as a result of being struck by one or more birds. The damage to the engine's rotating parts resulted in powerful vibrations which concords with the vibration indications the pilots got on the vibration indicator in the cockpit.

The right engine showed clear damage to the foremost rotating parts whereas the left engine was undamaged.

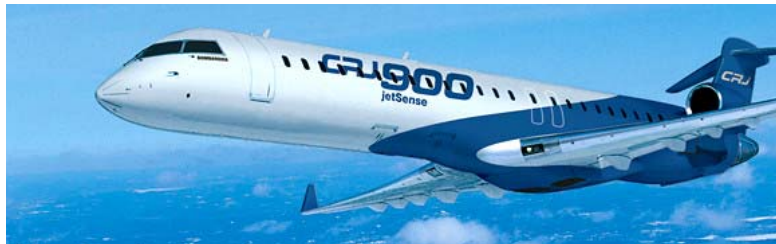
The aircraft was mainly struck by Barnacle geese on its right side which concords with the assertion that the migratory birds were driven towards the northwest in correlation with runway direction 40° northeast. As can be seen in the picture in Chapter 1.3 Information on the aircraft, aircraft type CRJ 900 has engines located on the side of the rearmost part of the fuselage. The Danish Accident Investigation Board cannot exclude the possibility that the left engine's location "in the lee of the fuselage" was the reason that it was not struck by the geese.

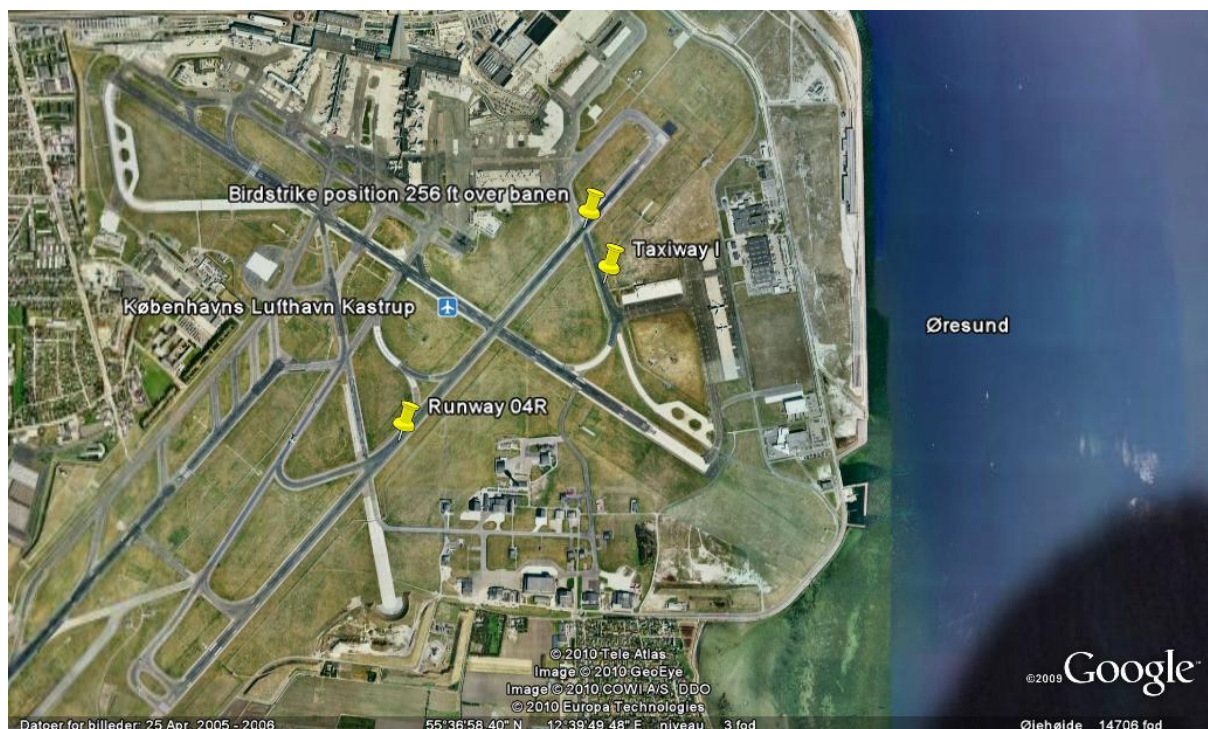
The picture below shows Runway 04R, Taxiway I and the position of the aircraft when it was hit by the birds is marked.
